## I. STRUCTURAL SYSTEMS (1)

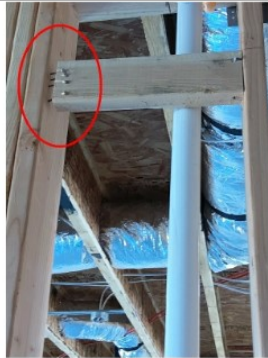
The boards should fill the voids they are meant to be attached between. This board has four nails in it, and it was cut too short. It should have been cut to the correct length, before it was attached. There are a lot of nails that missed their target.

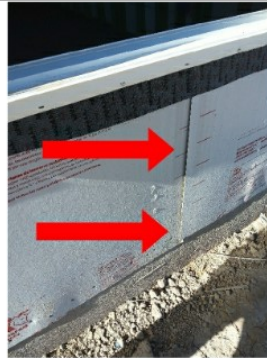
The exterior has pieces that are not sealed. Daylight comes through the gaps. The house should be sealed / wrapped to prevent the entry of insects or moisture.

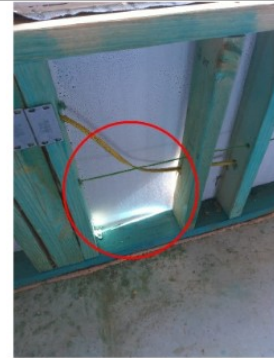
The exterior has pieces that are not sealed. Daylight comes through the gaps. The house should be sealed / wrapped to prevent the entry of insects or moisture. Multiple places around the house did not seal, they moved and allowed daylight through them. The house should be sealed. ALL exterior openings, not in the plans, should be corrected.

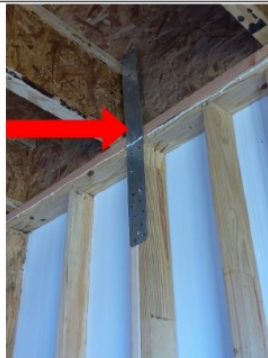
This metal strap goes thru the floor and is attached to the upstairs framework. Nothing wrong, but the inspector has never seen a house that had a metal strap going from the first floor to the second through the floor.

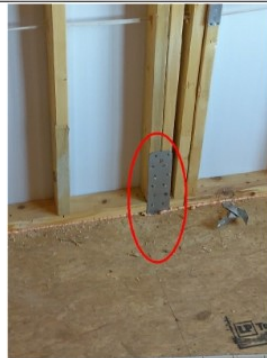
This metal plate begins on the first floor and extends thru the floor joist. Only one was found. The inspector does not know what it does or why it is there. Further research is required and will be completed.

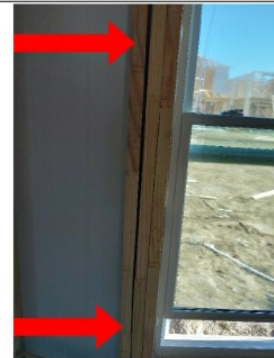
The board marked is not an equal distance from the board next to it. They touch at the bottom, but are separated at the top. It is believed they should be touching. It needs to be corrected or explained.
