# Inspection Report

## Towne Inspections

<b>Date:</b> 8/16/2019	<b>Time:</b> 09:00 AM	<b>Report ID:</b> 001093
<b>Property:</b>

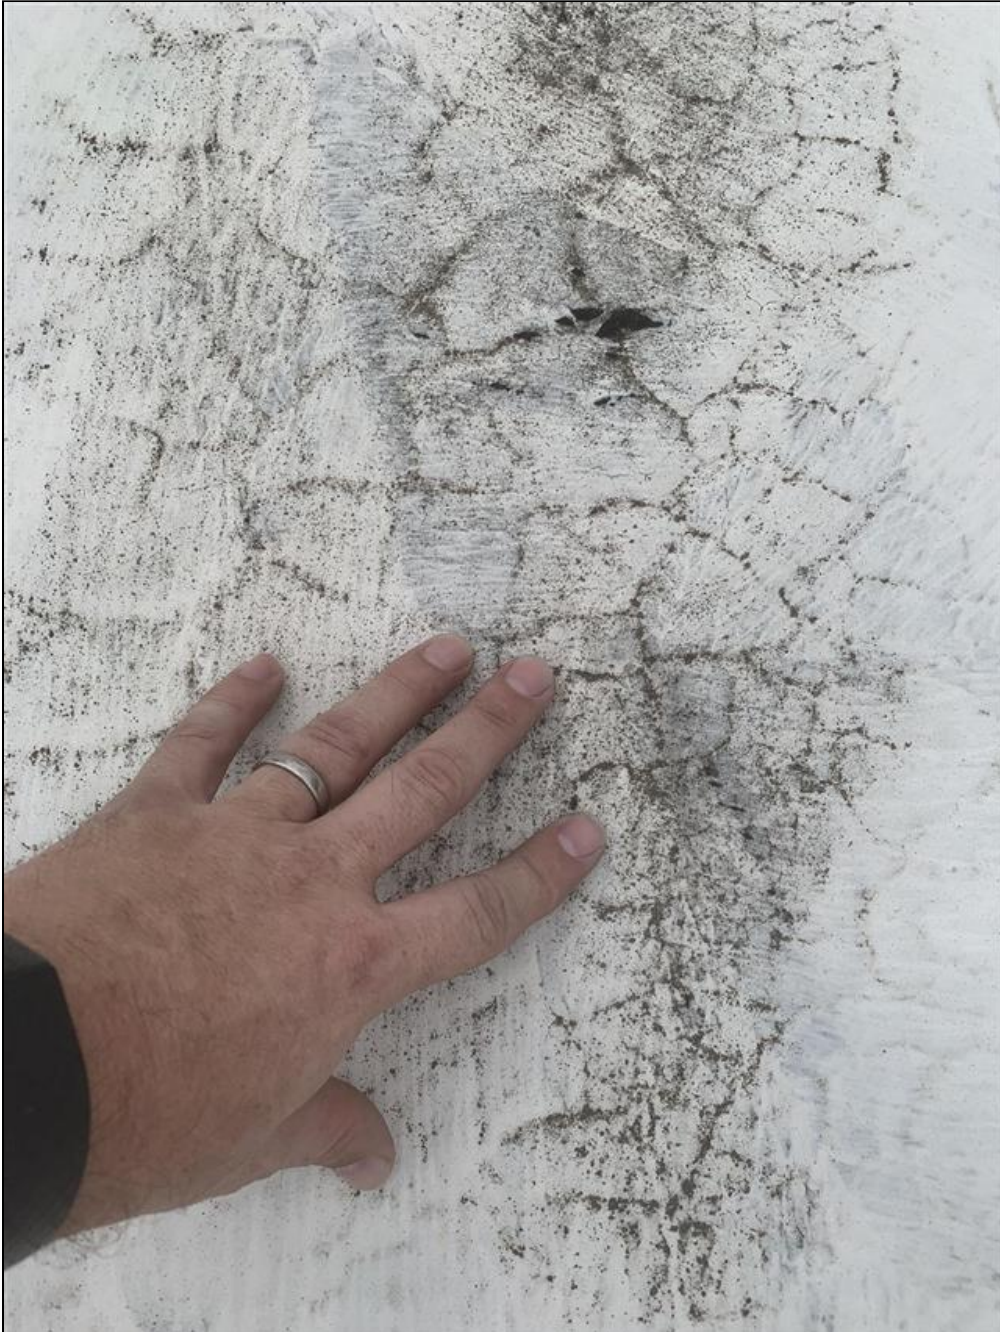
1.0 Item 3(Picture) A cracking pattern below the silicone coating was noted in some locations.

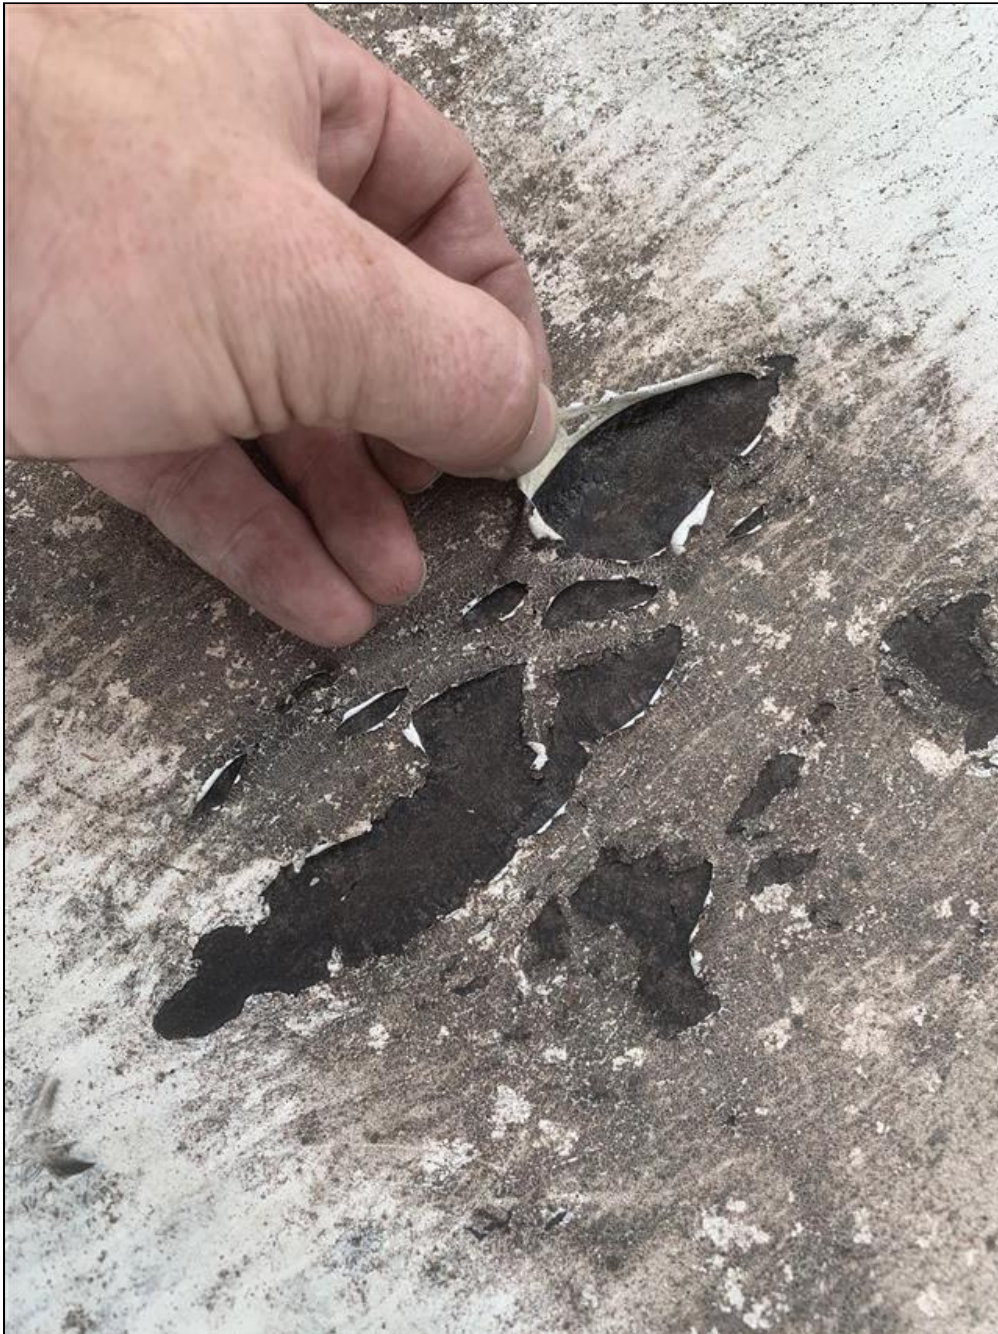
One small area where the silicone coating has worn away was noted (see photo). This is located close to the roof hatch and may have been caused by the roof hatch rubbing against it or from the silicone coating not adhering well to this area.

1.0 Item 4(Picture) Small spot near roof hatch where the silicone coating has worn away.

**Recommended:** Ideally roofs are expertly inspected annually, preferably in the autumn before the wind, rain and snow sets in. Otherwise, it's recommended to have a new roof inspected after the first five years, then at 10 years, 13, 15, 17, and every year after that. Handymen can be "handy" for small fixes and can save you a few dollars, but there's no substitute for a professional, licensed roofer who carries liability insurance and workers compensation on their employees.

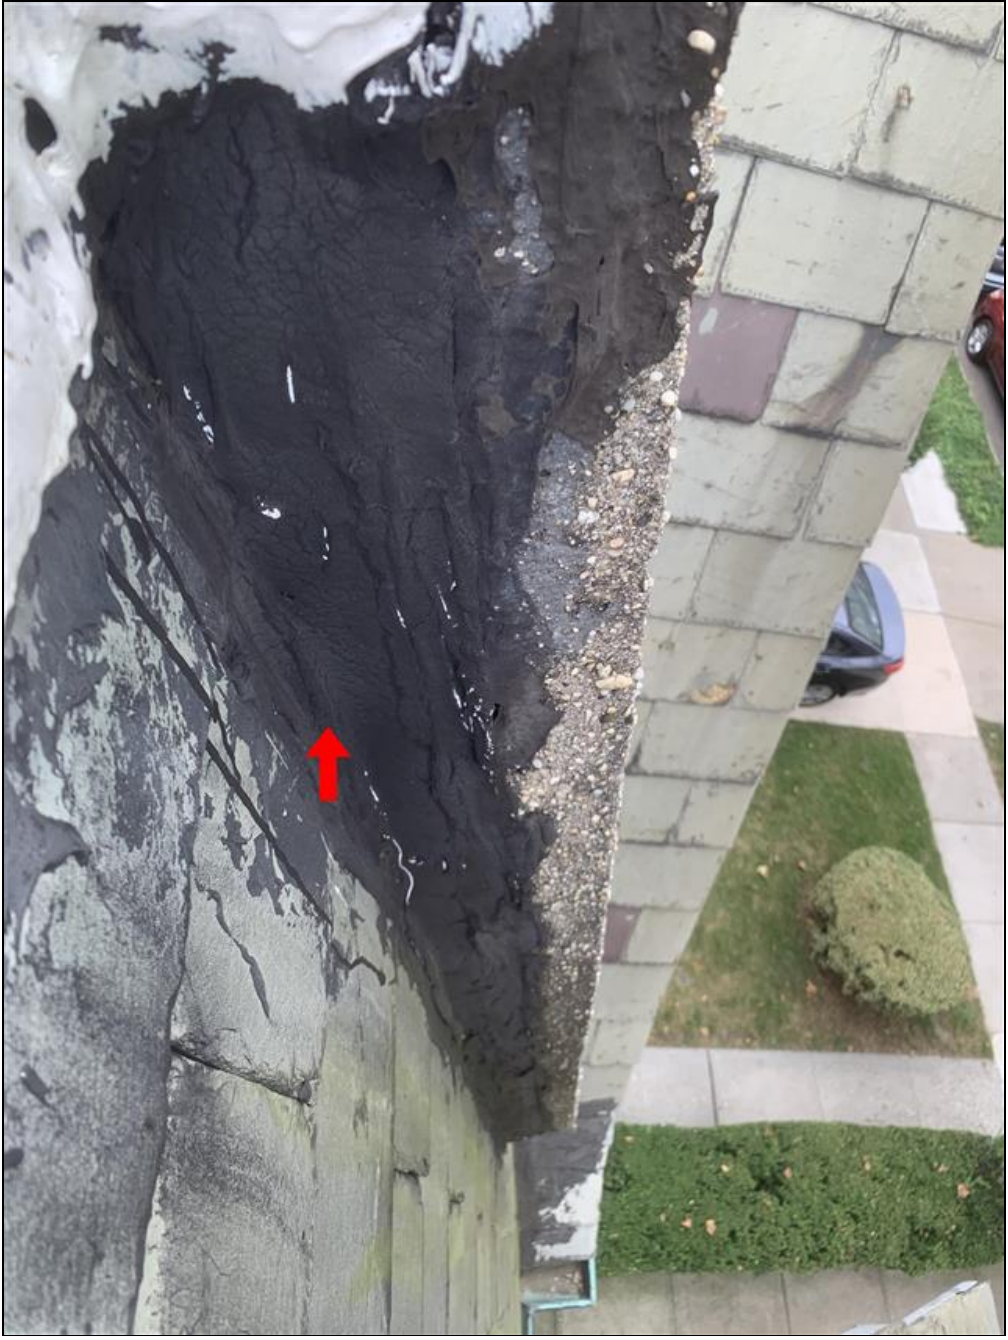
**Slate Roof Flashings - Maintain:** The slate roof of the home was observed to be flashed in some areas with flashing cement. Ideally, a slate roof should use metal flashings. When properly installed metal flashings will last much longer and require much less maintenance. The main thing to note here is that areas where flashing cement or other sealants have been used will eventually require maintenance or reapplication.

1.1 Item 3(Picture) Flashing cement used here appears to be holding its seal but will eventually need maintenance.

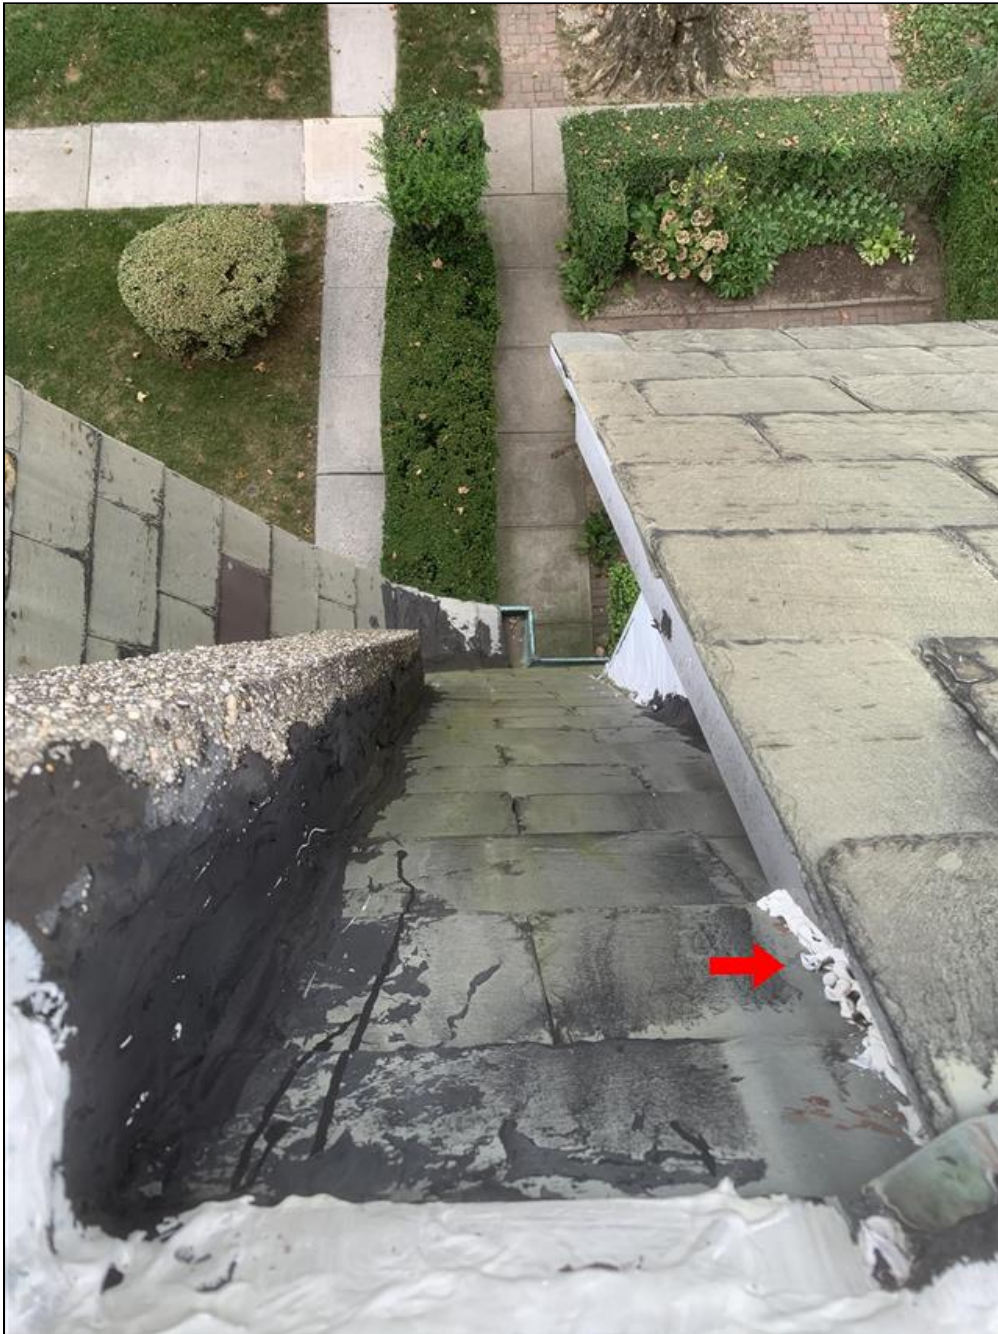
1.1 Item 4(Picture) Sealant at this location was applied very sloppy and does not appear to be doing much.

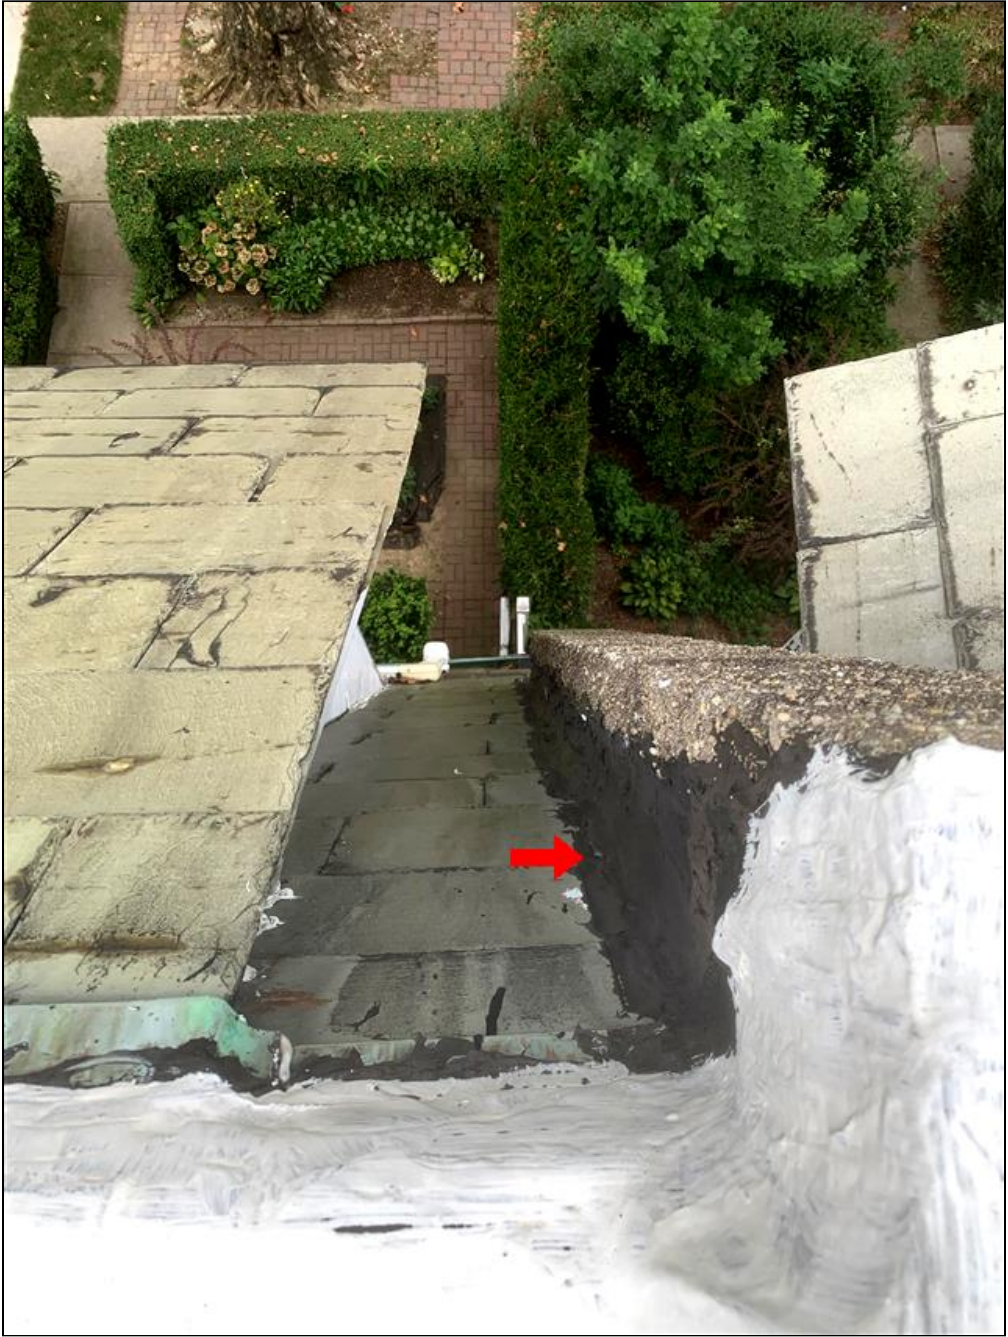
1.1 Item 5(Picture) Flashing cement used here appears to be holding its seal but will eventually need maintenance.

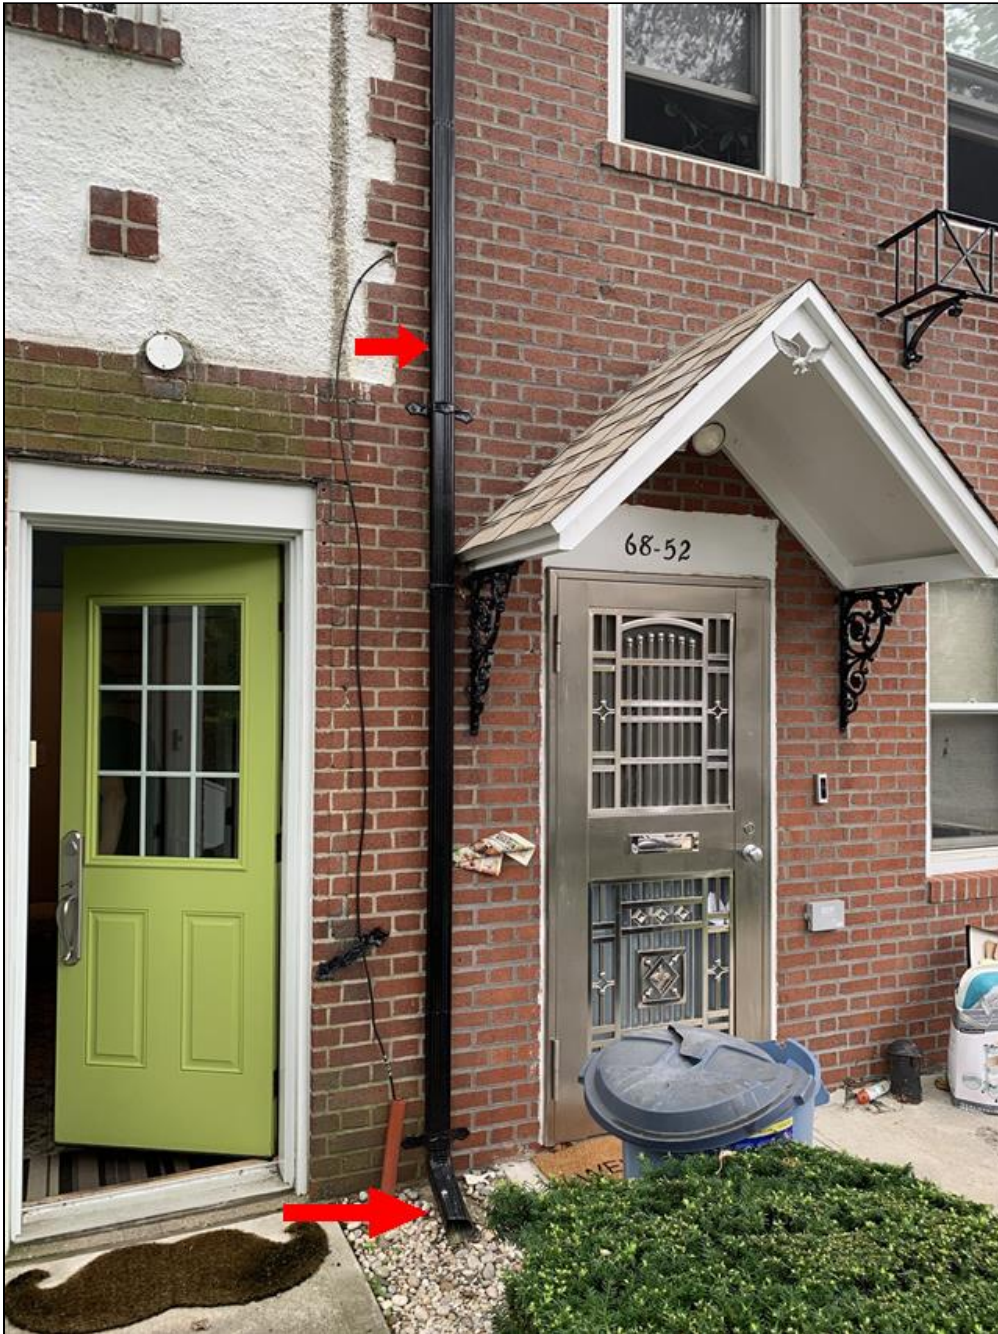
**Slate Roof Drainage - Right-hand downspout extension length:** The right-hand downspout at the front of the home should have a longer extension in order to direct water further away from the foundation (ideally 8-10 ft but even 3-6 ft would be better).

1.3 Item 6(Picture) Right-hand downspout terminates away from home but should extend further away from the foundation (ideally 8-10 ft but even 3-6 ft would be better).

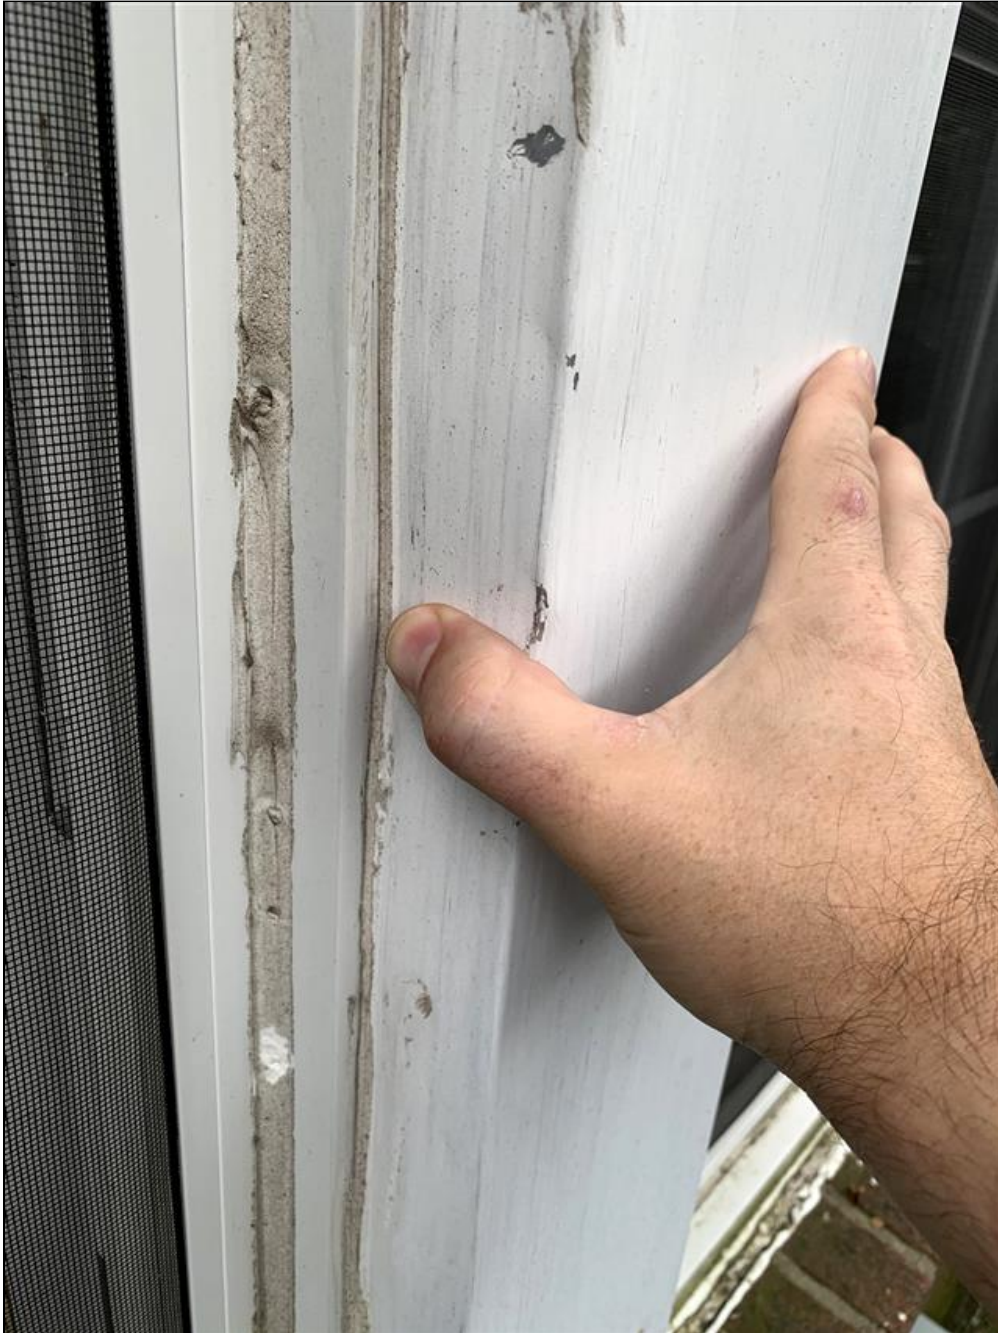
**Exterior Window Sealants (Maintain):** Window exteriors were observed to have protective flashings in place which is good. Sealants used around the seams of these flashings are starting to age and loose their seal (this is normal over time). Because sealants will eventually dry, shrink and crack, sealant-dependent areas should be examined on an annual basis and sealant re-applied as necessary. Only four photos are provided for brevity, but this condition was witnessed to varying degrees outside all window exteriors that were examined. It is recommended that all exterior window sealants be maintained to prevent moisture intrusion.

2.2 Item 1(Picture) Exterior window sealant has lost its seal.

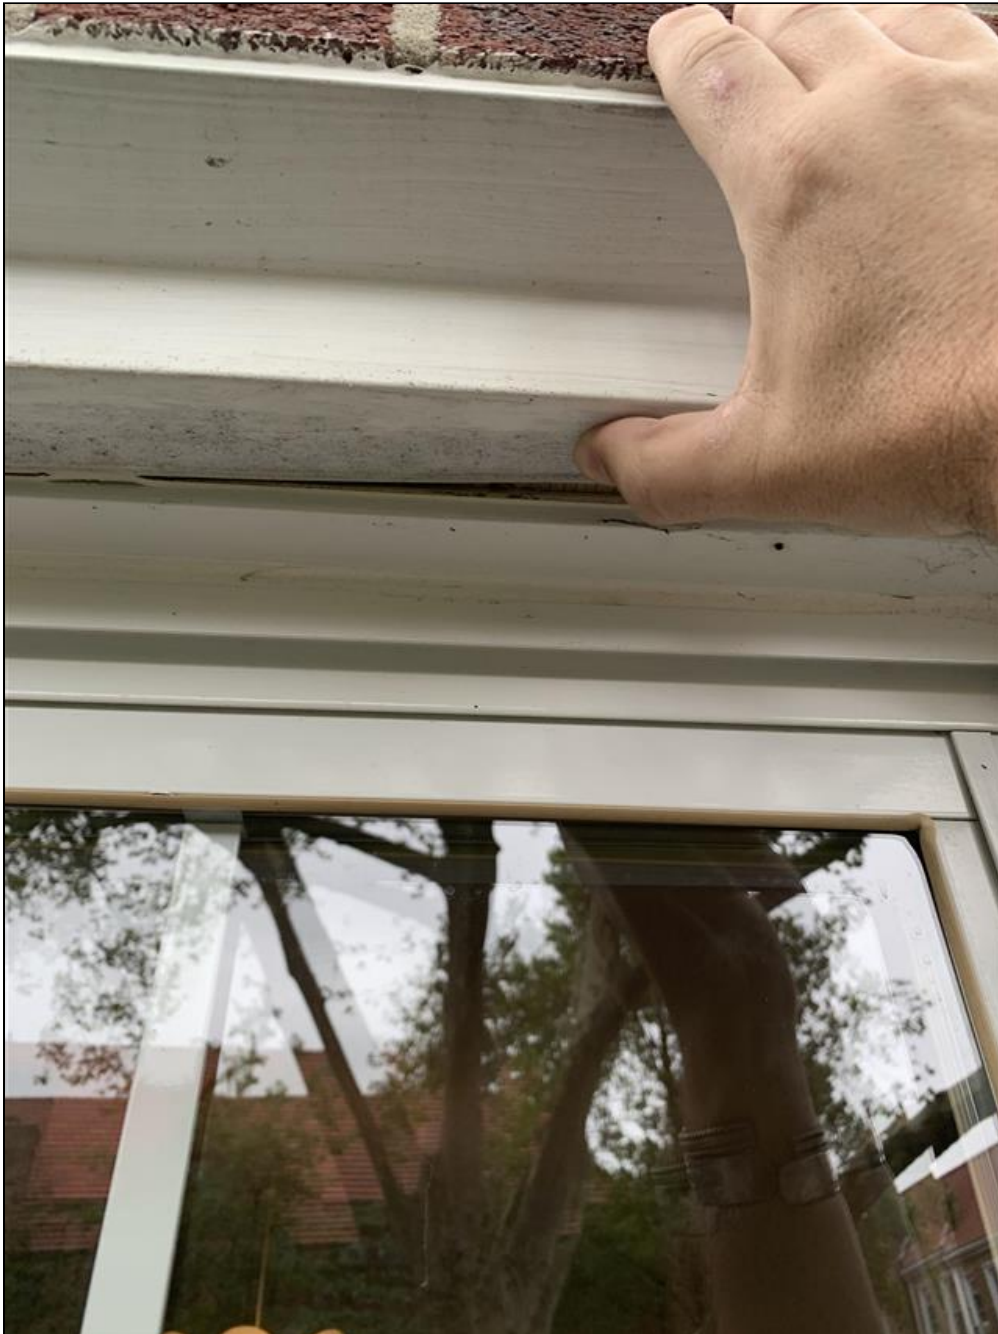
2.2 Item 2(Picture) Exterior window sealant has lost its seal.

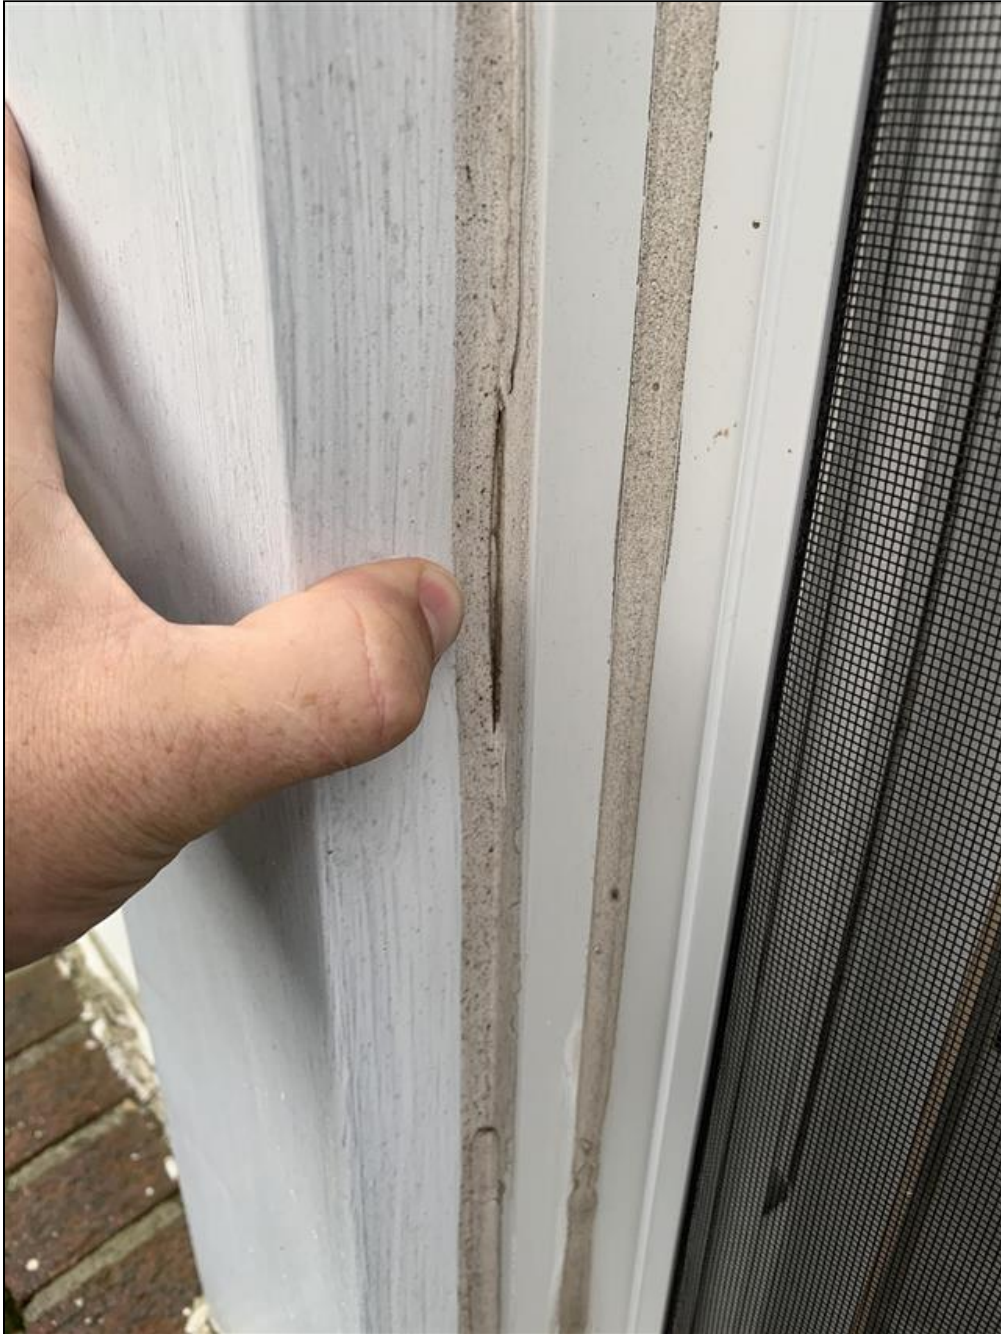
2.2 Item 3(Picture) Exterior window sealant has lost its seal.

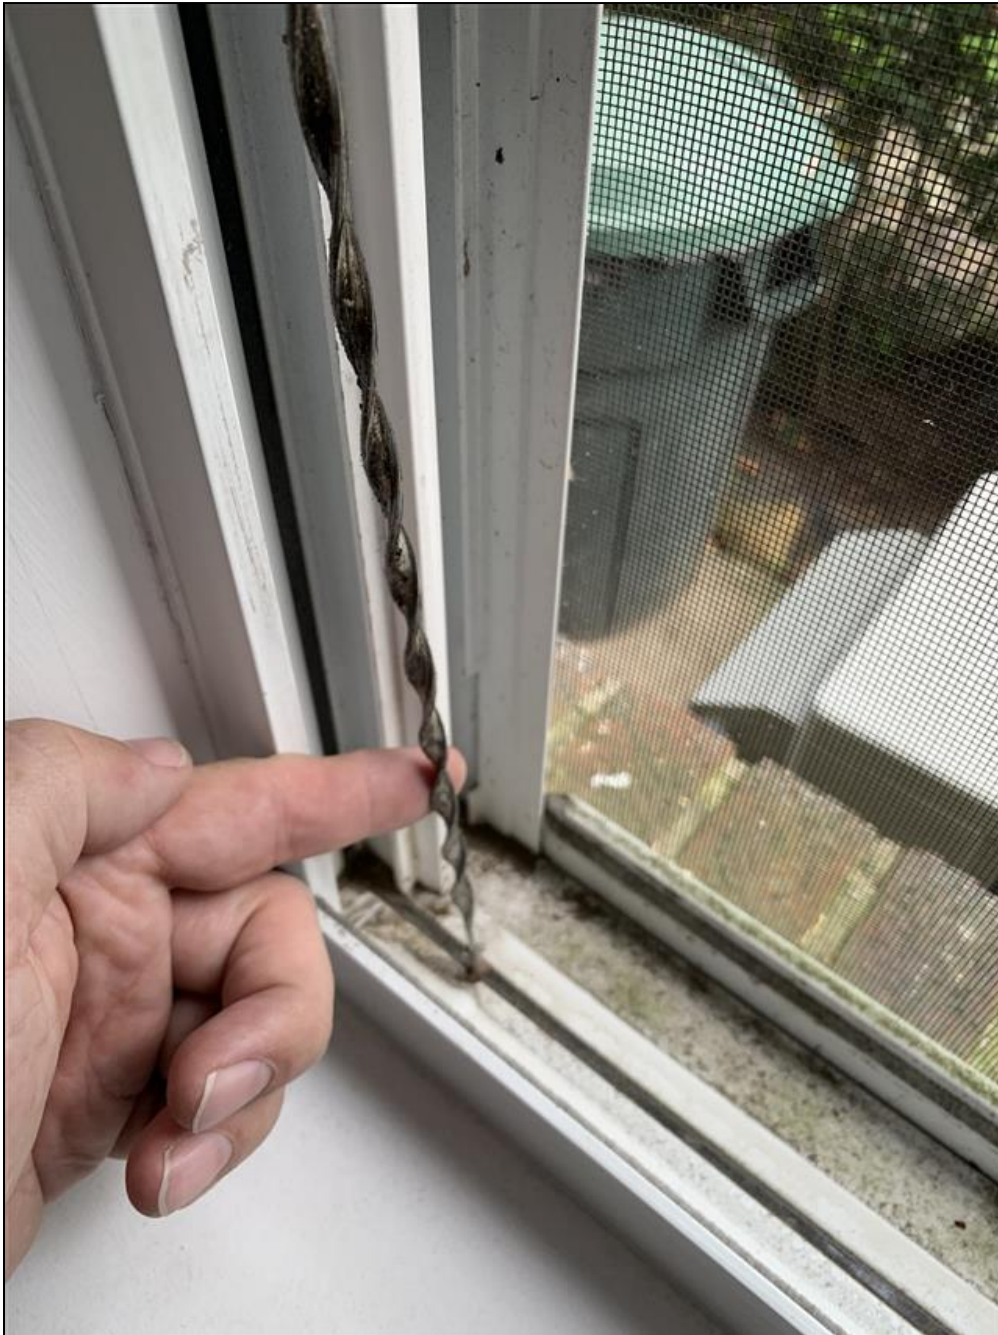
**Window Channel Balances Disconnected / Broken:** While inspecting the windows of the home two windows were observed to have disconnected or broken channel balances. Window channel balances can sometimes be reconnected, however; there also may be a broken component requiring that the balances be replaced. Further investigation and proper sizing for replacement parts may be needed.

4.7 Item 1(Picture) One of the window channel balances was found to be disconnected or broken in the first floor bedroom (right most window).

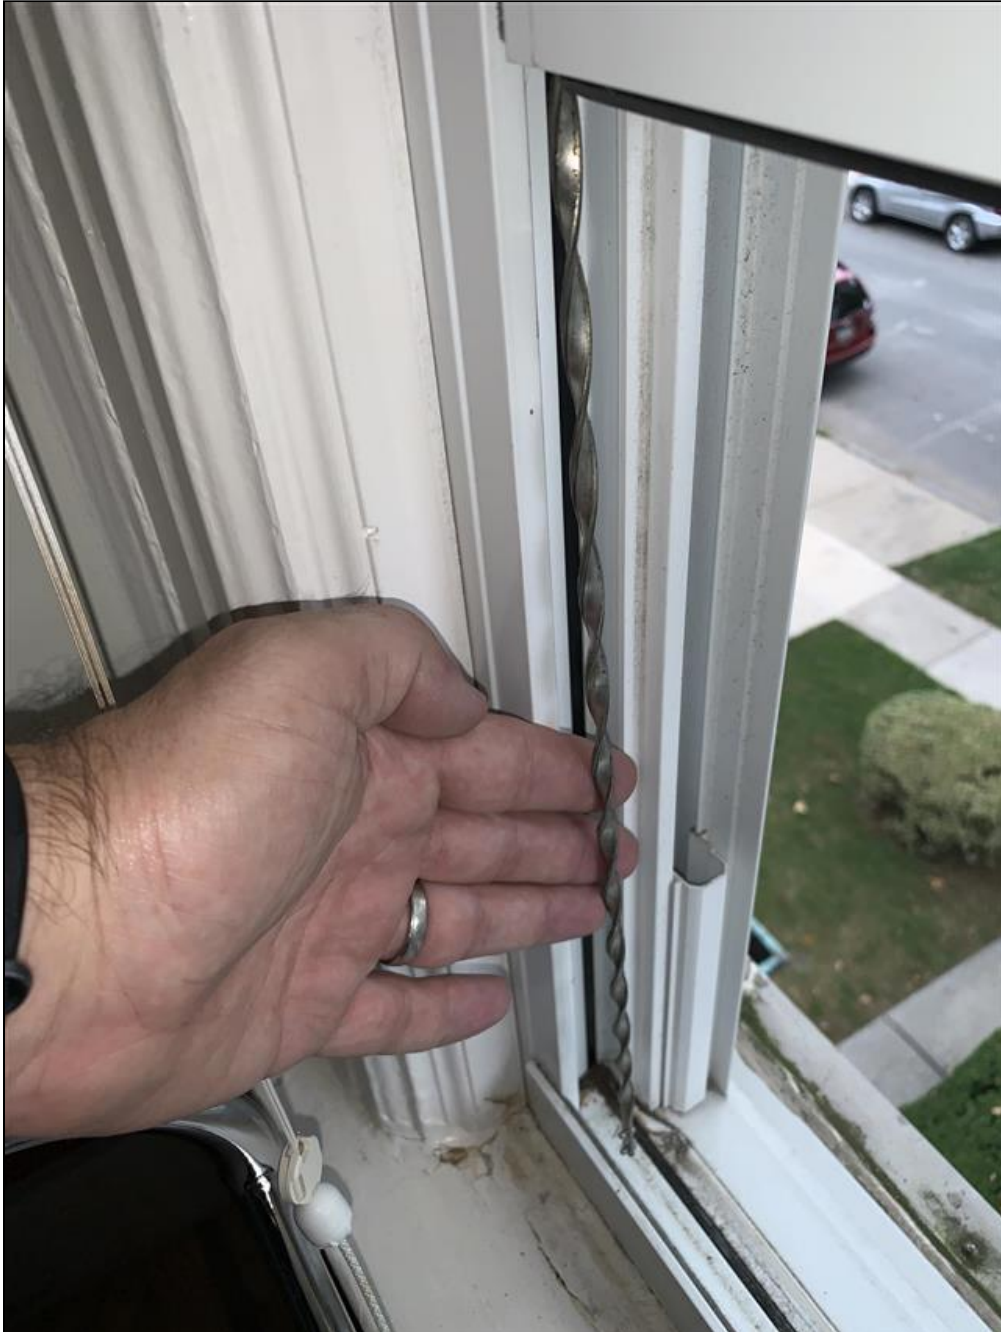
4.7 Item 2(Picture) A window channel balance was found to be disconnected or broken in the third floor walk-in-closet / bedroom.

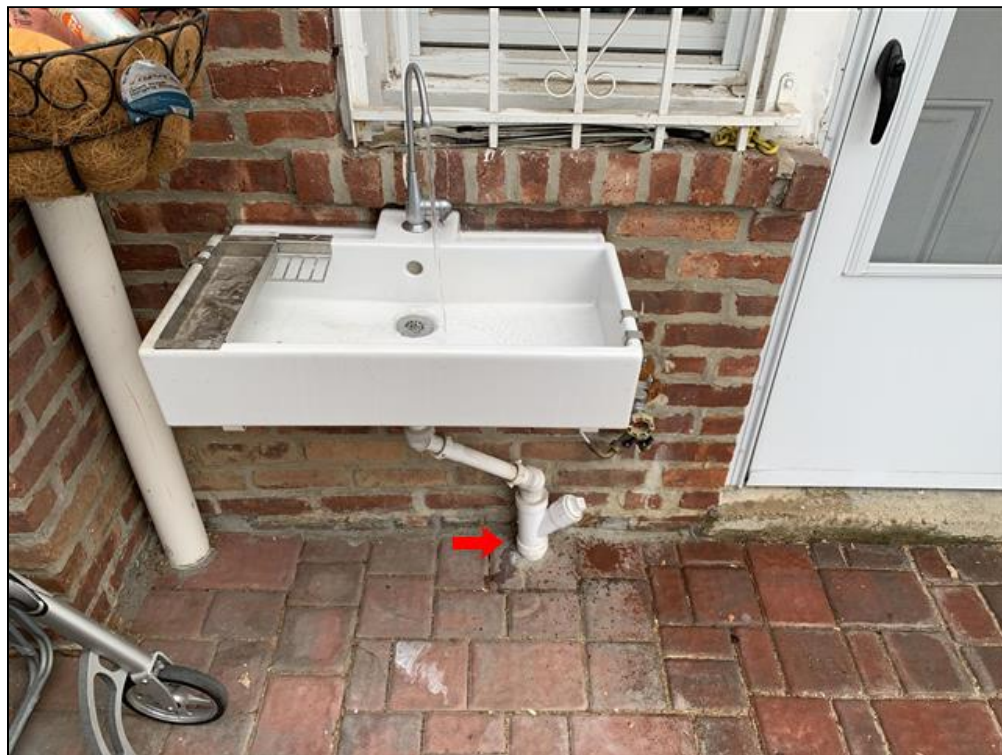
**Leaking Drain Below Backyard Sink:** A sink was installed at the rear of the home in the back yard. This sink was working on the day of inspection but the PVC drain pipe below it has a leak. It appears that this could easily be fixed using PVC joint compound at the joint where it is leaking.

6.0 Item 4(Picture) Sink at back of home with leak location indicated.

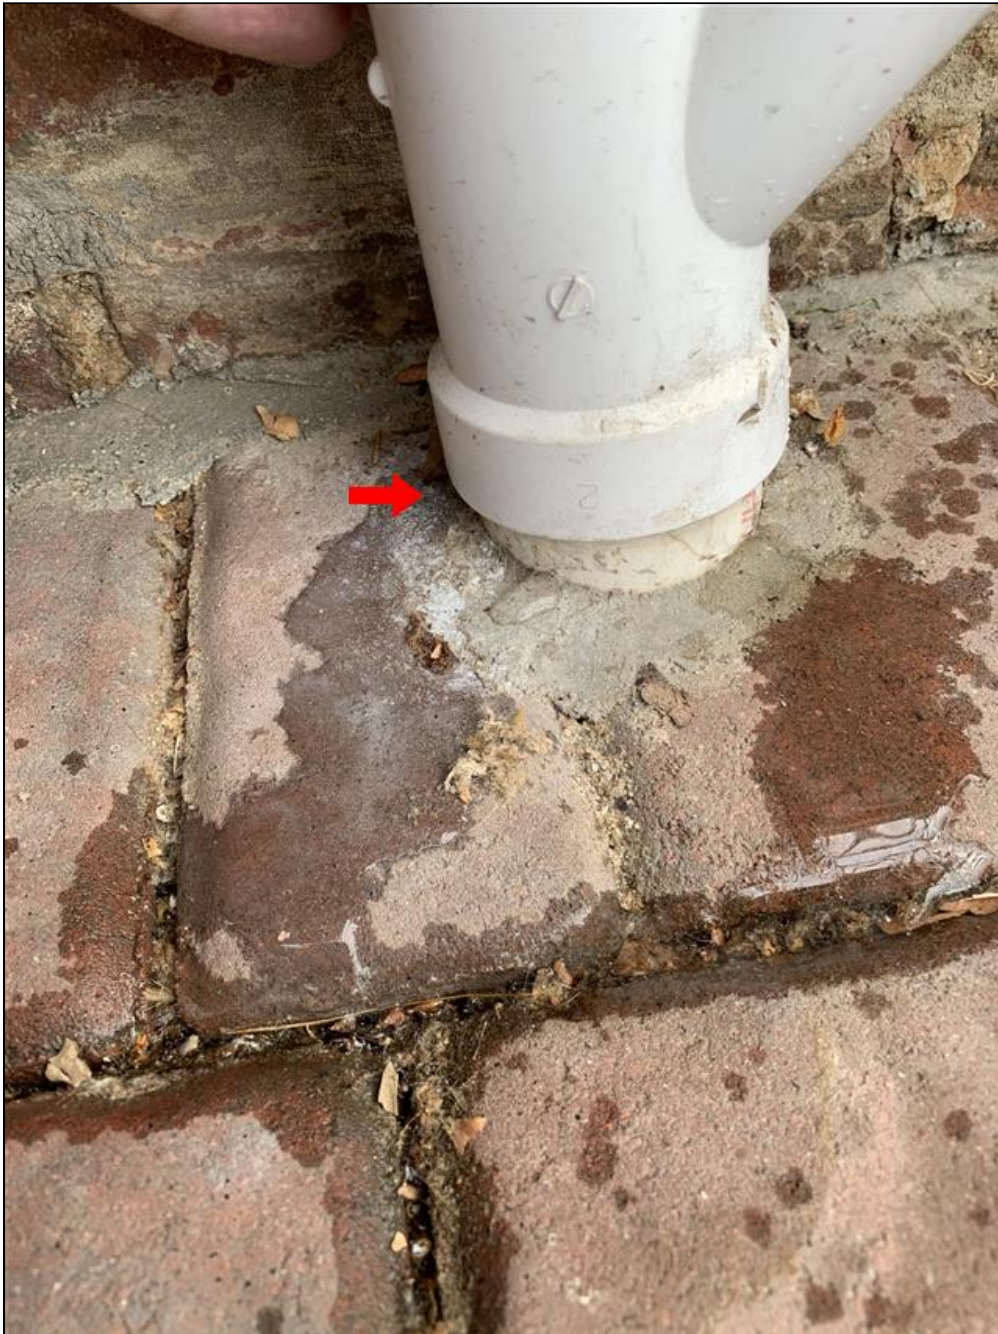
6.0 Item 5(Picture) PVC drain below sink at rear of home. The leak appears to be coming from the joint indicated in the photo and can likely be fixed using a PVC joint compound.

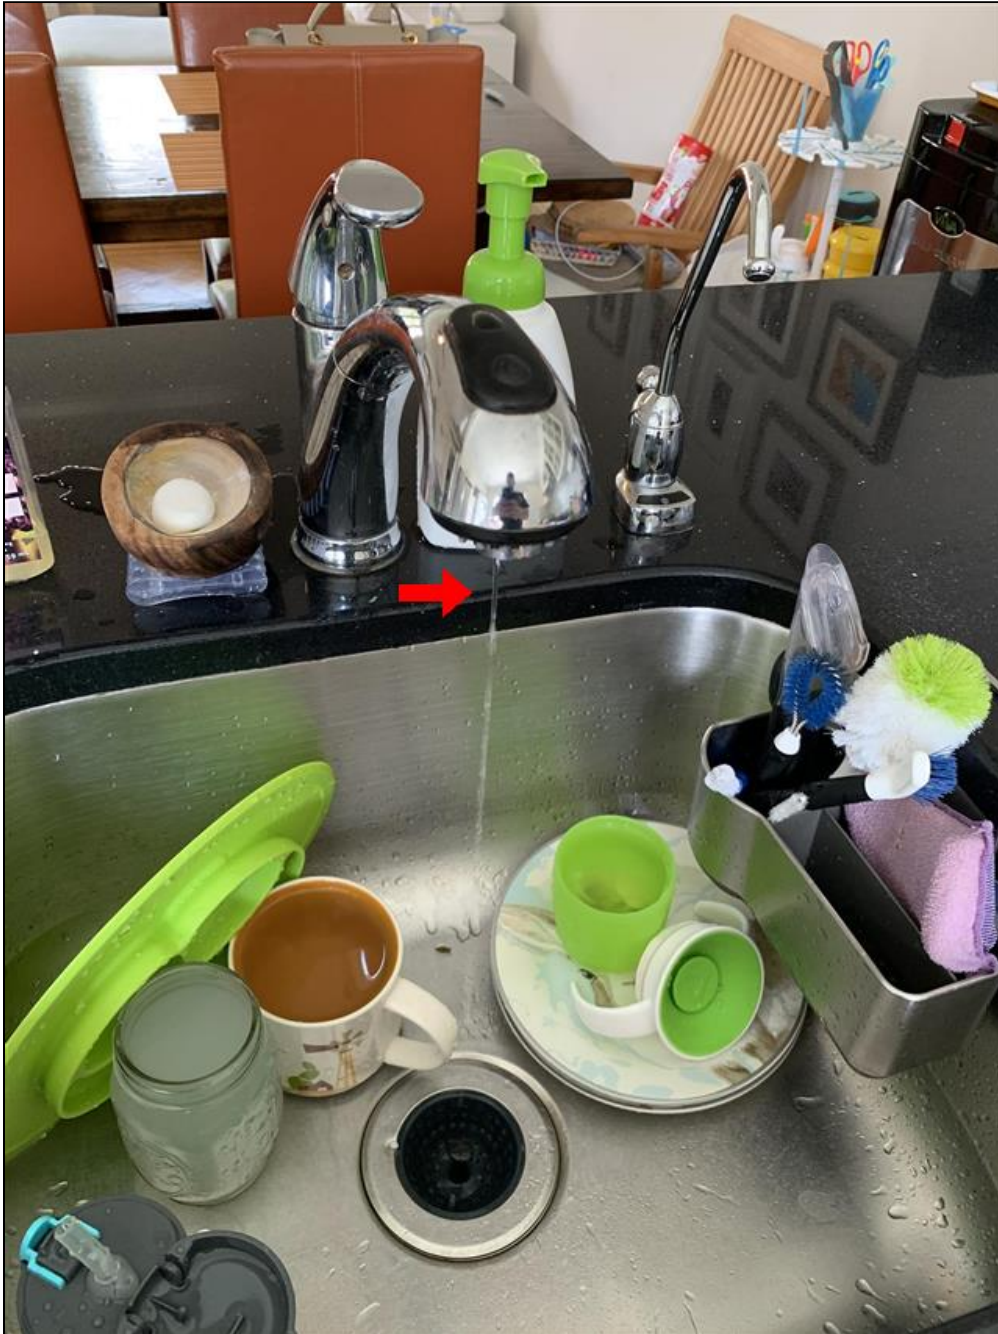
**Kitchen Faucet Keeps Running:** The kitchen faucet keeps running after being turned off. The Inspector was able to get the faucet to stop running by moving the valve arm around but this shouldn't be necessary. Over time this will likely get worse until addressed.

6.1 Item 1(Picture) Faucet still running when in off position.

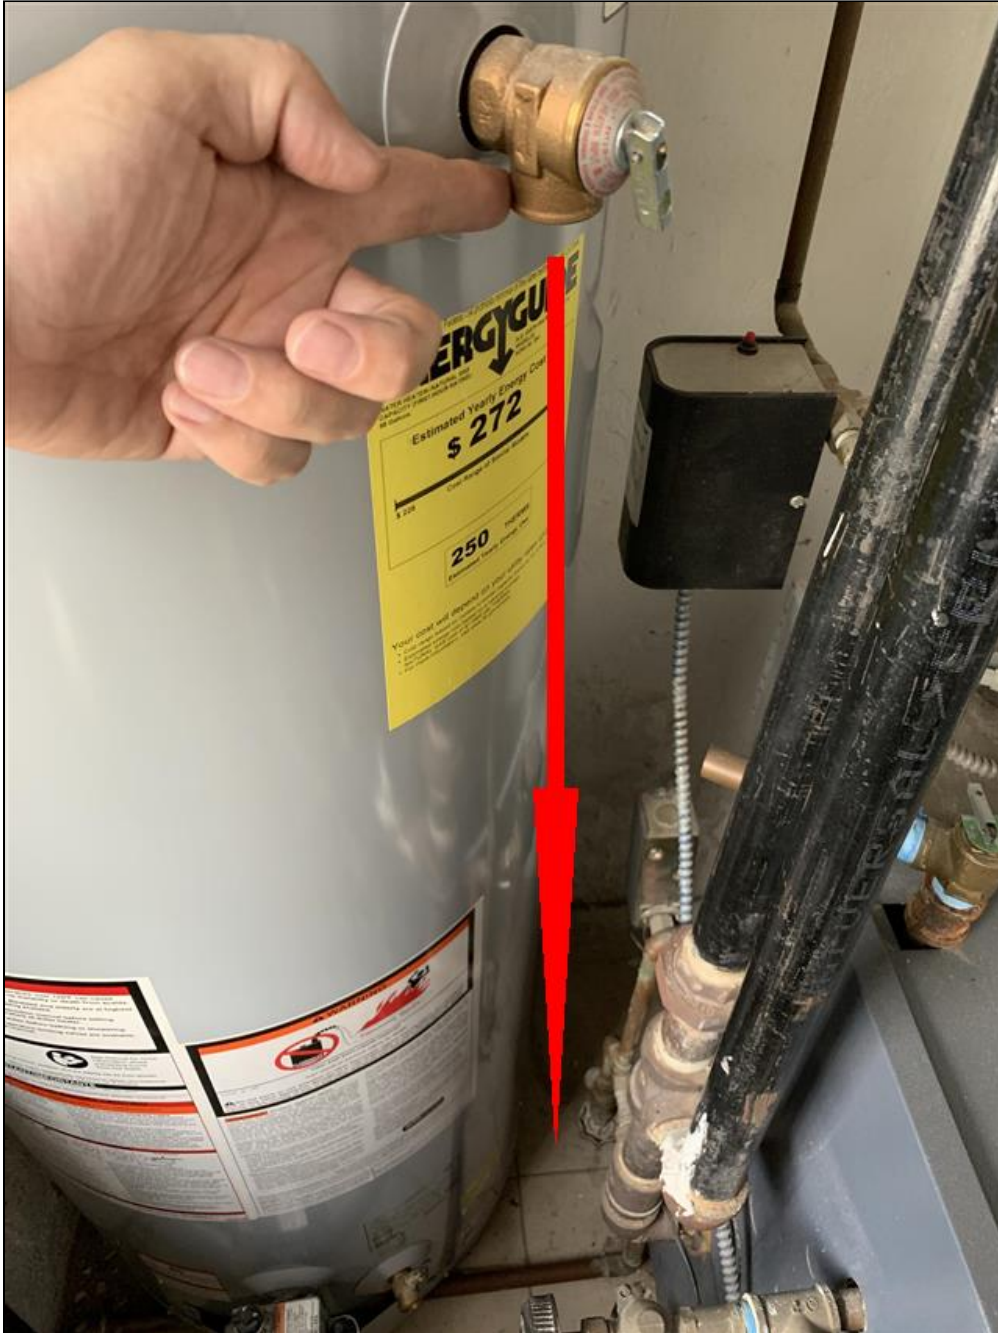
**Test & Pressure Valve Extension:** At the time of inspection no TPR valve extension was present. The TPR (Test & Pressure-relief) valve extension pipe should be constructed of an approved material, such as CPVC, copper, polyethylene, galvanized steel, polypropylene, or stainless steel. PVC and other non-approved plastics should not be used since they can easily melt. The extension should not terminate more than 6 inches (152 mm) above the floor or waste receptor. The Inspector recommends repair by a qualified plumber.

6.2 Item 5(Picture) A TPR valve extension pipe should be installed here for safety.

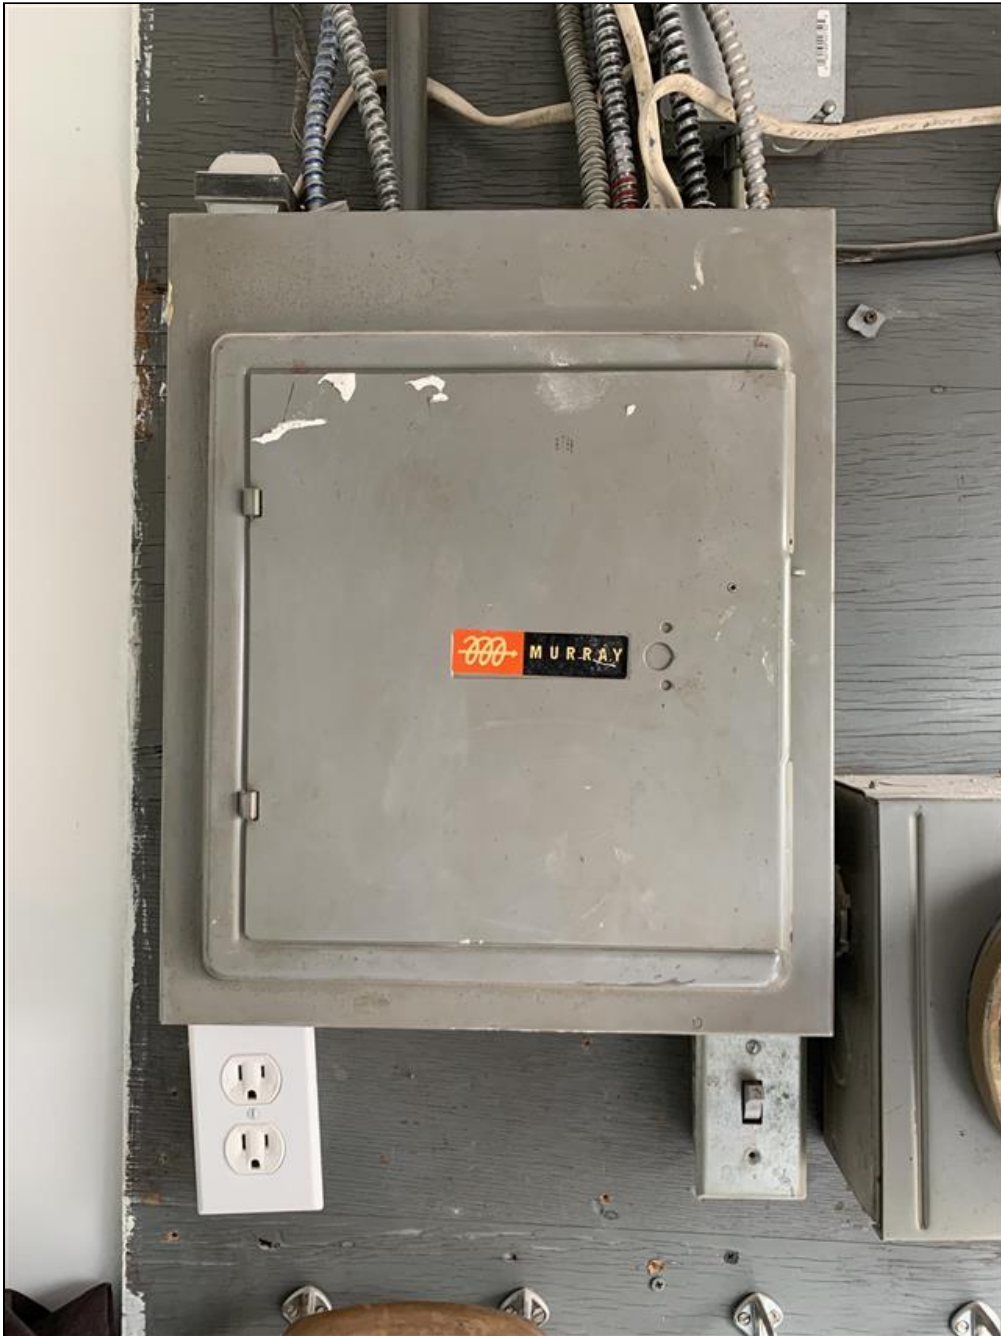
**100 Amp Service:** The manufacturer's label listed the service panel amperage rating at 100 amps, which is considered marginal by modern standards. 100 amp services were typically installed before modern appliances were common in homes. Homes with 100 amp services that contain modern electrical appliances such as dishwashers, dryers, ranges, water heaters and air conditioners may have a higher risk excessive amounts of breaker tripping. You may wish to consult with a qualified electrical contractor to discuss the need for and to determine options and prices for upgrading the service panel. **Note:** While the above is technically true no breakers tripped while testing various appliances. The two heat pumps and all six air handling units were running at the same time during the inspection while other appliances were being turned on and tested. This is mentioned primarily for your knowledge as requirements may change depending on your electrical needs.

7.1 Item 2(Picture) Murray brand electrical panel.
