# Inspection Report

## Towne Inspections

<b>Date:</b> 8/16/2019	<b>Time:</b> 09:00 AM	<b>Report ID:</b> 001093
<b>Property:</b>

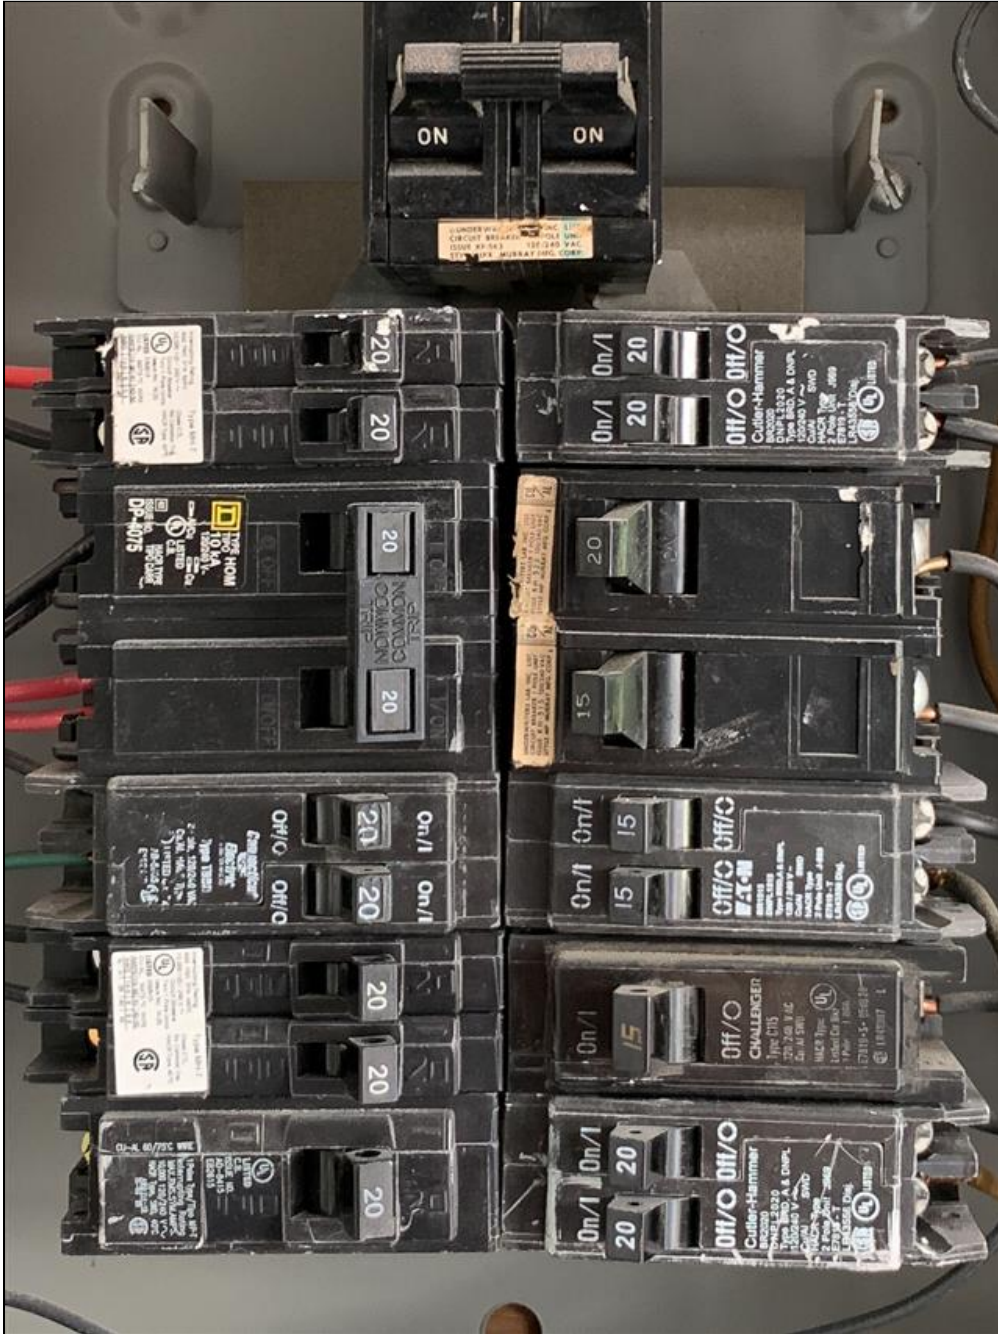
**Mismatched Brands:** Circuit breakers in the service panel were of a brand (Cutler-Hammer, Challenger, Eaton, Square D, Connecticut) different from the main panel brand (Murray / Westinghouse). Because circuit breakers made by different manufacturers vary in design, panel manufacturers typically require that breakers manufactured by their company be used in their panels. Breakers from one manufacturer used in the panel of another manufacturer may result in poor connections which can create a potential fire or shock/electrocution hazard. Using the wrong brands can also void the warranty of the panel. The Inspector recommends correction by a qualified electrical contractor.

7.1 Item 4(Picture) Mismatched brands.

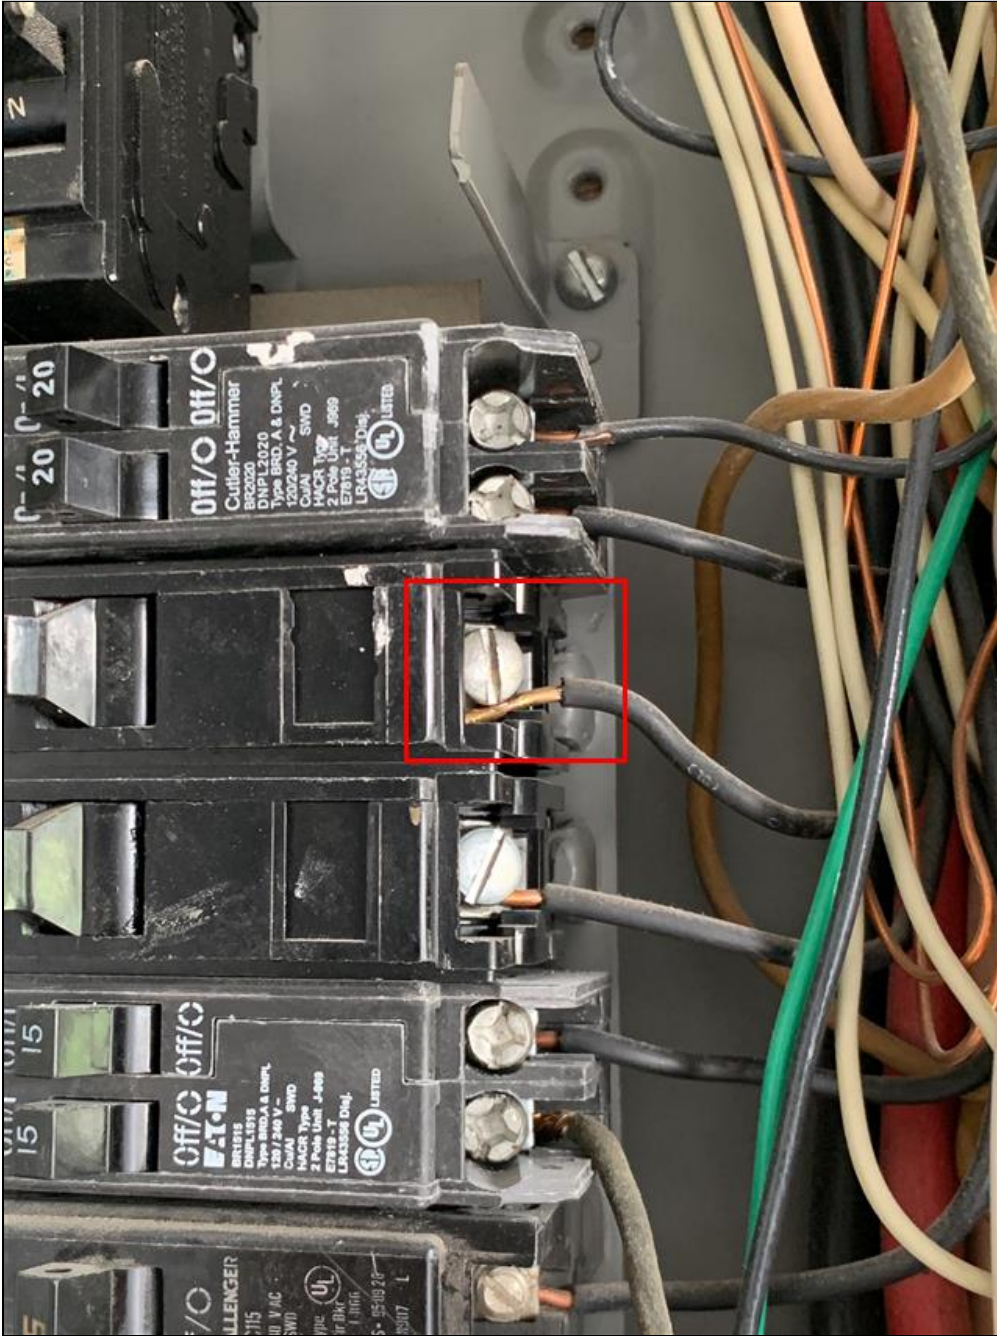
**Wire Not Properly Connected to Breaker:** A branch circuit conductor appears to be improperly secured to a breaker terminal. This wire should be connected properly to avoid it coming loose.

7.1 Item 5(Picture) Conductor is not properly secured to breaker terminal.

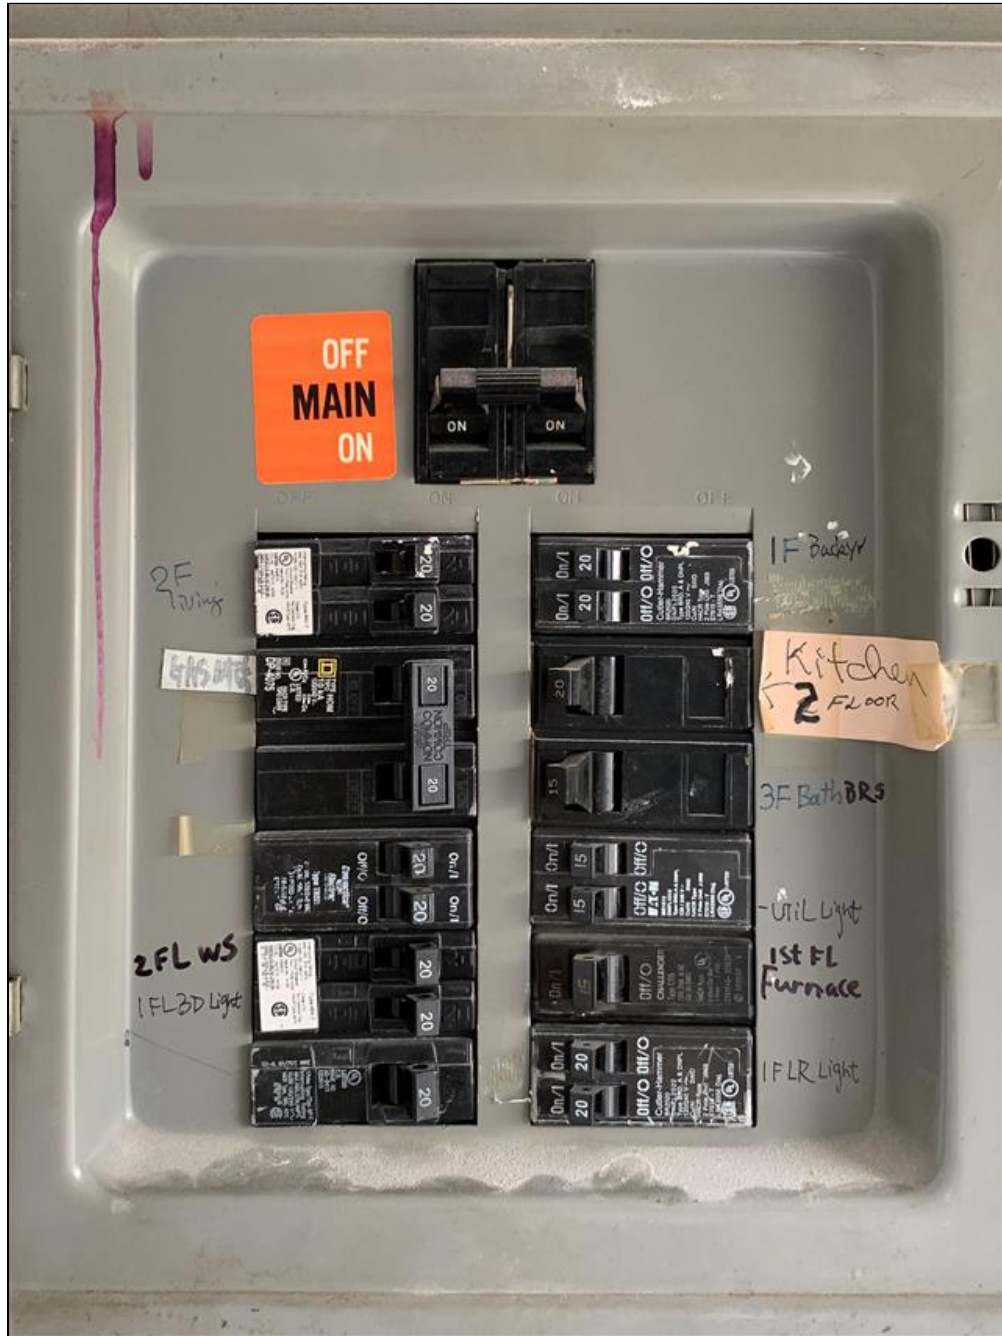
one circuit is labeled with "Furnace" but there is not a furnace on this property. The Inspector recommends that the Circuit Directory labels be filled out better than they are for the reasons stated above.

7.1 Item 6(Picture) All circuits should be clearly and correctly labeled.

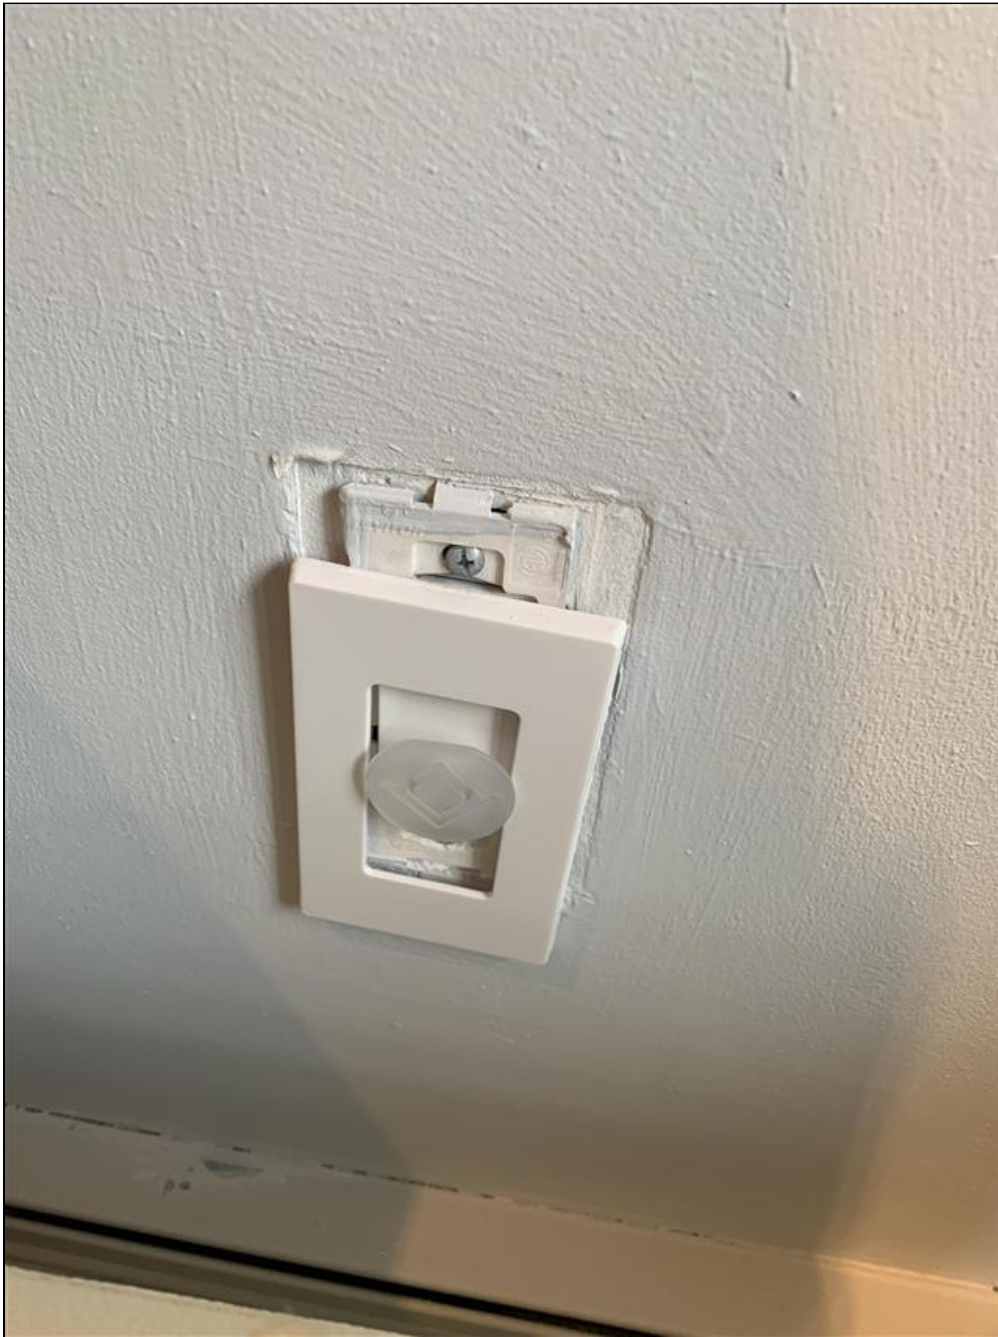
**Loose Face Plate:** One electrical receptacle in the first floor recreational room was found to have a loose face plate that falls off. This should be repaired to help avoid electrical shock.

7.3 Item 1(Picture) Face plate is loose and falling off.

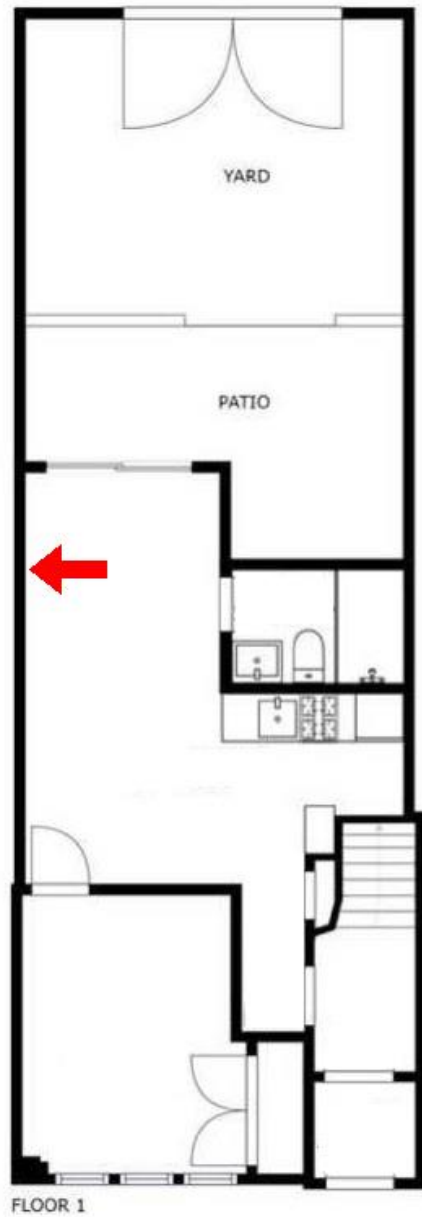
7.3 Item 2(Picture) First Floor: Location of loose face plate.

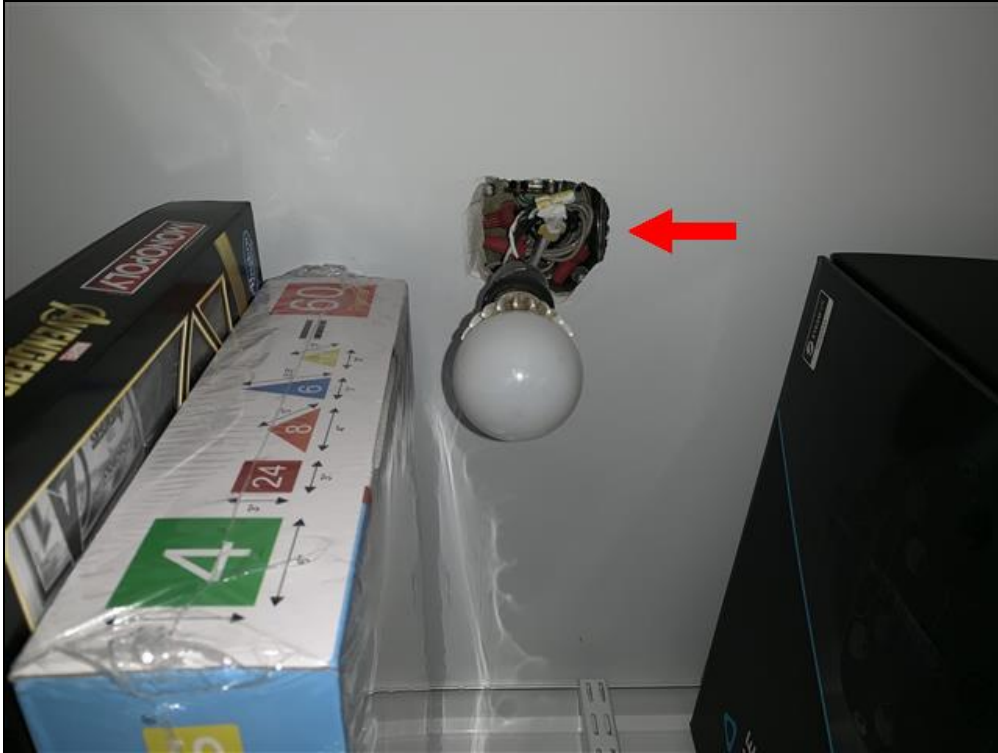
**Missing Cover Plate:** At the time of the inspection, a light fixture located in the first floor bedroom closet was observed to be installed without a proper cover plate. This condition leaves energized electrical components exposed to touch and also could lead to a fire being that this is in a closet with clothing and other flammable items.

7.3 Item 3(Picture) Exposed wires in first floor bedroom closet.

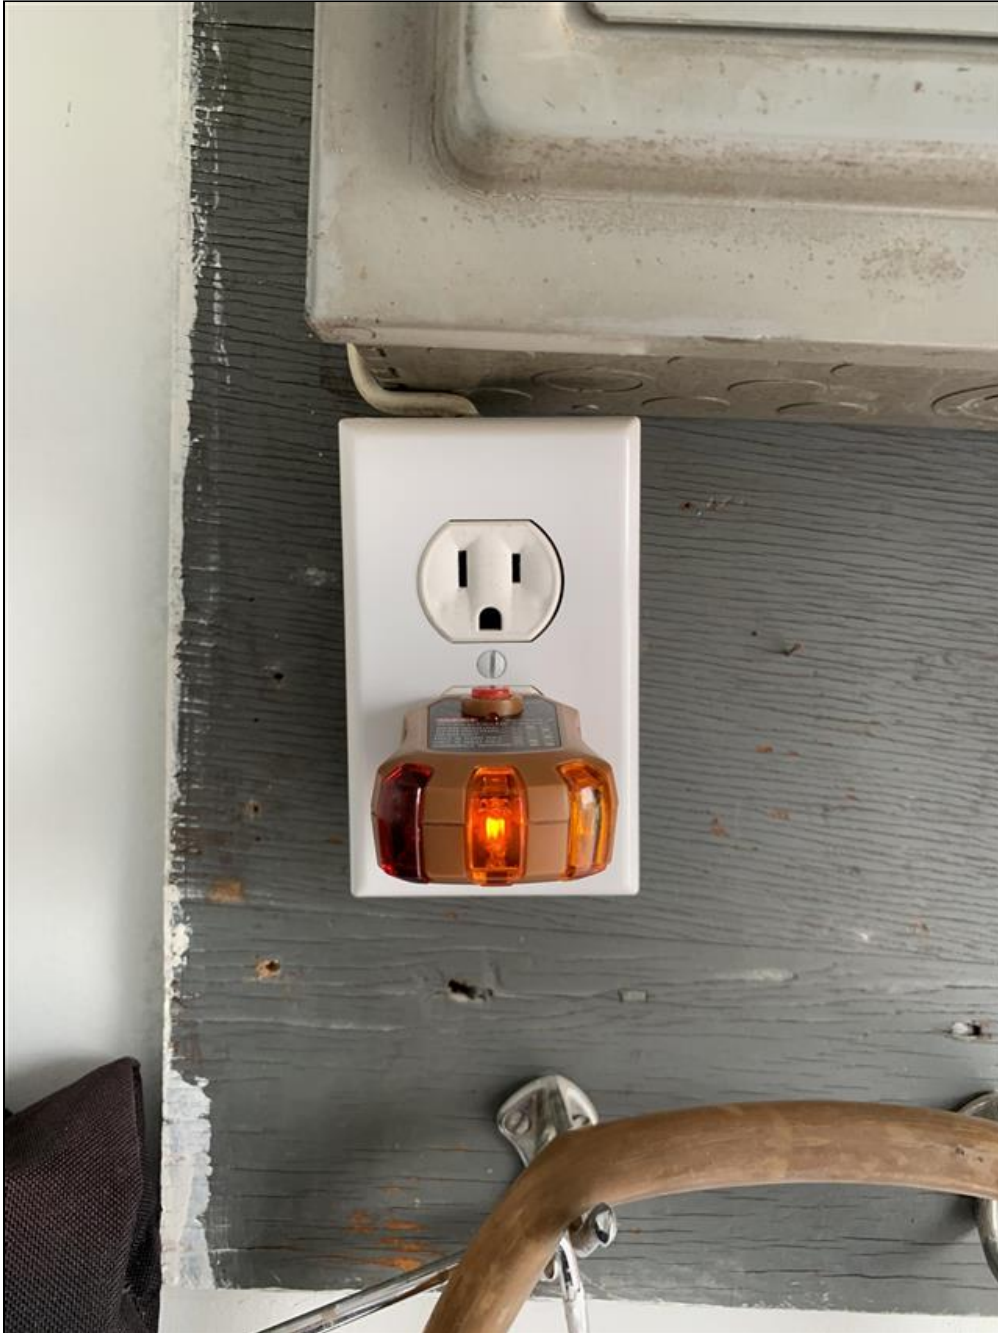
**Loose or missing electrical ground:** An electrical receptacle located in the utility room (just below the electrical panel) appears to have a loose or missing ground. Other receptacles in the home were grounded. It is recommended that this receptacle have a functional equipment grounding conductor installed (or reconnected) by qualified electrical contractor.

7.3 Item 5(Picture) Loose or missing ground.

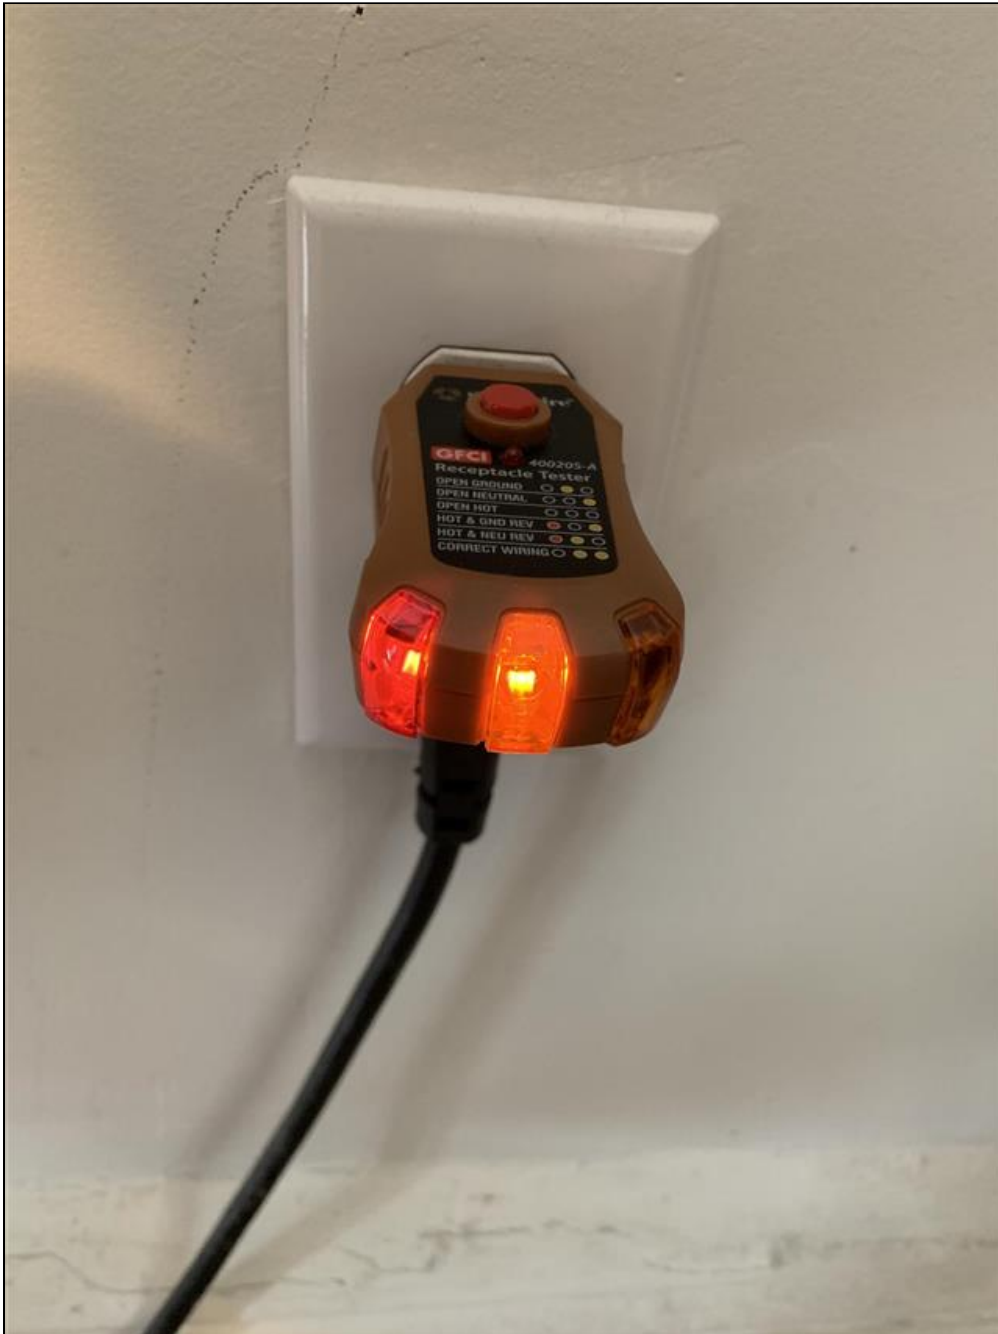
**Explanation:** Most electrical appliances and devices are designed so that their "on-off" switch interrupts electrical power at the point of entry into the appliance or device circuitry or components. If the hot and neutral wires are reversed that may not be the case, and parts of the device will remain energized or potentially energized even when the electrical device switch is OFF. No electrical current may flow, but it could flow if someone touches the wrong part of the device, or damage may be caused in other circumstances as well. Reversed polarity on an electrical outlet is dangerous. If you accidentally reverse these wires the device you plug in to the receptacle may "work" but it is unsafe and risks a short circuit, shock, or fire.

7.3 Item 6(Picture) Hot & neutral wires reversed.

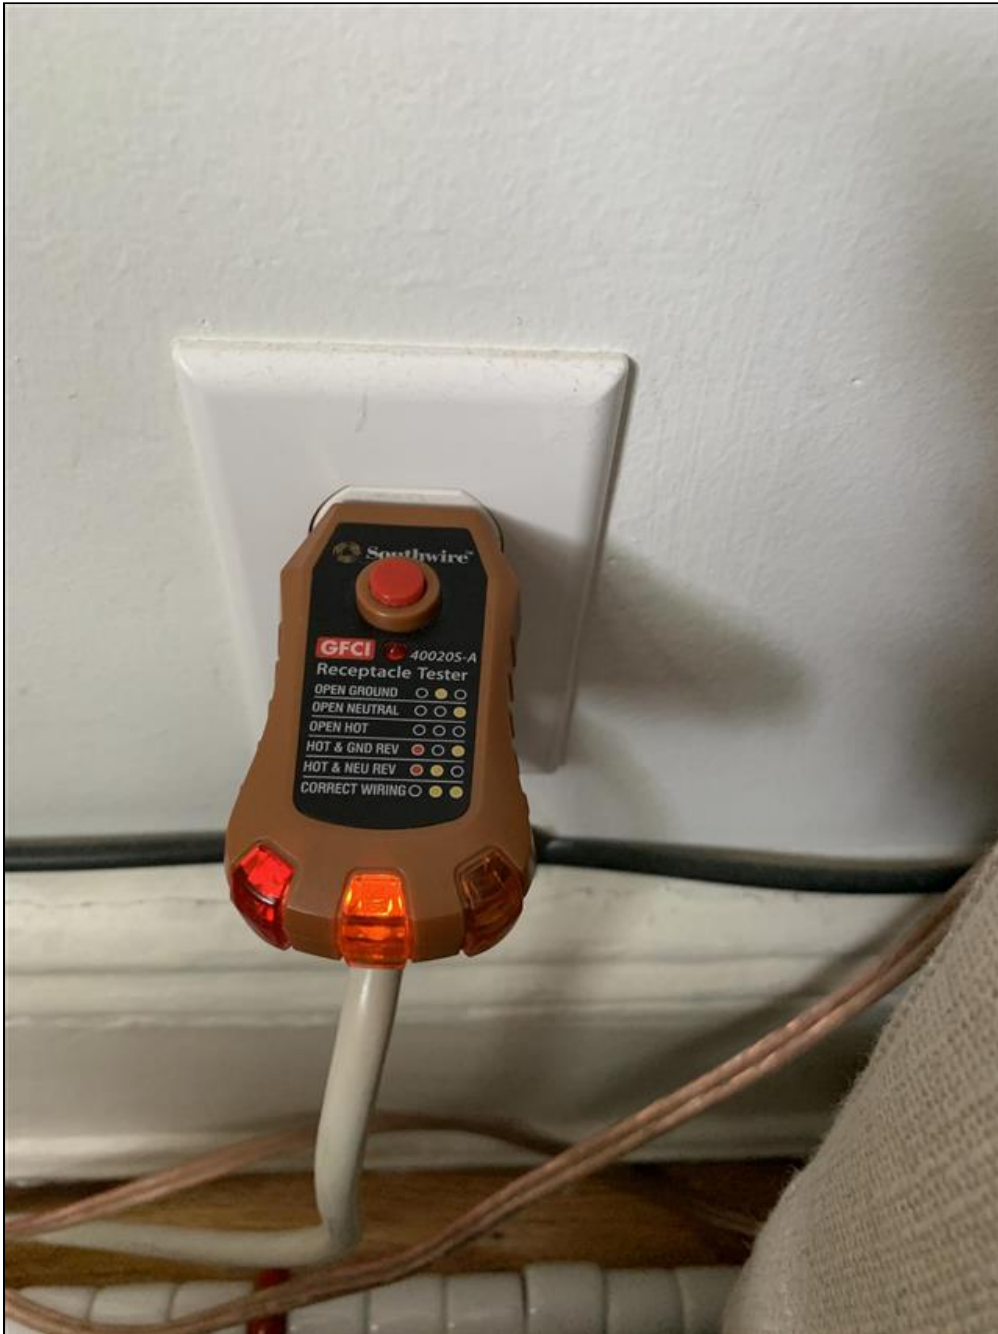
7.3 Item 8(Picture) Hot & neutral wires reversed.

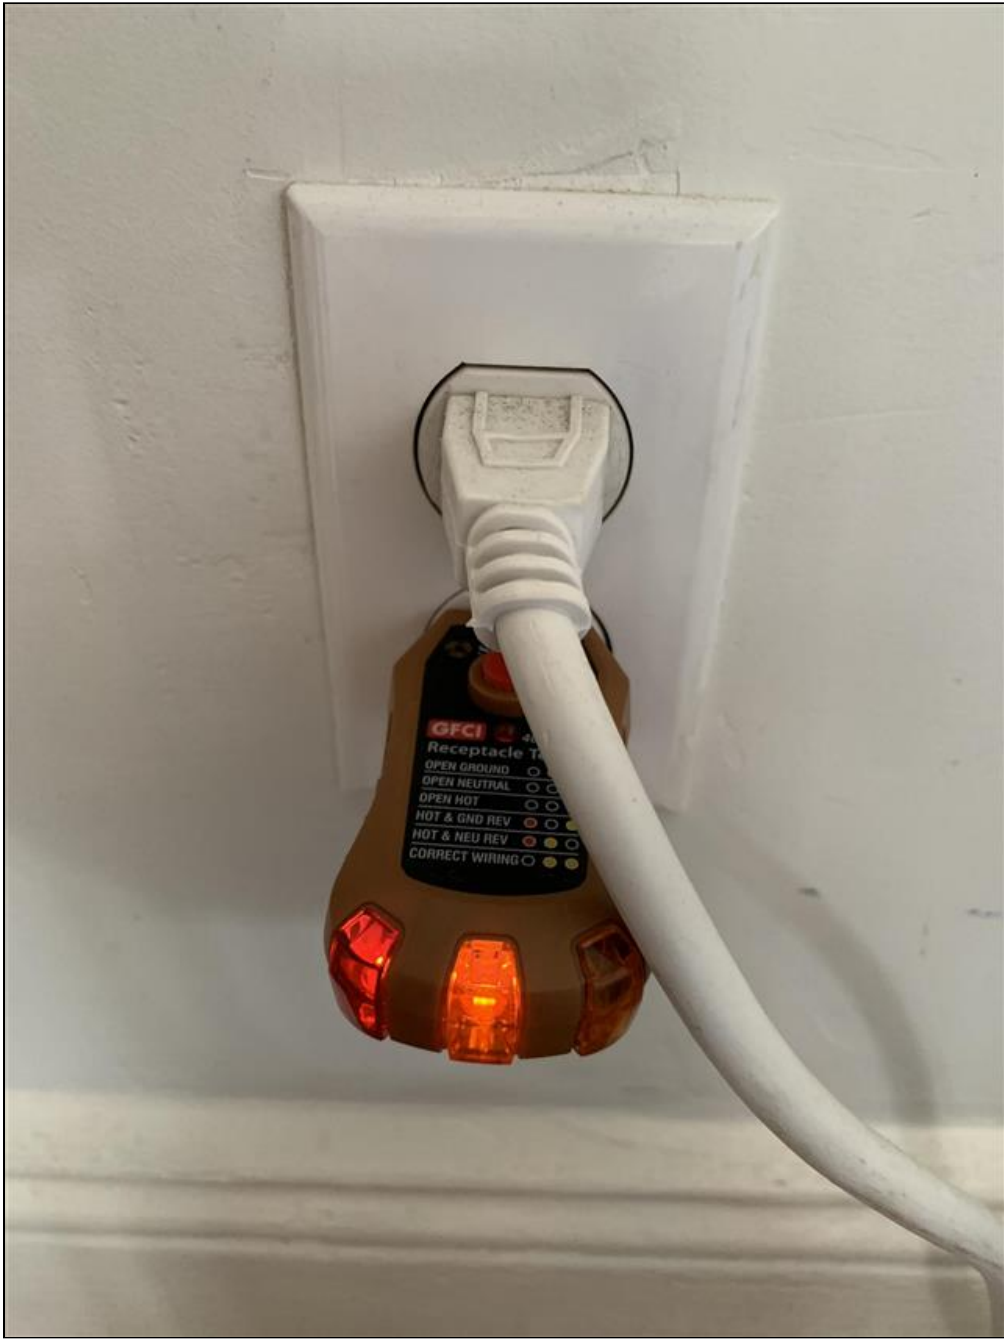
7.3 Item 9(Picture) Hot & neutral wires reversed.

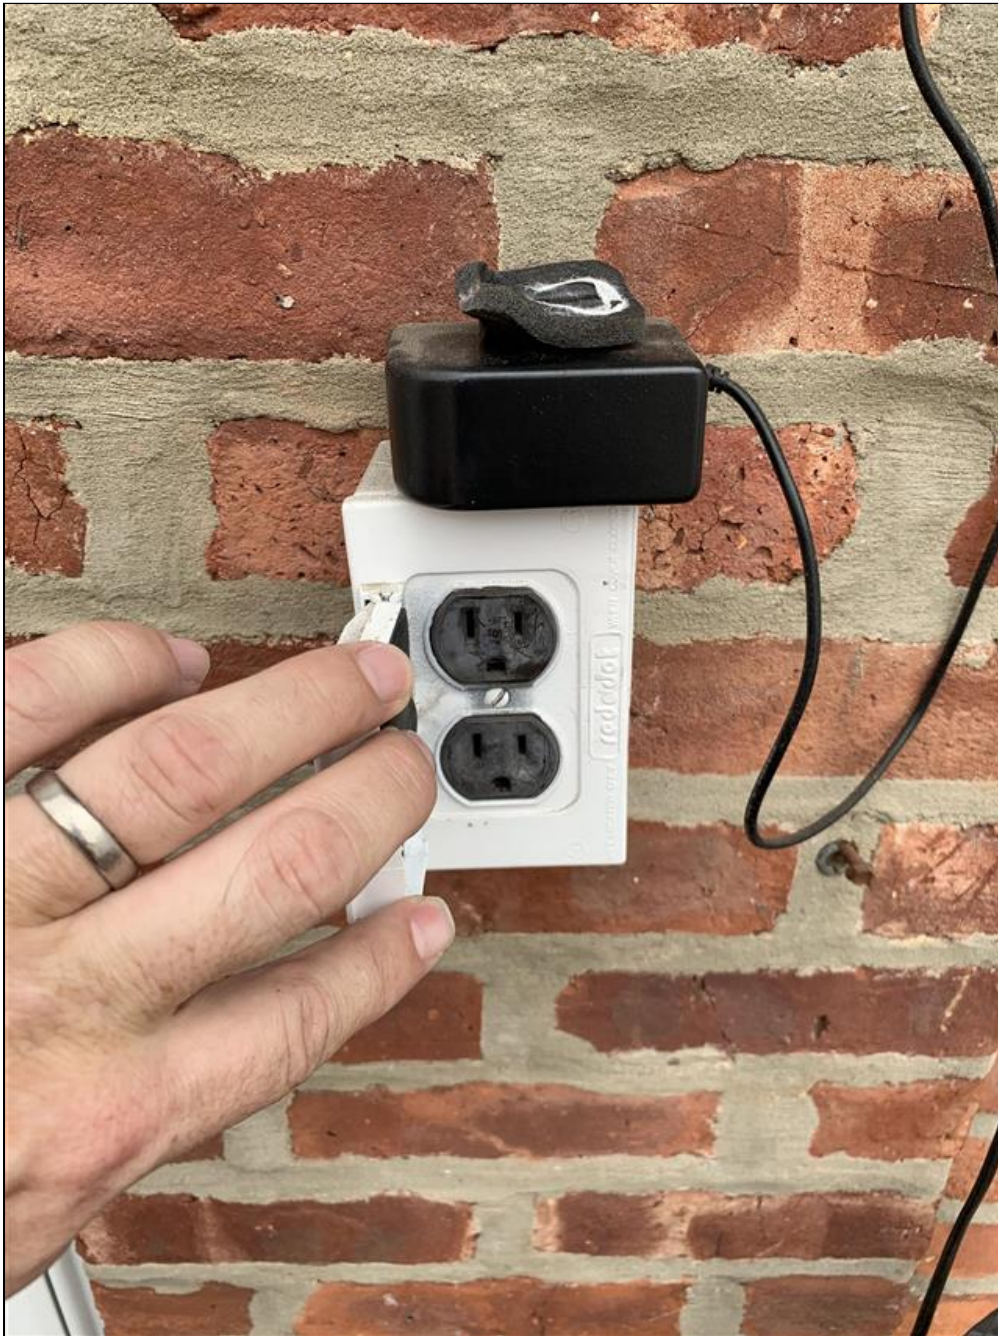
fixture be provided with ground fault circuit interrupter (GFCI) protection in good working order to avoid potential electric shock or electrocution hazards.

7.4 Item 1(Picture) Rear of home: Exterior electrical receptacles should be GFCI protected for added safety.

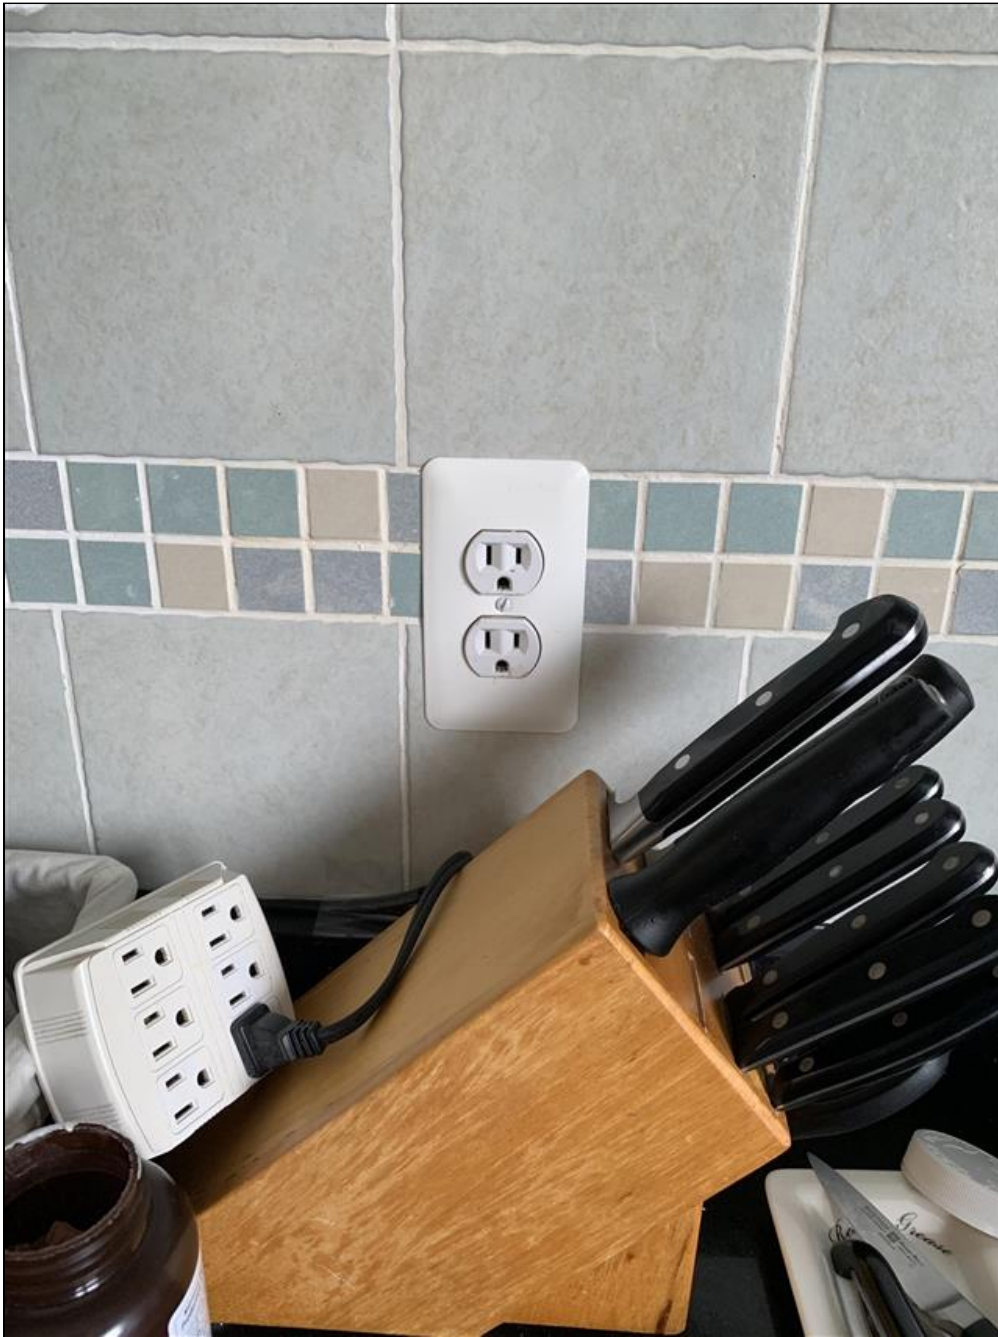
at the time the home was built, for safety reasons, the Inspector recommends that electrical receptacles located in basements, crawlspaces, garages, the home exterior, **and interior receptacles located within 6 feet of a plumbing fixture** be provided with ground fault circuit interrupter (GFCI) protection in good working order to avoid potential electric shock or electrocution hazards.

7.4 Item 2(Picture) Second floor kitchen counter: Electrical receptacles located within 6 feet of a plumbing fixture should be provided with GFCI protection.

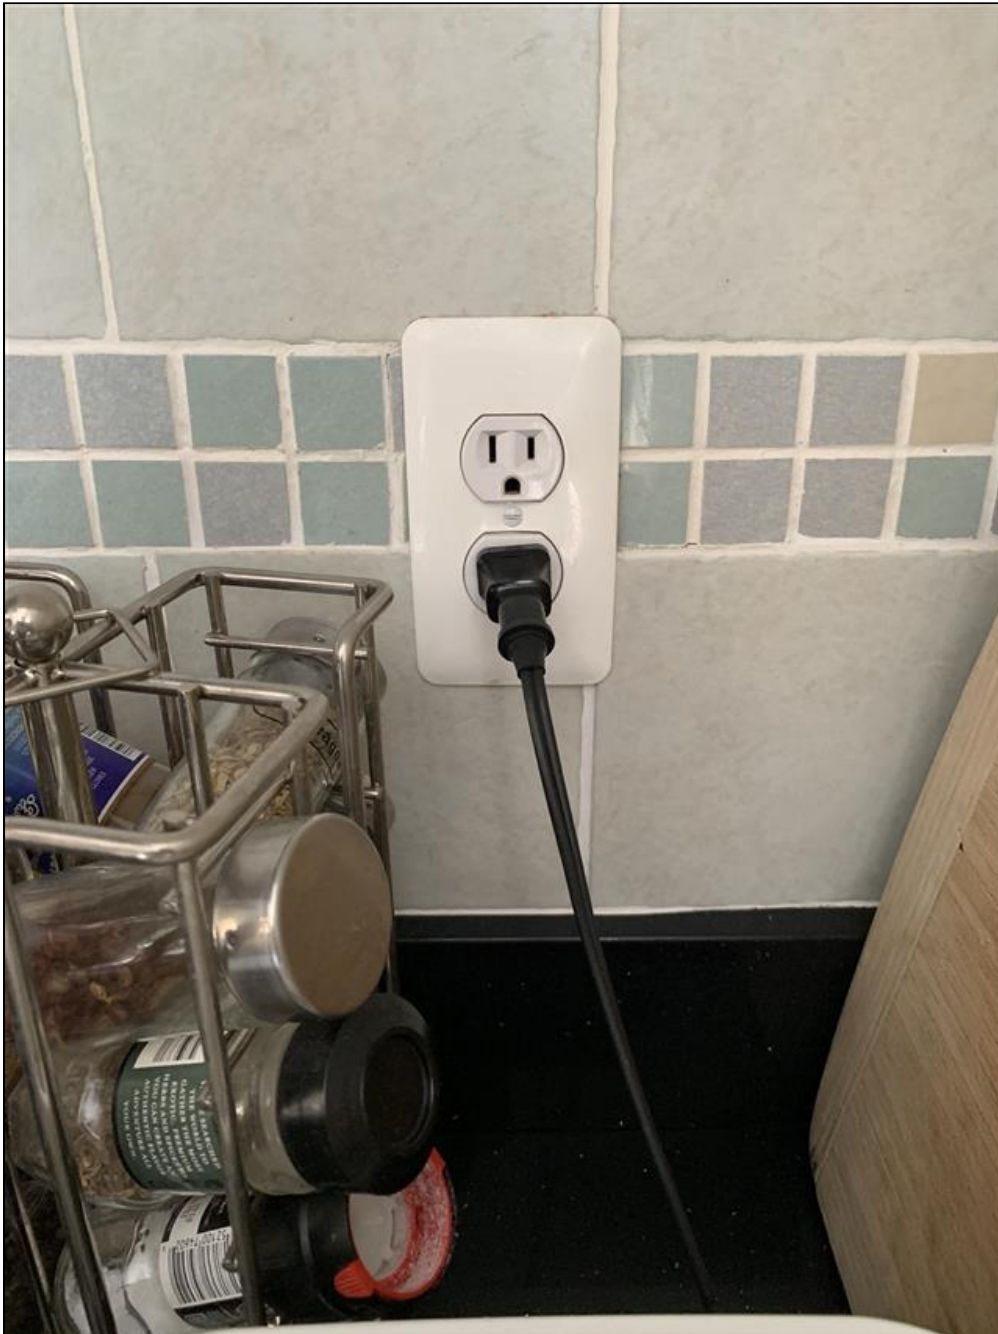
7.4 Item 3(Picture) Second floor kitchen counter: Electrical receptacles located within 6 feet of a plumbing fixture should be provided with GFCI protection.

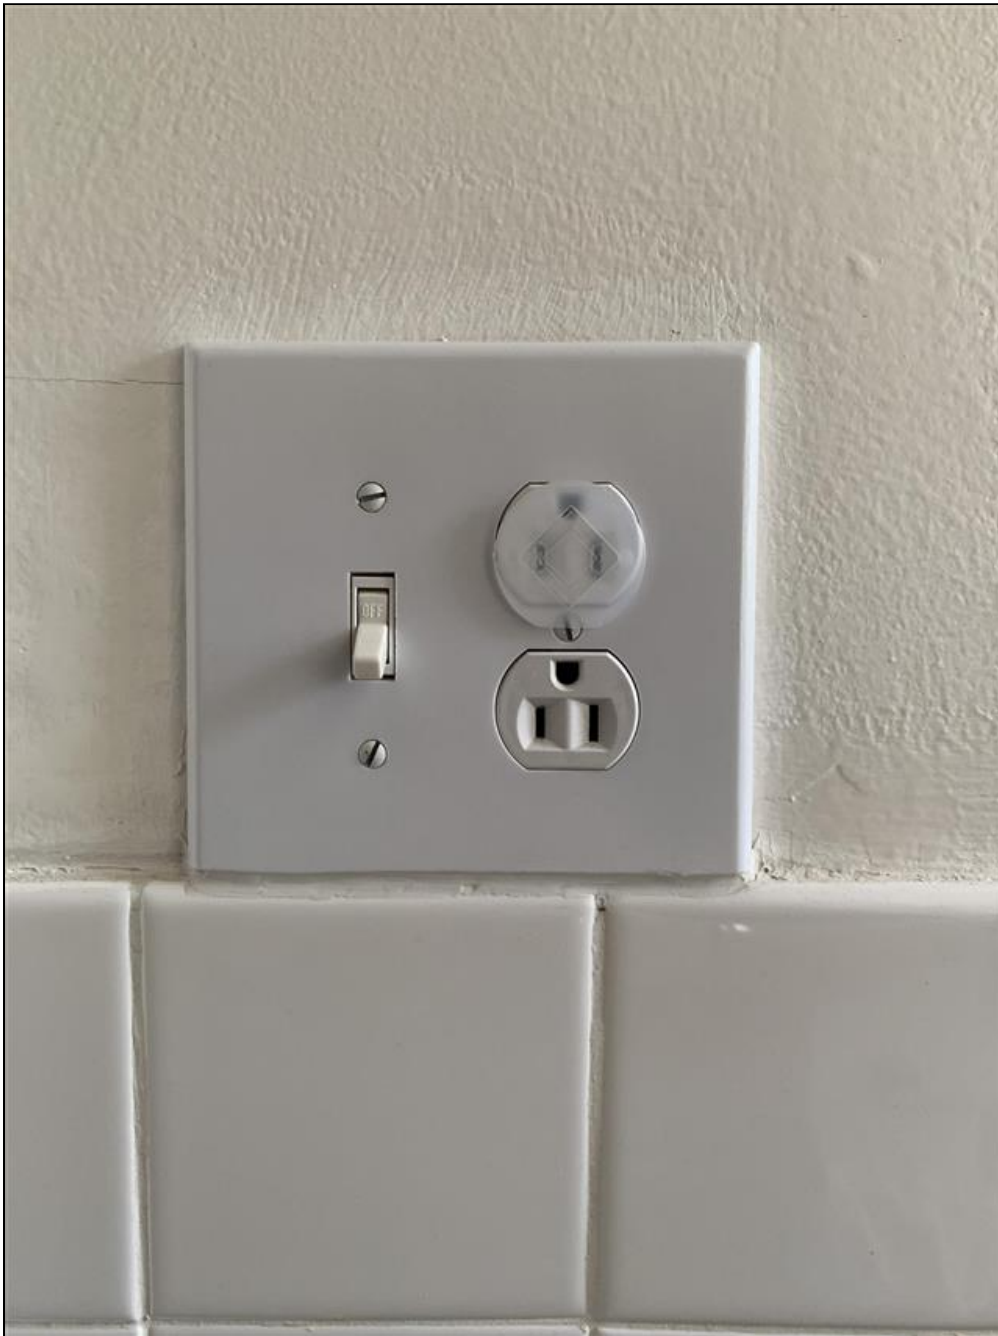
**No GFCI - Recommended Upgrade:** No ground fault circuit interrupter (GFCI) protection was present at the electrical receptacle in the second floor bathroom. Although GFCI protection may not have been required at the time the home was built, for safety reasons, the Inspector recommends that electrical receptacles located in basements, crawlspaces, garages, the home exterior, **and interior receptacles located within 6 feet of a plumbing fixture** be provided with ground fault circuit interrupter (GFCI) protection in good working order to avoid potential electric shock or electrocution hazards.

7.4 Item 4(Picture) Second floor bathroom: Electrical receptacles within 6 feet of a plumbing fixture should have GFCI protection for added safety.

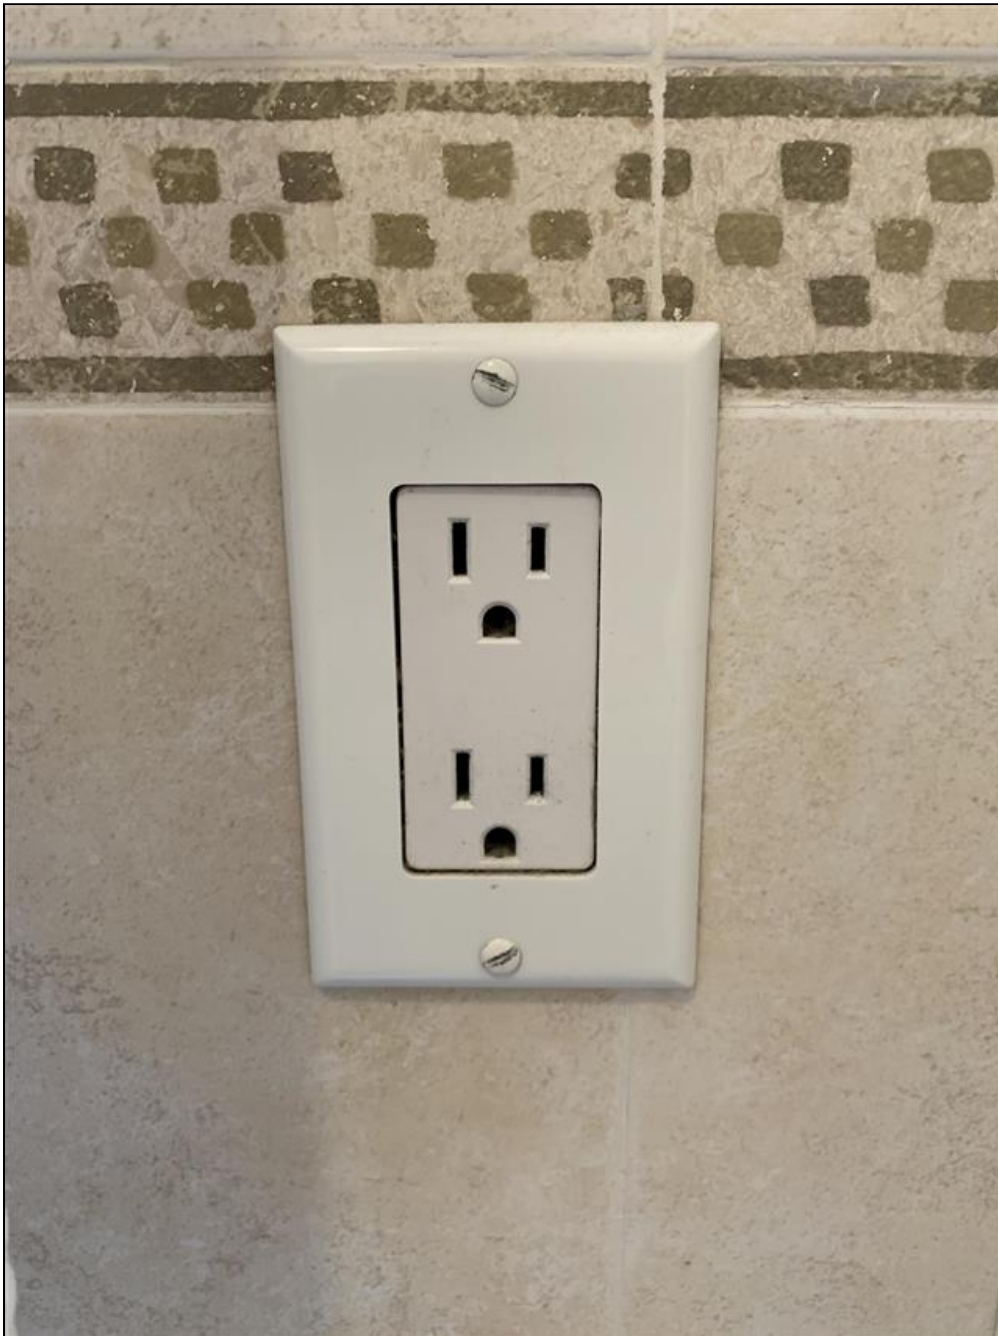
**No GFCI - Recommended Upgrade:** No ground fault circuit interrupter (GFCI) protection was present at the electrical receptacle in the third floor bathroom. Although GFCI protection may not have been required at the time the home was built, for safety reasons, the Inspector recommends that electrical receptacles located in basements, crawlspaces, garages, the home exterior, **and interior receptacles located within 6 feet of a plumbing fixture** be provided with ground fault circuit interrupter (GFCI) protection in good working order to avoid potential electric shock or electrocution hazards.

7.4 Item 5(Picture) Third floor bathroom: Electrical receptacles within 6 feet of a plumbing fixture should have GFCI protection for added safety.

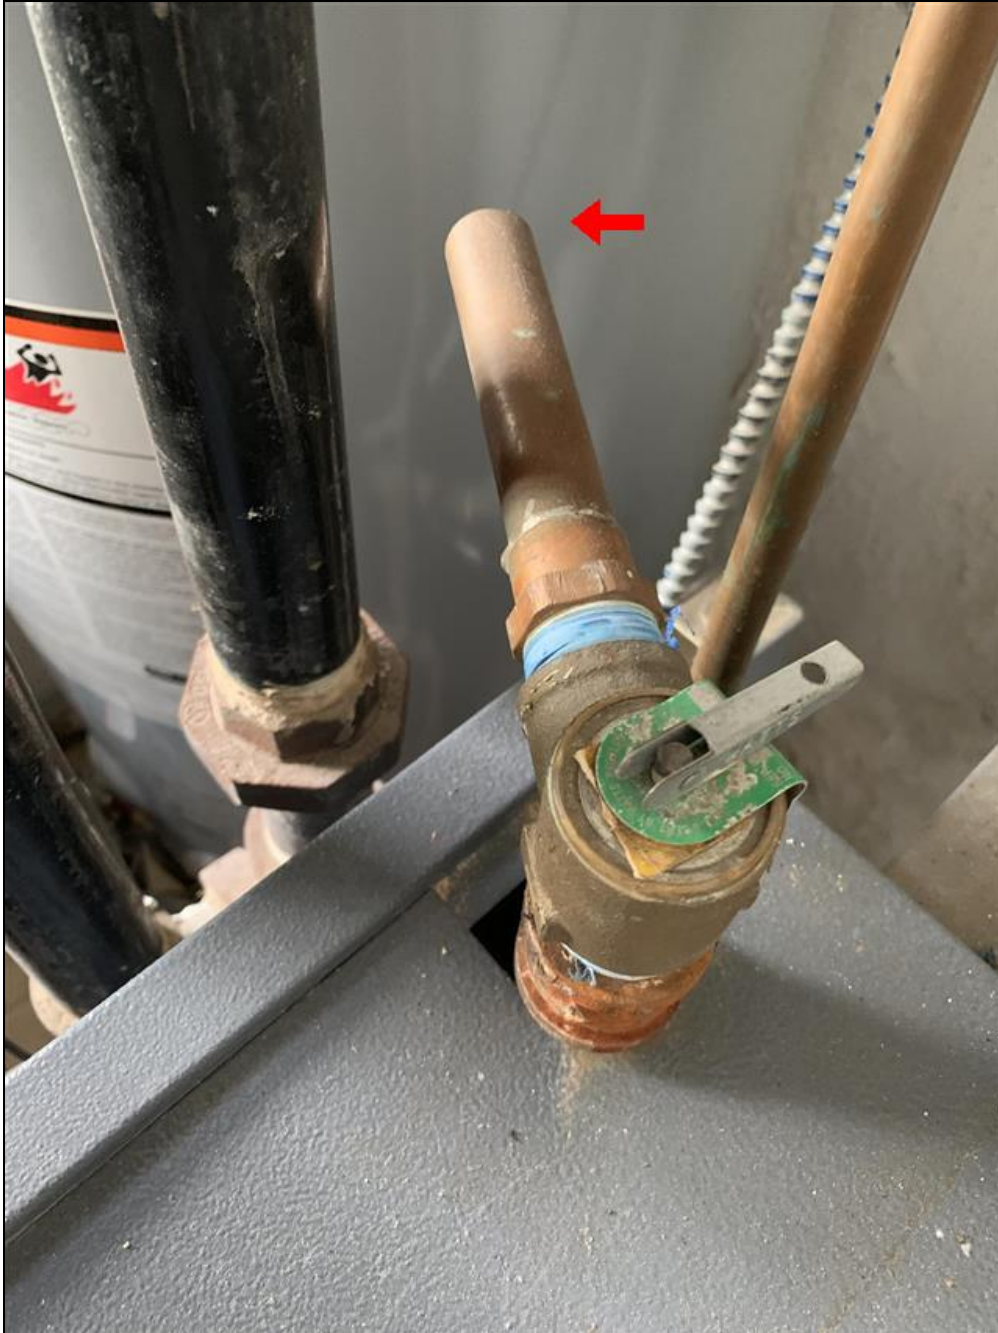
8.0 Item 5(Picture) TPR valve discharge pipe does not extend to 6 inches above the floor.
