Inspection Date February 10, 2020

Inspector Brandon Feltner

TREC # 22952, TDA #
0802086

PROPERTY INSPECTION REPORT

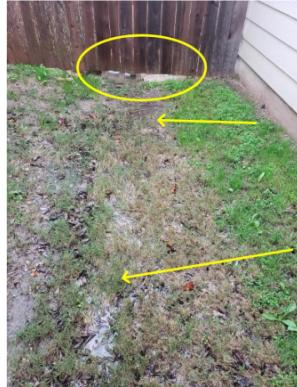
Left side of home

Concern Drainage not optimal between homes

Impact The grading away from the foundation is appropriate, however, the drainage from between the homes to the back yard is lacking. This is causing water to stand which can create negative effects on the foundation due to the expansive soil.

Other Information Standing water is an indication of improper drainage away from the home & foundation. Water should not stand for more than 24 hours without fully draining away.

Suggested Action I recommend that the slope toward the backyard be cleared of debris & the stones at the fence to help prevent the accumulation & standing of water between the homes. I also recommend installing gutters along the sides of the home to prevent roof runoff from contributing to excessive water along the foundation wall. The gutter discharge should be at the front & back corners of the home to direct the water away from the foundation.

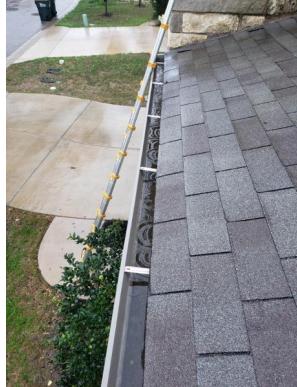
Front porch

Item Gutter
Concern Slope is insufficient causing the water to accumulate
Location Roof
Impact Without a proper slope, proper drainage is not occurring. This can lead to overflowing of water or accumulation of debris.
Suggested Action Have a gutter installation professional adjust the slope of the gutter to discharge the water.

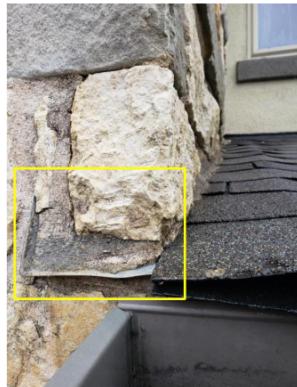
At front porch roof

Item Roof Flashing
Concern Masonry used as counter flashing with ineffective kickout flashing & weeps
Location Roof
Impact Water & vapor that enters the masonry needs to have a way to get out of the wall.(usually from a weep hole at the bottom end of the flashing) Also, the through wall flashing that protects the wood sheathing needs to be able to drain at the lower end of the roof plane as well.
Suggested Action Have corrected by a qualified roofing contractor. A masonry may also be required.

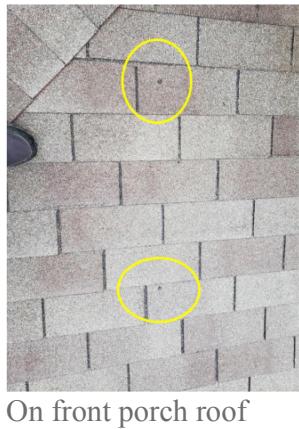
On front porch roof

Item	Roof Material
Concern	Exhibits exposed nail heads
Location	Roof
Impact	This is a regular maintenance item that is commonly found due to drying out from the hot Texas sun. If left unattended over time, however, it could be possible for the nail head to deteriorate & allow water to damage the wood sheathing.
Suggested Action	Have a roofing contractor or qualified person apply roofing cement to cover the existing nail hole.
Other Information	While this is one of the most minor of roof defects it is still a defect nonetheless.

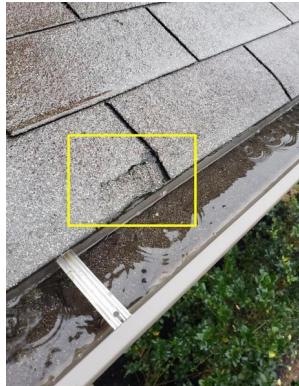
Front porch roof

Item Roof Material
Concern Minor damage in isolated areas
Location Roof
Impact The damaged areas could possibly wear faster than the surrounding shingles.
Suggested Action Have a qualified roofing contractor repair or replace the damaged shingle.

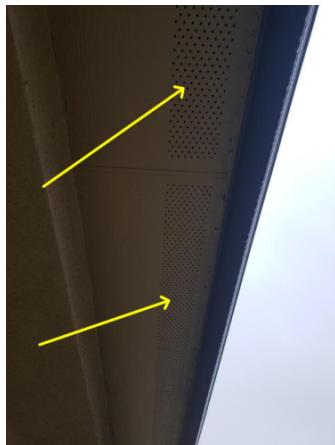
Item	Attic Ventilation
Concern	Attic venting missing
Location	Roof
Impact	The portion above the front porch appears to be conventional (not sealed like the rest of the attic) & does require venting. Without proper ventilation, excessive heat may build & damage roof decking and roof shingles.
Suggested Action	Have a qualified roofing contractor install appropriate ventilation for the portion of the roof above the front porch.

Soffit vents indicating conventional ventilation

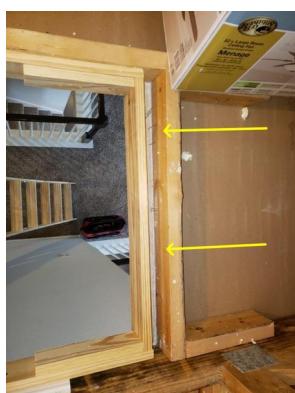
Rear of attic ladder frame

Item	Attic Ladder
Concern	Not properly secured to framed opening
Location	Attic
Impact	There should be spacers between the ladder assembly & the framed opening for the nails to pull tight against & secure the ladder assembly. This configuration is weak & the ladder assembly could pull away or break at the connection causing the stairs to become unstable or fall.

Suggested Action	Have a qualified contractor install the appropriate shims & re-secure the ladder assembly to the framed opening.
-------------------------	--

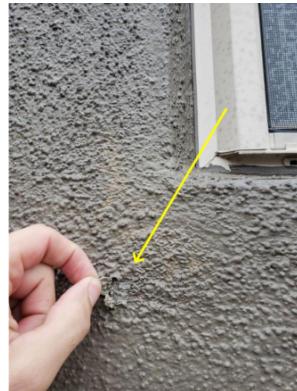
Close-up view

Item	Siding
Concern	Stucco paint is bubbling/peeling
Location	Roof
Impact	This could be as simple as bad paint at this location or more complex such as moisture not draining from behind the stucco.
Suggested Action	Have a stucco professional evaluate the stucco at this location to determine if it is just poor painting or caused by an underlying issue.

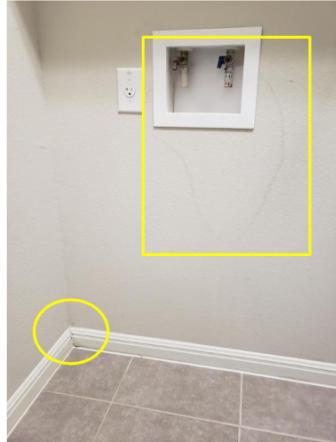
In laundry room

Item	Wall
Concern	Wall has signs of previous water damage
Location	Master Bathroom, Laundry Room
Impact	It appears the leak originated from the laundry room at the clothes washer connection. The exact source is unknown. It appears to have spread along the floor affecting multiple rooms, walls & baseboards. While I couldn't see the framing behind the walls, the drywall & baseboards did appear to still have appropriate structural integrity.
Suggested Action	Monitor the clothes washer connections when used & if leaking is observed, have repaired by a licensed plumber.
Other Information	All locations showing water staining were checked with a moisture meter & did not indicate excessive moisture levels at the time of inspection.

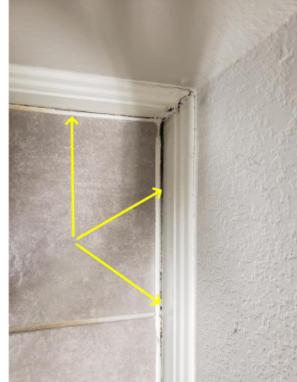
In laundry room

Item	Floor
Concern	Caulk maintenance needed at tile floor & baseboard intersection.
Location	Laundry Room, Partial Bathroom
Impact	Any liquid that gets on the floor can easily spread underneath the tile causing damage behind the wall or loosening the tiles.
Suggested Action	Seal the intersection with a moisture resistant caulk.
Other Information	This is recommended in wet areas such as bathrooms & laundry rooms.

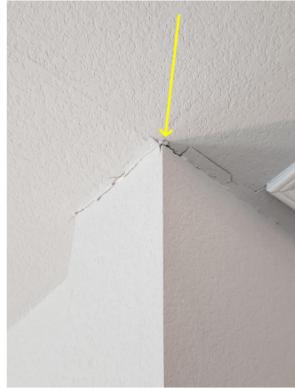
In loft near railing
overlooking the living
room

Item	Ceiling
Concern	Drywall crack observed
Location	Loft
Impact	This appears to be from typical settlement of the home. Large open floor plans will sometimes have this condition occur as the home settles & transfers load through specific points. Wide cracks can create air drafts into the wall/ceiling cavity & should be sealed.
Suggested Action	Have the cracks repaired to seal the ceiling. Monitor for further cracking/separation going forward. If condition continues to worsen or widen more than $\frac{1}{8}$ of an inch, consult qualified contractor for further evaluation.

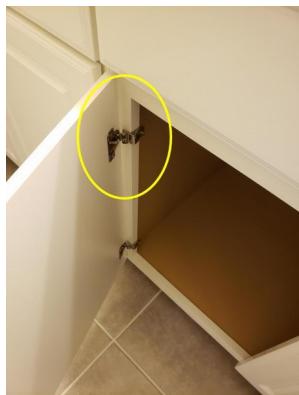
In upstairs bathroom

Item Vanity

Concern Hinges is loose

Impact May not open or close properly

Suggested Action Tighten the hinge to the cabinet

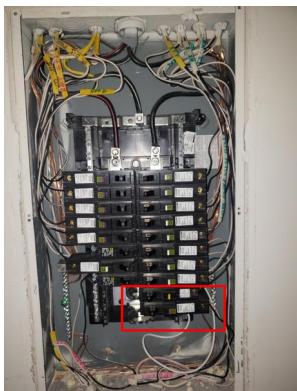
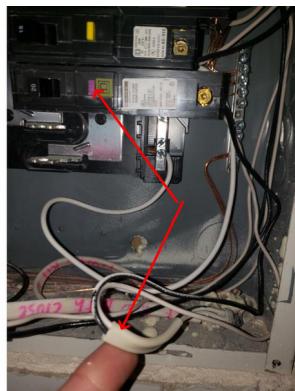
Bottom breaker, right side of sub panel in garage

Item	Sub / Distribution Panel
Concern	Breaker is oversized for wire used
Location	Attached Garage
Impact	The breaker may not trip when necessary, causing the wiring to overheat.
Suggested Action	Have a licensed electrician or qualified person replace these breakers with properly sized/rated breakers.
Other Information	It appears that these breakers have been replaced with the wrong size. These are 14 gauge wires being supplied power by a 20 amp circuit breaker. 14 gauge wire is rated for a maximum 15 amps.

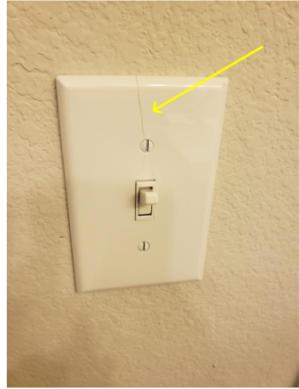
Upstairs bathroom

Item Switch

Concern Cover plate is damaged

Impact Besides being aesthetically pleasing, the cover separates you from the interiors of the outlet and helps to prevent electrical shock.

Suggested Action Replace the cover plate.

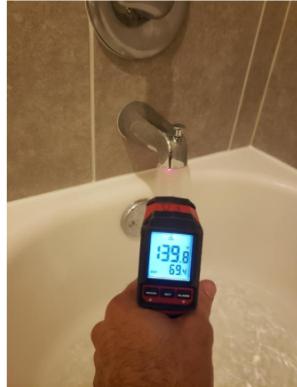
Upstairs bathroom

Item	Shower / Tub
Concern	Tub/shower temperature too hot
Location	Upstairs Bathroom
Impact	Scalding can occur. 120 degrees is considered a safe maximum water temperature for tubs & showers. Current building standards call for the regulation of max water temperature at bathtubs & showers.
Suggested Action	While this is usually a preference thing, if you desire the safest operation, a licensed plumber or qualified person may be able to adjust the limiter at the fixture or add a temperature limiting device so that cold water will automatically mix with the hot to bring the maximum water temperature down.
Other Information	Older homes are not likely to be equipped with such devices as they were not available or required at the time of construction.

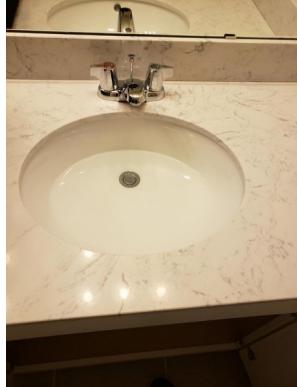
Right sink, upstairs
bathroom

Impact Sink is unable to hold water.

Suggested Action Replace the seal or the entire drain stop as needed.

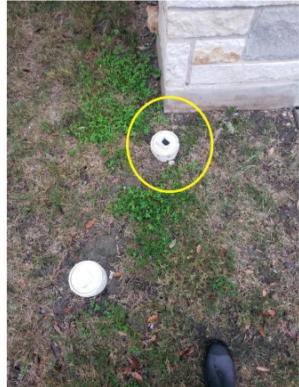
Front left corner of home

Item Cleanout

Concern Cap is damaged

Impact The cap prevents objects from entering the pipe & creating a blockage.

Suggested Action Install a new cap.

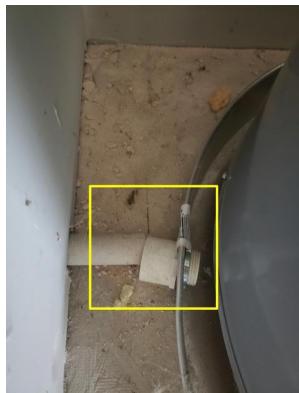
Behind water heater

Impact In the event the water leaks from the water heater & into the pan, this discharge pipe should carry the water outside so that it does not damage finishings in the home.

Suggested Action Have a licensed plumber repair the safety pan discharge.

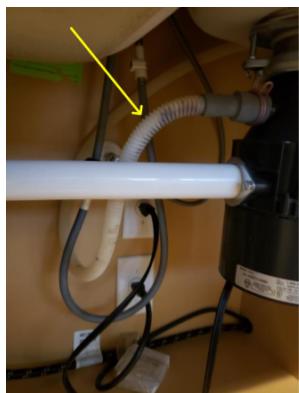
Under kitchen sink

Item	Dishwasher
Concern	High drain line loop ineffective
Location	Kitchen
Impact	While technically correct because the hose does enter the cabinet from a higher point than the drain, the loop that hangs down lower than the drain outlet at the disposal may collect debris & eventually clog.
Suggested Action	Remove the loop that is hanging low by fastening the excess drain line to the countertop.
