QUICK Foundation Repair

This low-cost method saved a bulging block wall with poured concrete

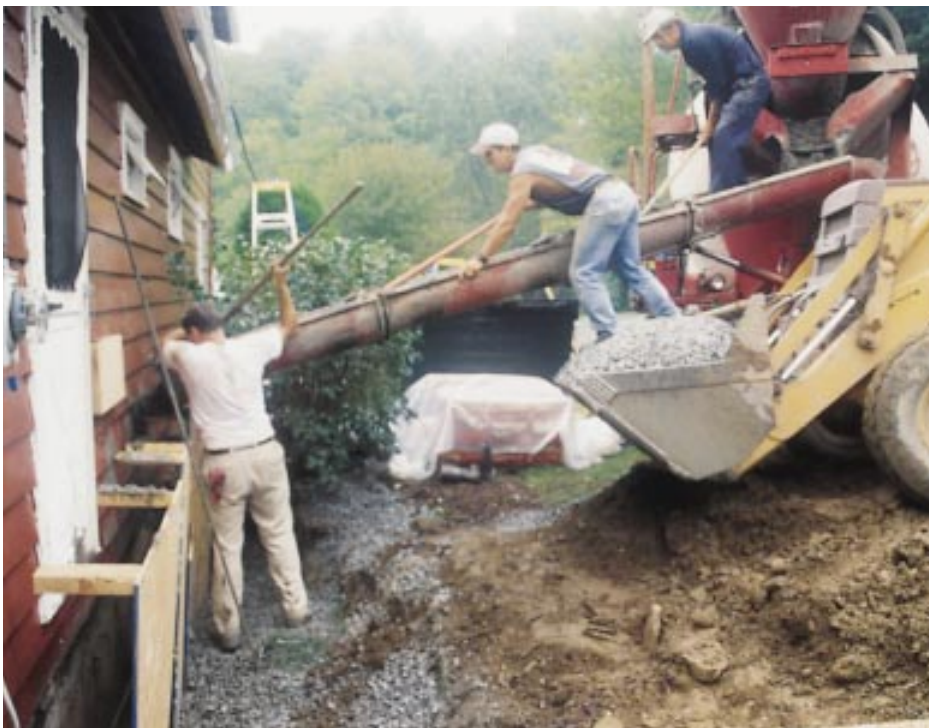
Figure 1. In this simple foundation repair, the new wall reinforces the existing buckling wall. The new drain system relieves water and frost pressure against the foundation.

vating a trench directly outside the wall, and installing a drain and gravel. My plan, while the trench was open, was to pour a new concrete wall directly against the existing block wall (see Figure 1). The new wall didn't have to be pretty — it just needed to reinforce and take the pressure off the existing wall.

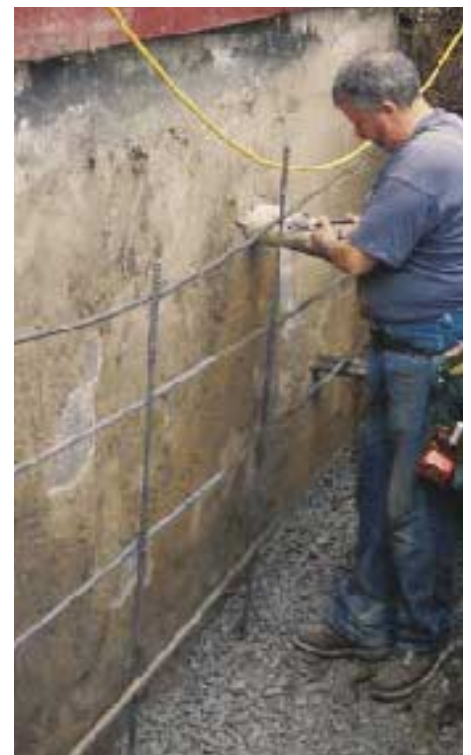
Figure 2. After the trench was dug, the author installed #5 rebar 4 feet on-center vertically, and 2 feet on-center horizontally.

My excavator dug the trench, and we wired up #5 bars 4 feet on-center vertically and 2 feet on-center horizontally (Figure 2).

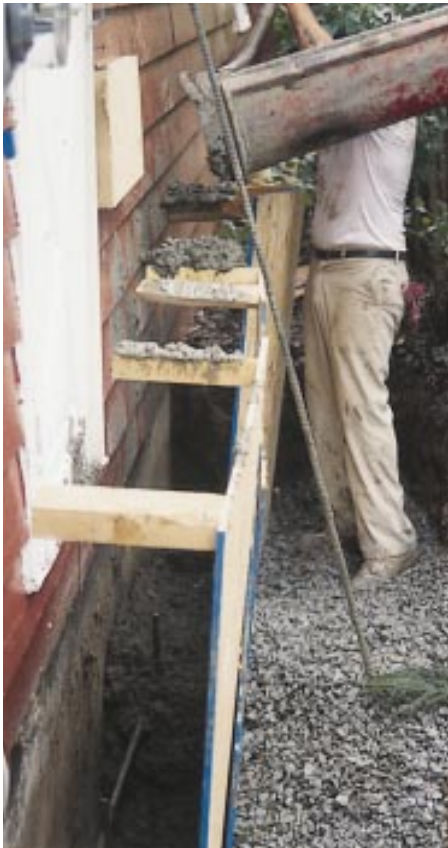
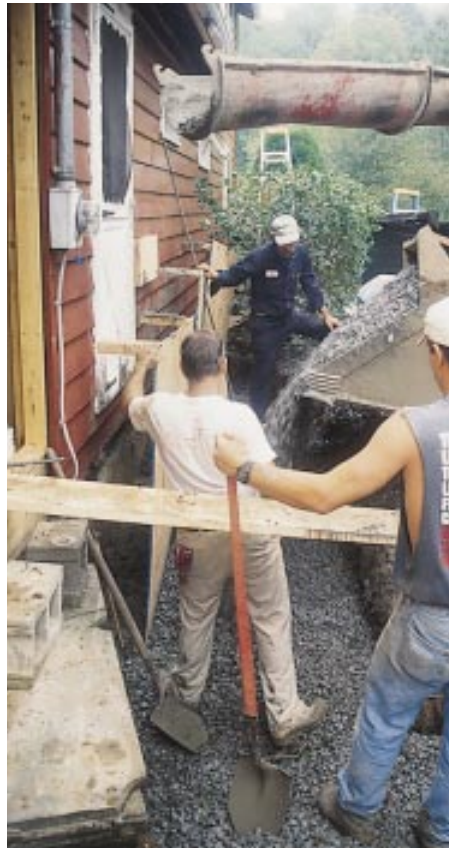
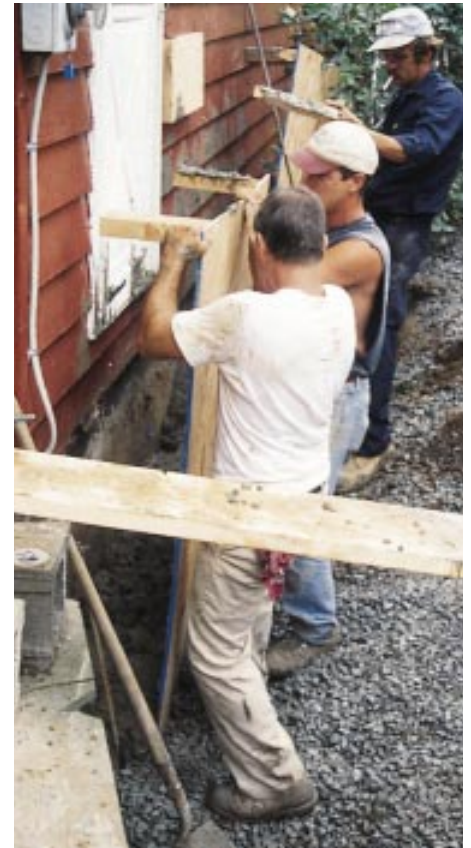
Figure 3. OSB backed with gravel provided a movable form for the stiff concrete mix (left). As the form filled with concrete, additional gravel was dumped against the panels (middle). The OSB was pulled up in one-foot lifts as the pour progressed (right).

We set the OSB in the bottom of the trench, about a foot from the foundation. We laid the footing drain in a bed of gravel just outside the form. I had the backhoe operator dump gravel in the trench until it just started to bear against the OSB, then we started pulling concrete out of the chute and into the form (Figure 3). We made sure the ready-mix operator kept the mix dry. I'm guessing I used a mix with a slump between 1 and 2. In more practical terms, the stuff didn't slide down the chute by itself; we had two guys with shovels working the chute, coaxing the stiff mud down.

As the concrete rose in the form, I worked the pile of gravel with my feet, pushing gravel against the OSB, and matching the height of the concrete. I'd call for more gravel as needed, and when

the concrete was about 16 inches deep, I grabbed the first sheet of the OSB and wrestled it back and forth, pulling it up about a foot. I went on down the line, pulling each sheet up a foot. It didn't take long to realize that the sheets that had the smooth side towards the concrete were easier to pull up.

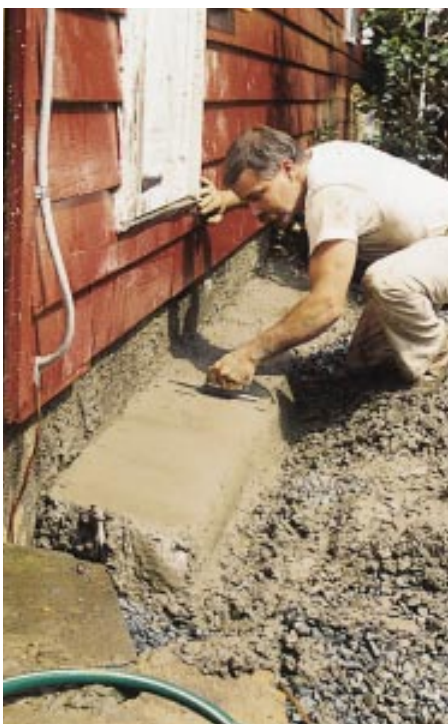
Figure 4. The stiff mix was easy to mold and trowel at the top of the foundation, where 6 inches of the new foundation remained visible.

I started the process again at the other end of the wall form: gravel as needed, about another foot of concrete, and a wrestling match with the OSB. After seven 20-minute rounds, the wall was poured and backfilled, and I was left with about 6 inches of concrete protruding above grade. As the exposed concrete set, I molded and troweled off the top of the wall (Figure 4)
