# Inspection Report

## Towne Inspections

<b>Date:</b> 8/16/2019	<b>Time:</b> 09:00 AM	<b>Report ID:</b> 001093
<b>Property:</b>

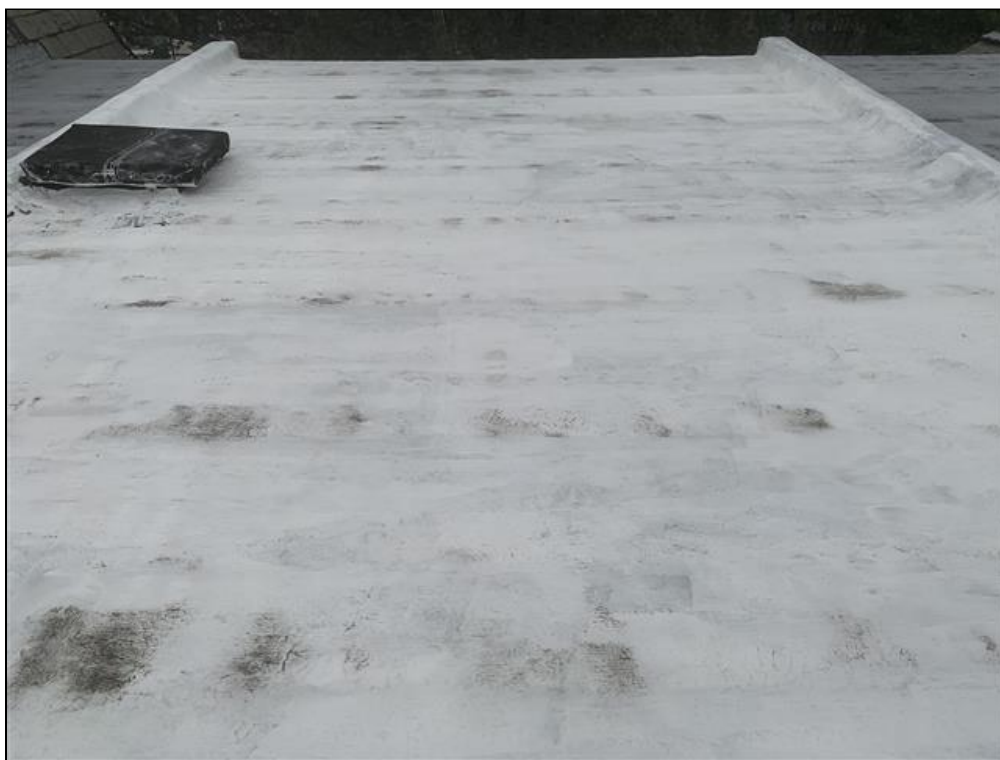
1.0 Item 1(Picture) Roof (facing toward street).

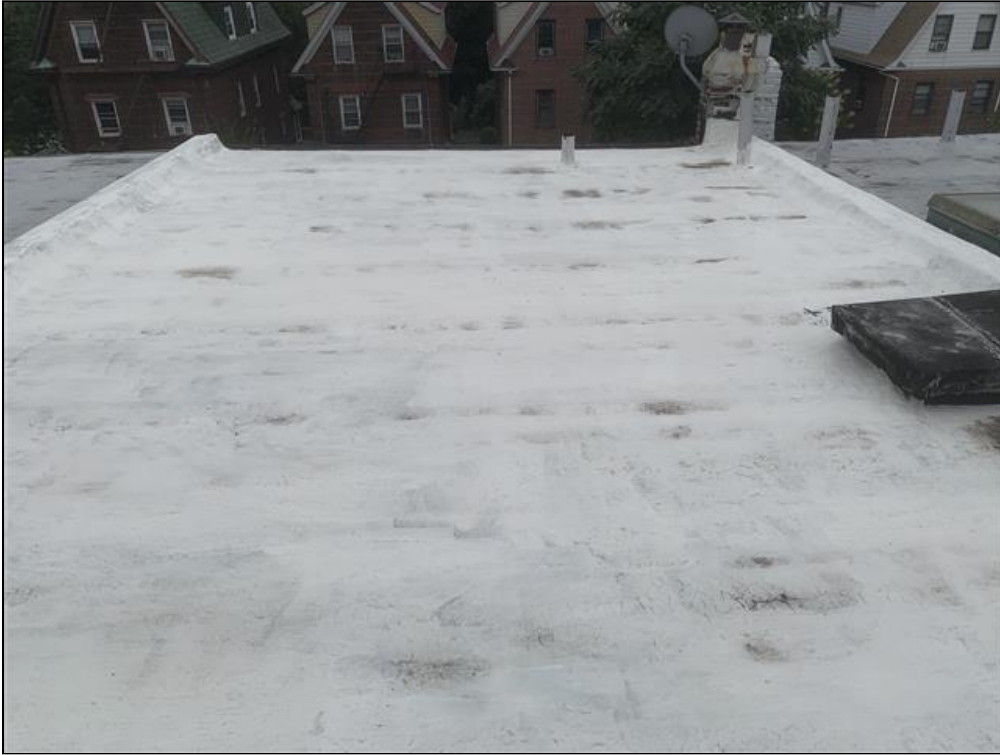
1.0 Item 2(Picture) Roof (facing toward rear of home).

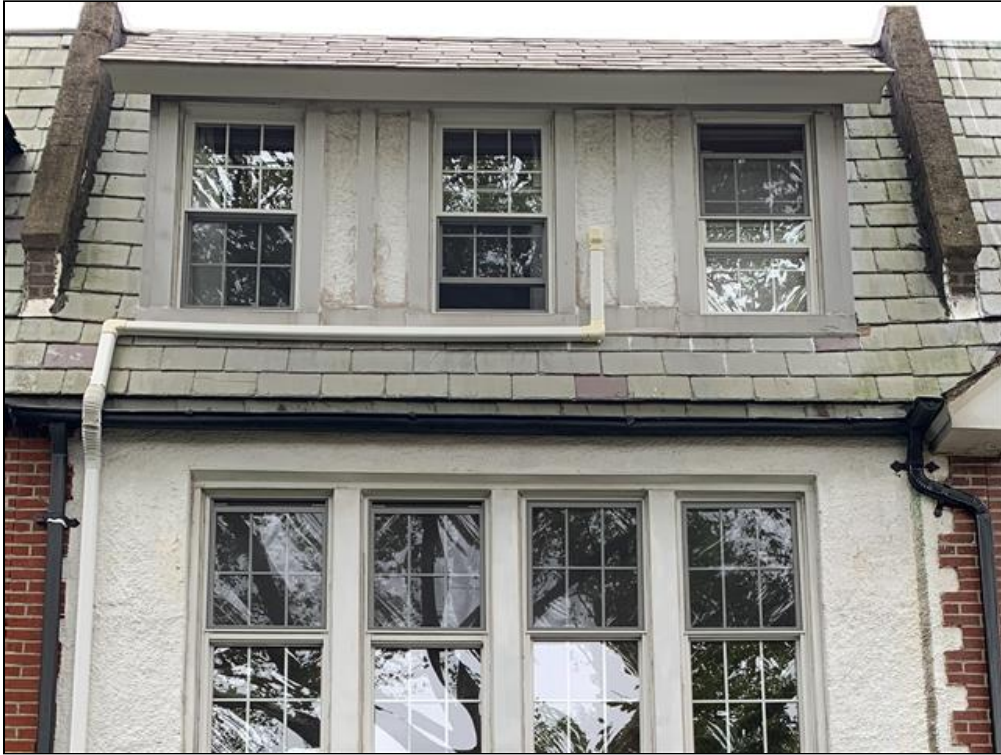
**Slate Roof:** The home also has a slate roof at the front (street side). Slate roofs can last 125 years or more. At the time of inspection the slate shingles covering these roof surfaces appeared to be in good shape.

1.0 Item 5(Picture) Slate roof surfaces at front of home.

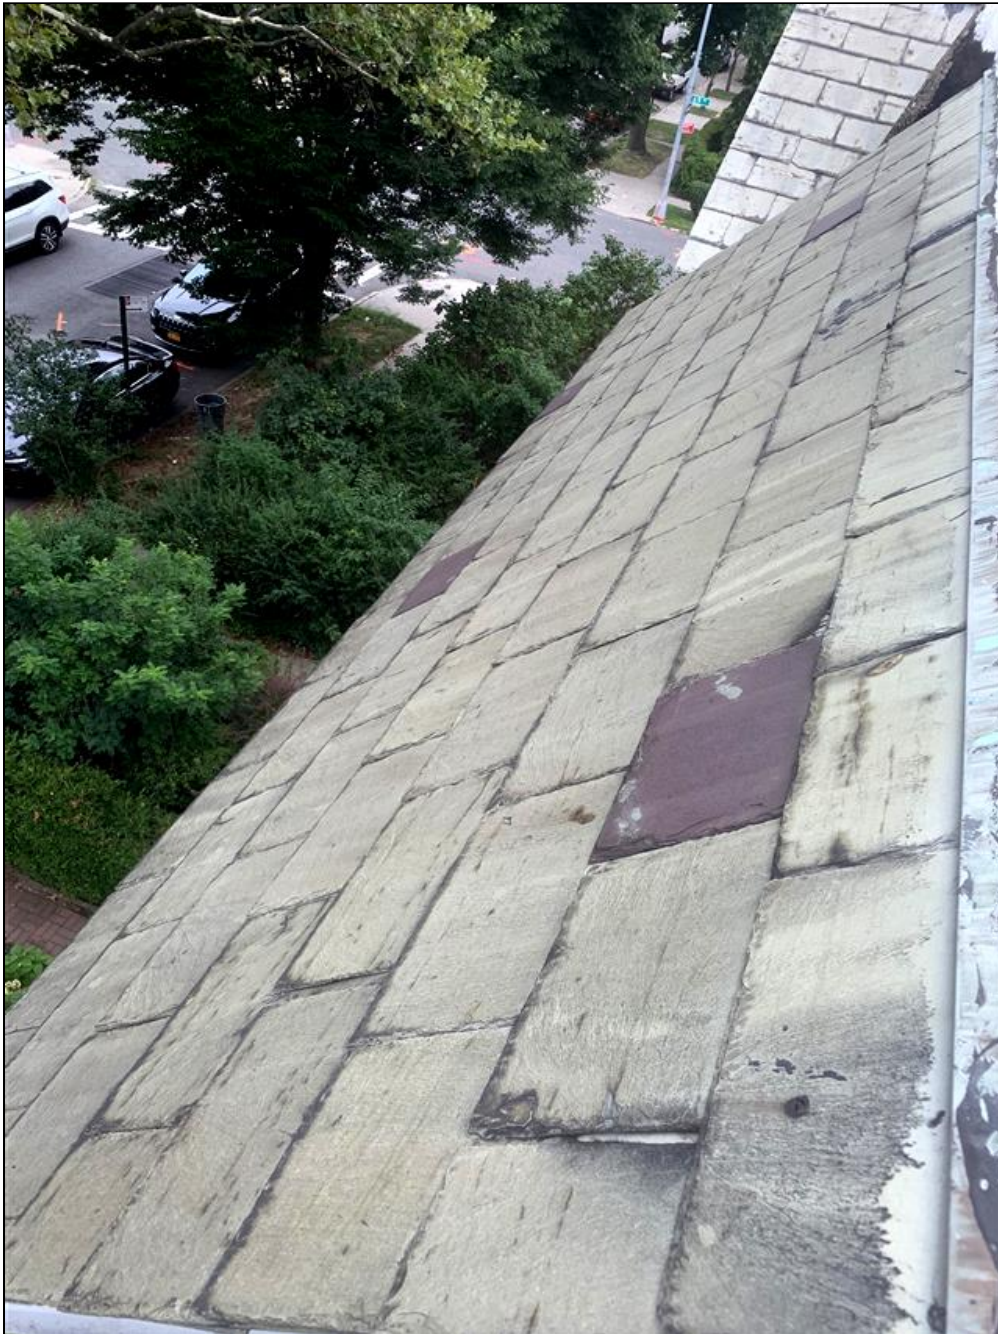
1.0 Item 6(Picture) Slate roof above front third floor windows.

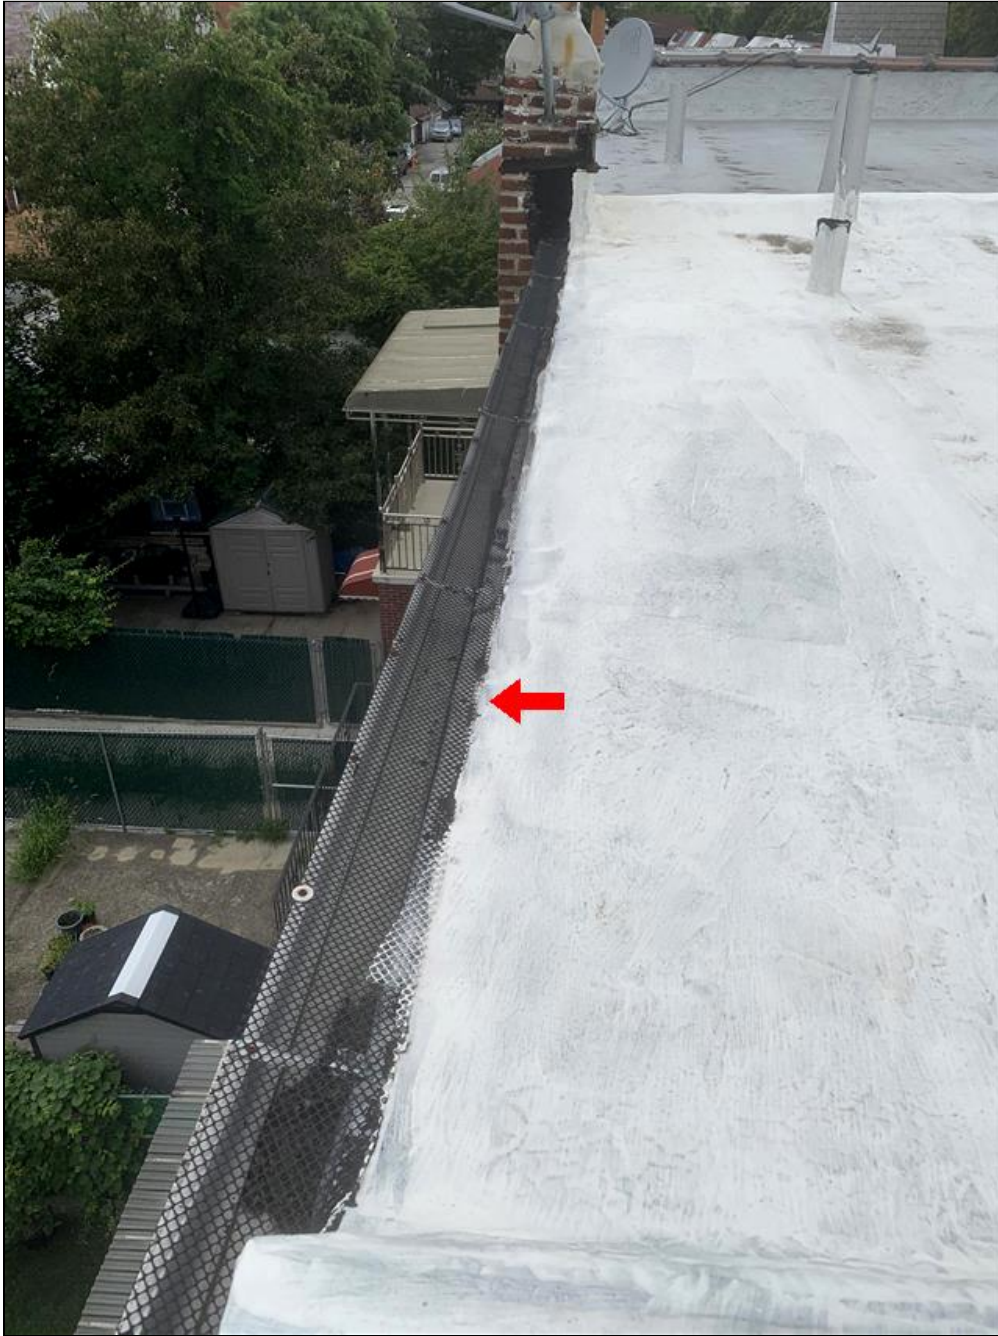
1.1 Item 1(Picture) At the rear of the home the roof cladding curls over the edge and acts as edge flashing.

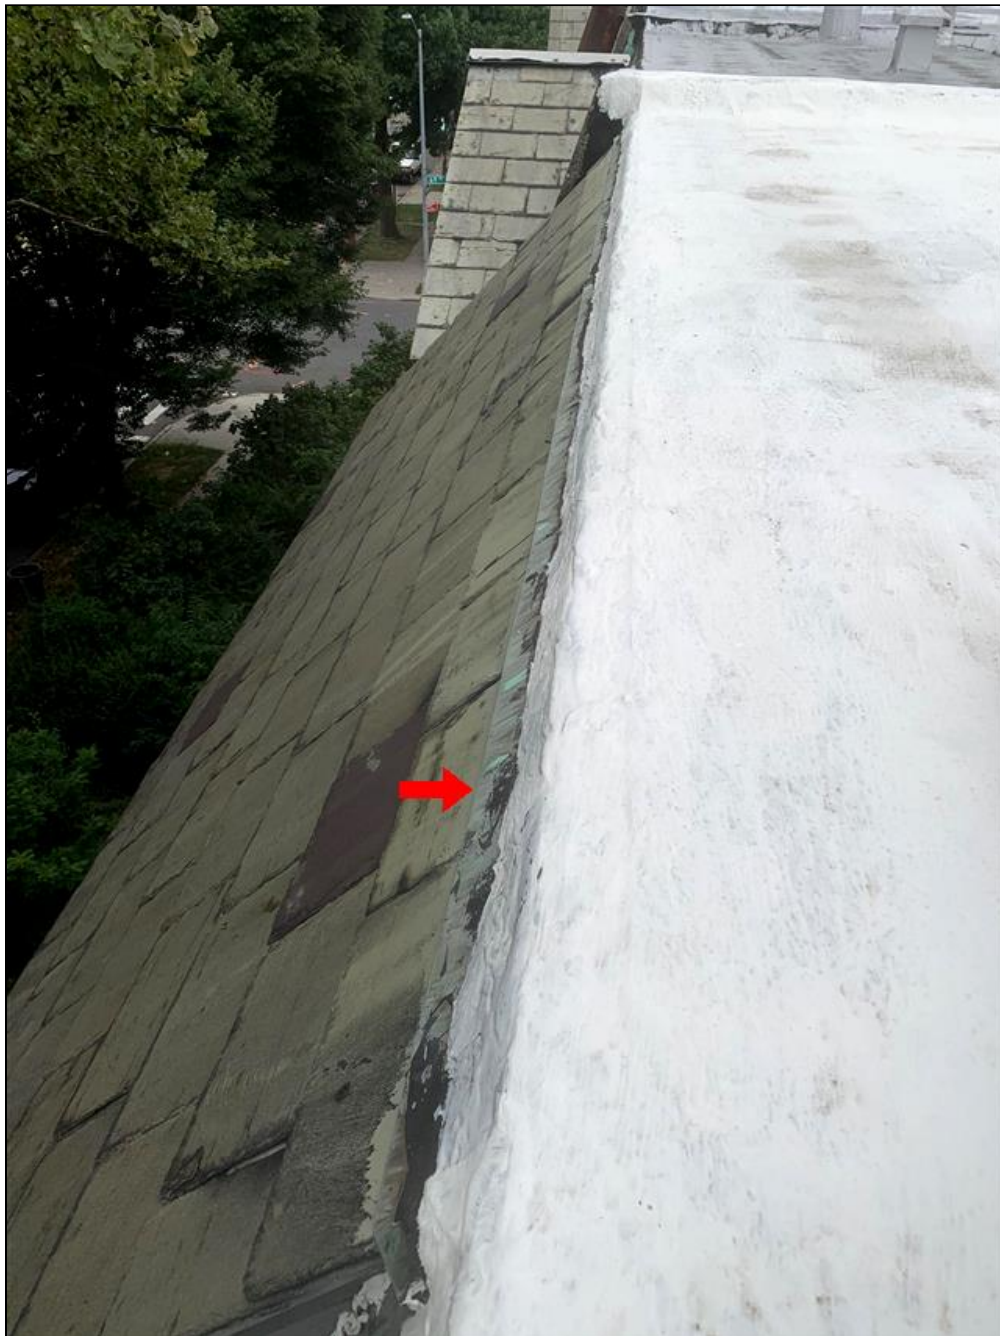
1.1 Item 2(Picture) At the front of the home metal flashing is installed above the slate roof (to keep water from getting below the slate) and then the roll roofing of the main room curls over the top edge of this flashing to keep water from getting behind the flashing.

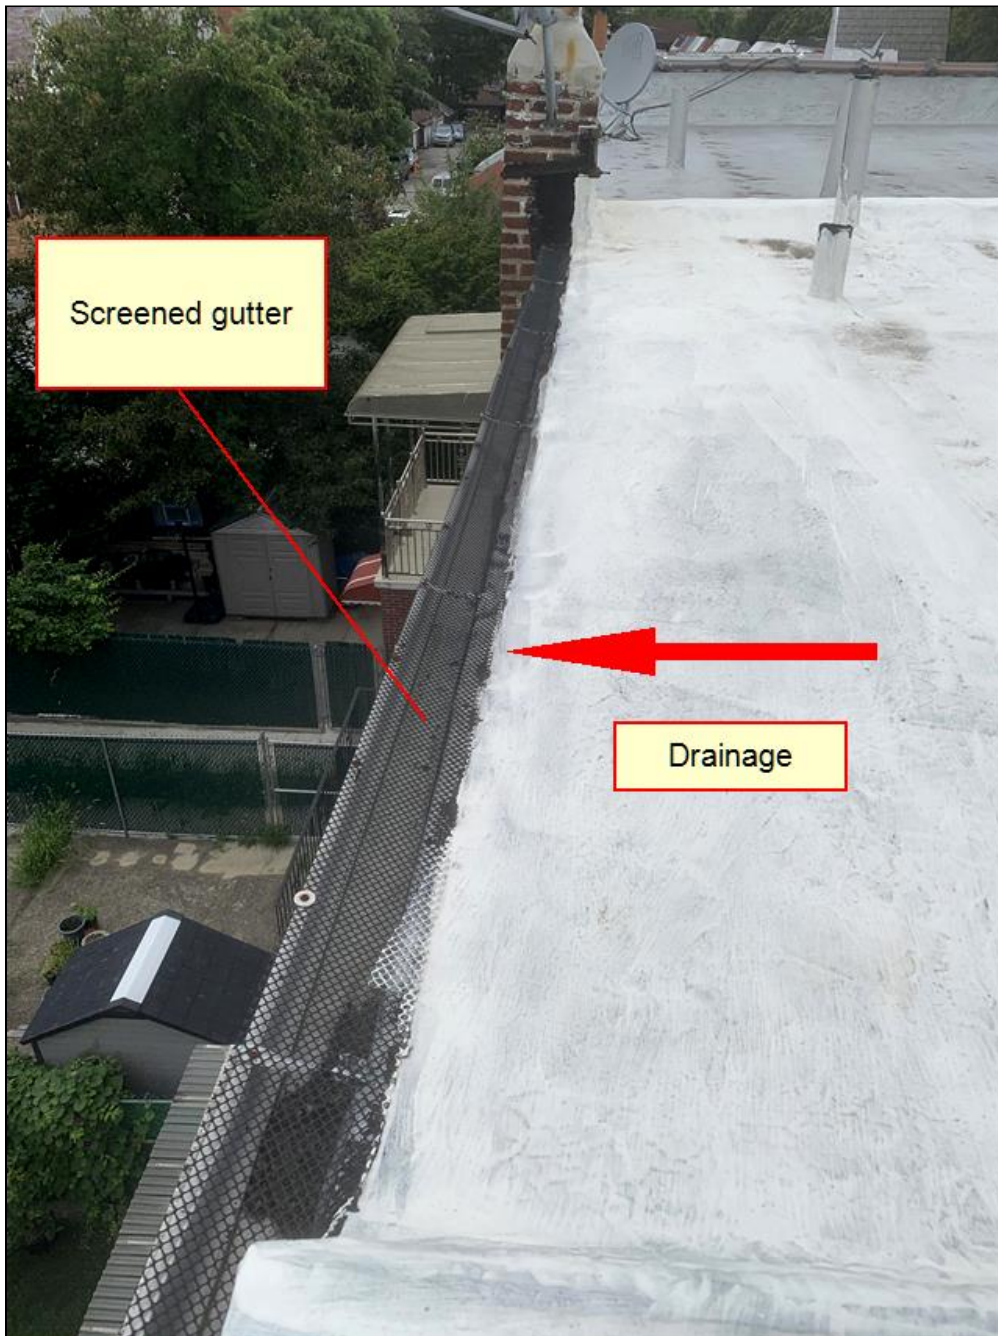
1.3 Item 1(Picture) Photo showing direction of drainage into screened gutter at back of home.

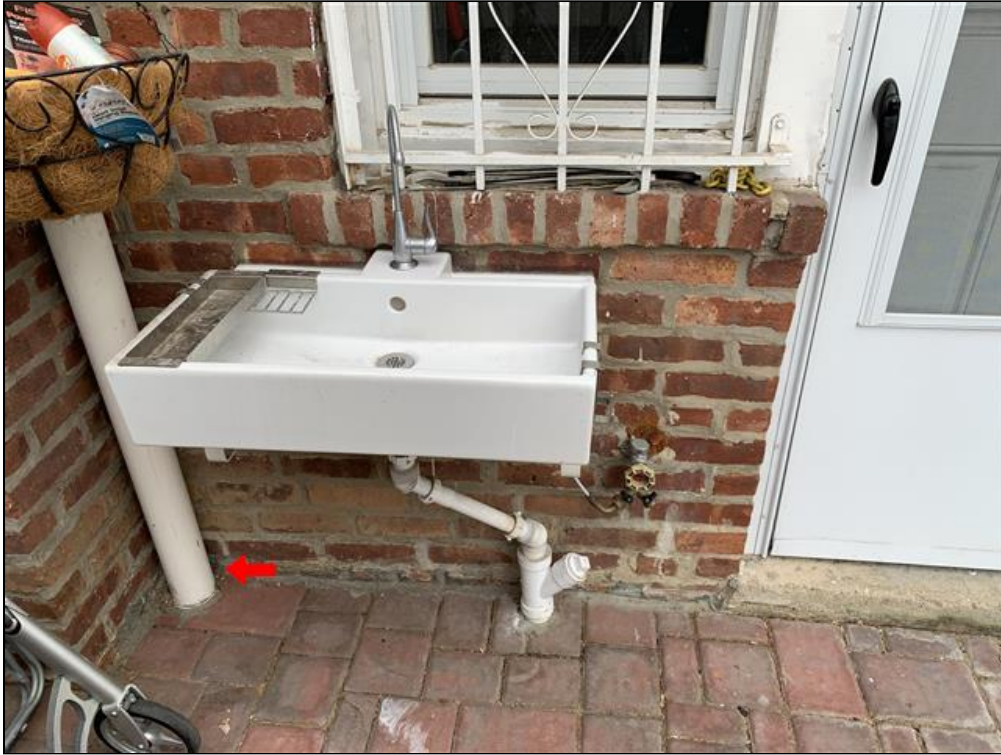
1.3 Item 2(Picture) Downspout from back of roof.

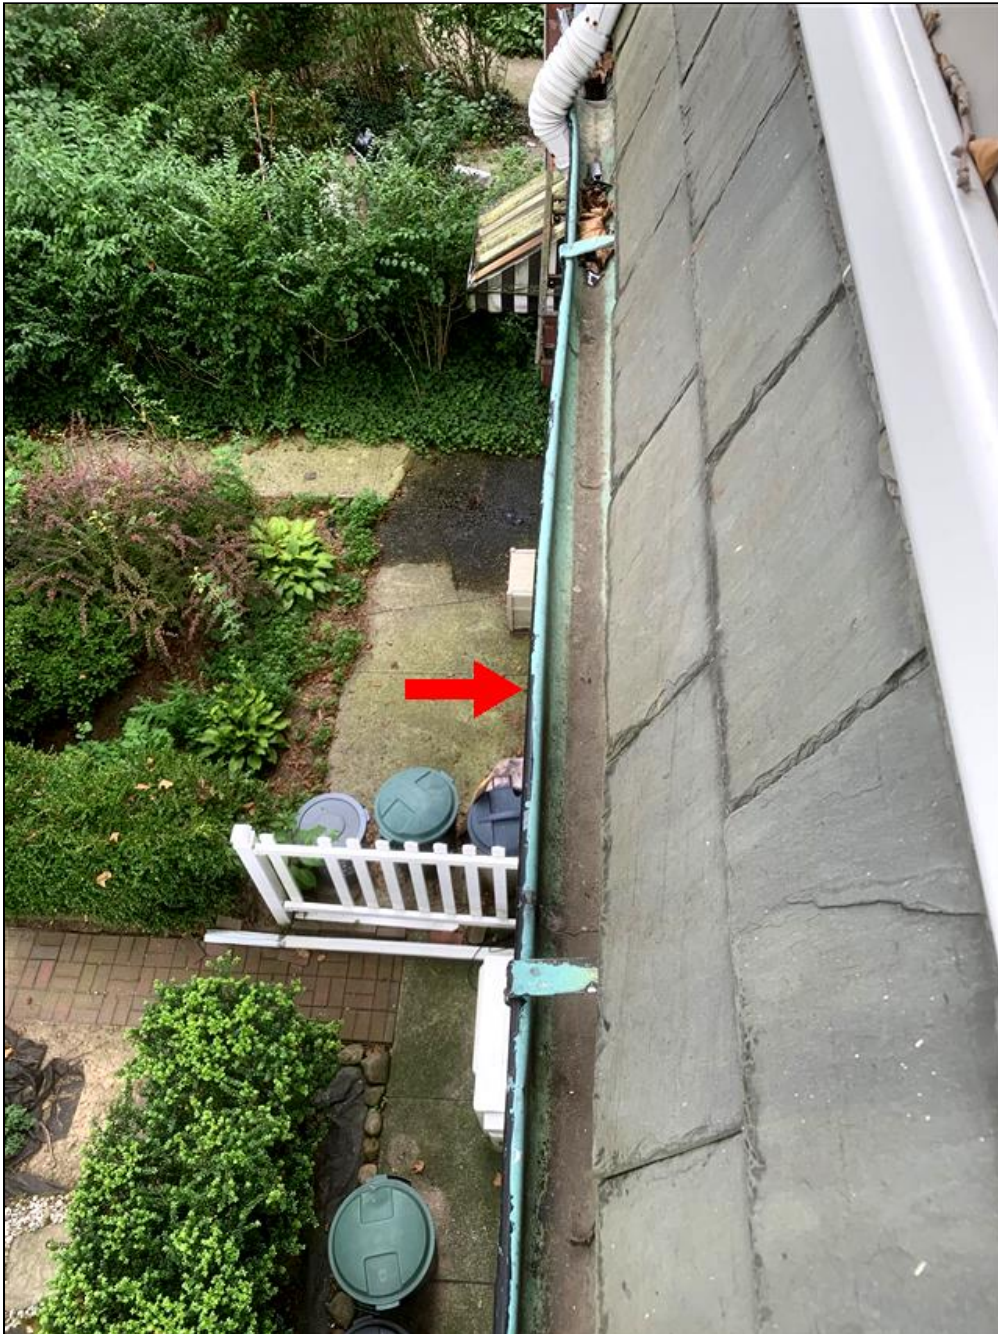
1.3 Item 3(Picture) Gutter serving slate roof at the font of the home.

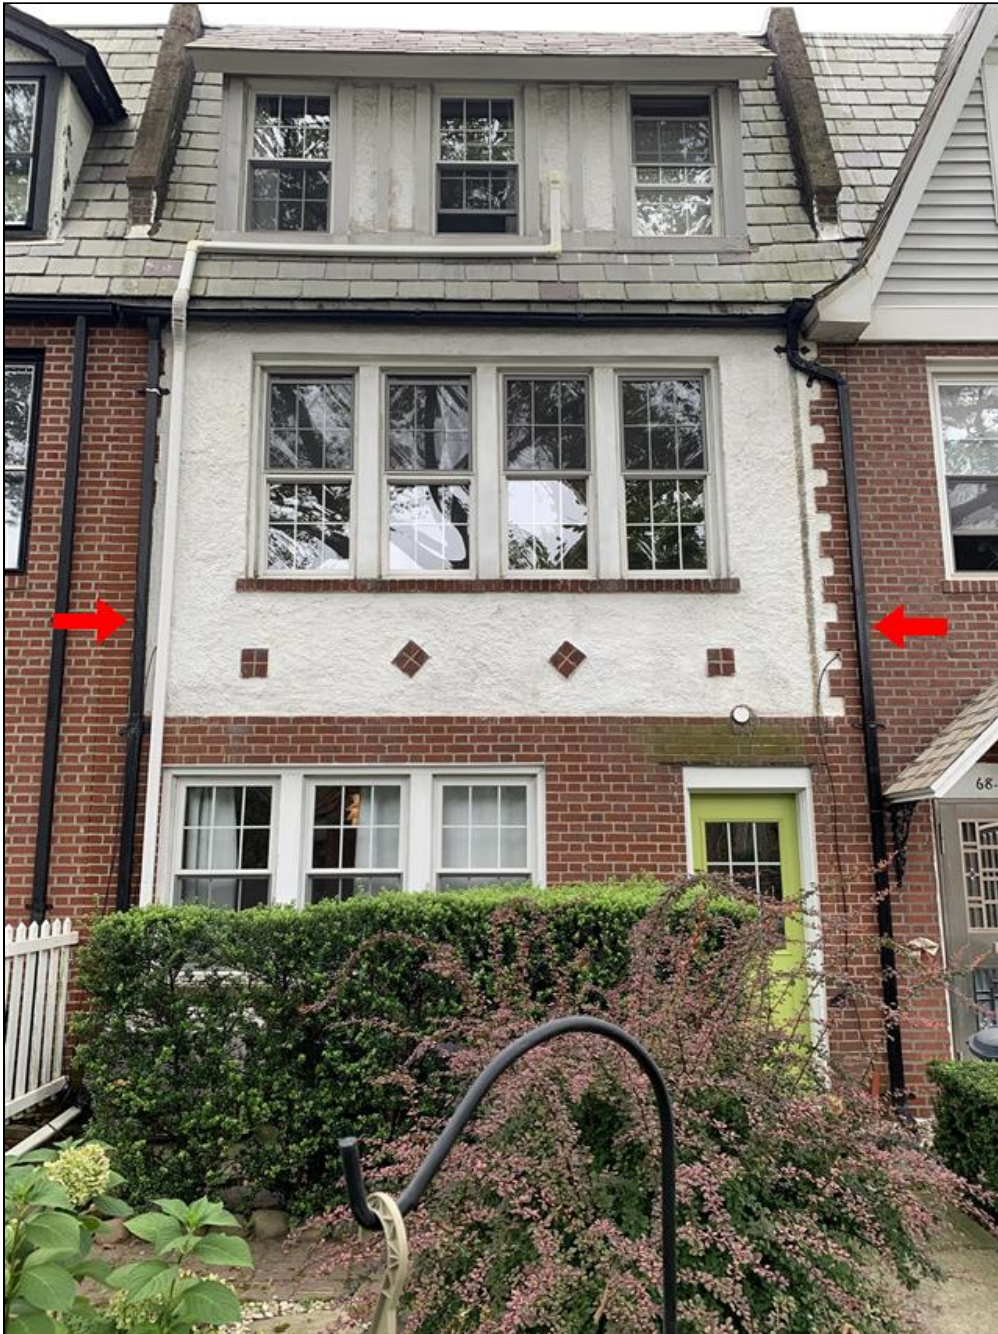
1.3 Item 4(Picture) Downspouts from gutter at front of home.

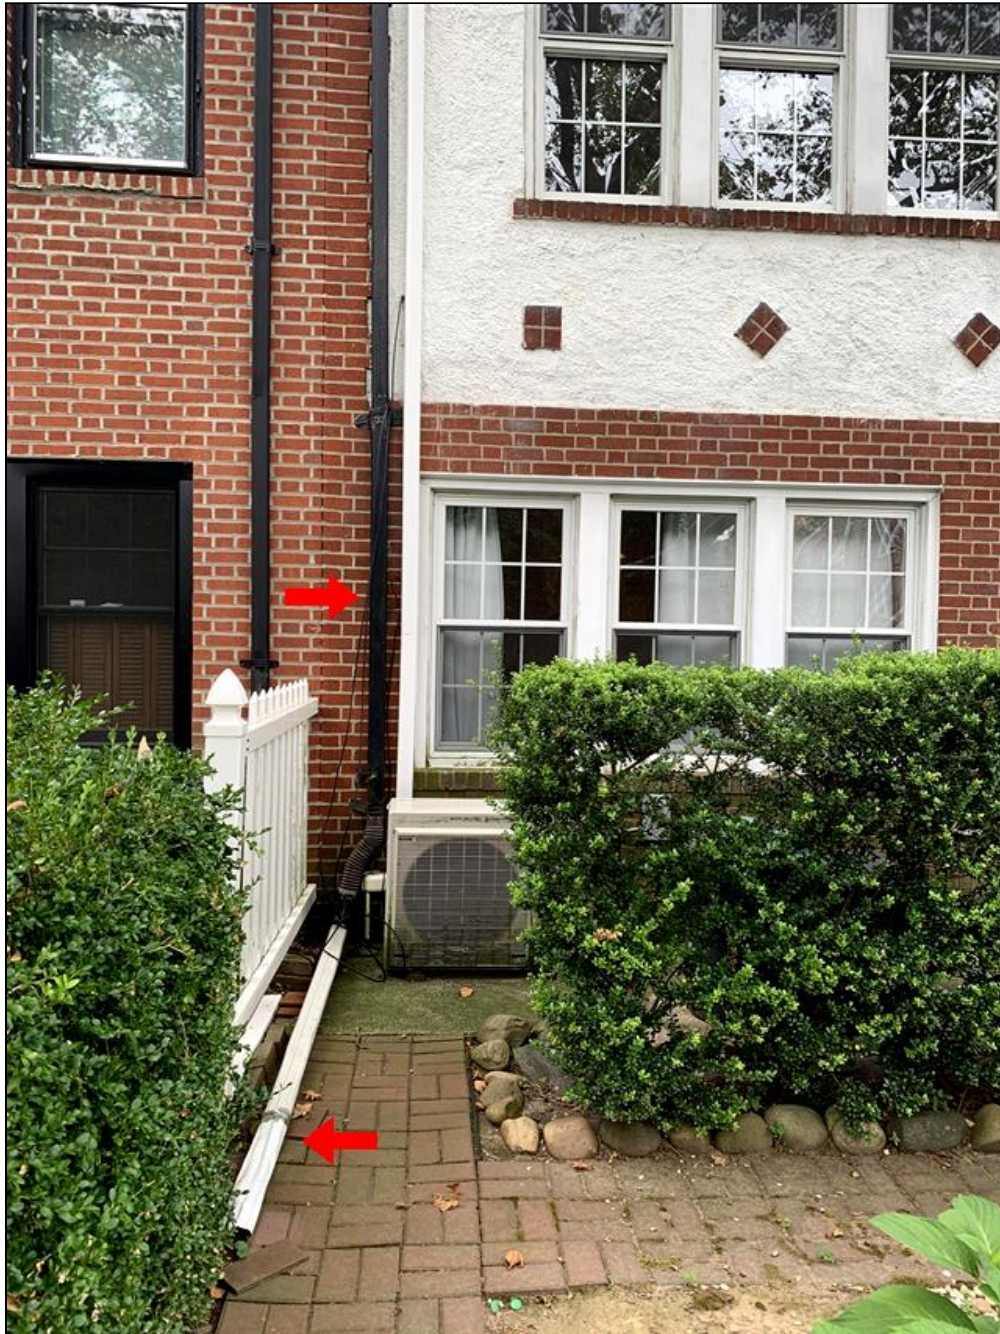
1.3 Item 5(Picture) Left-hand downspout terminates a good distance away from home.

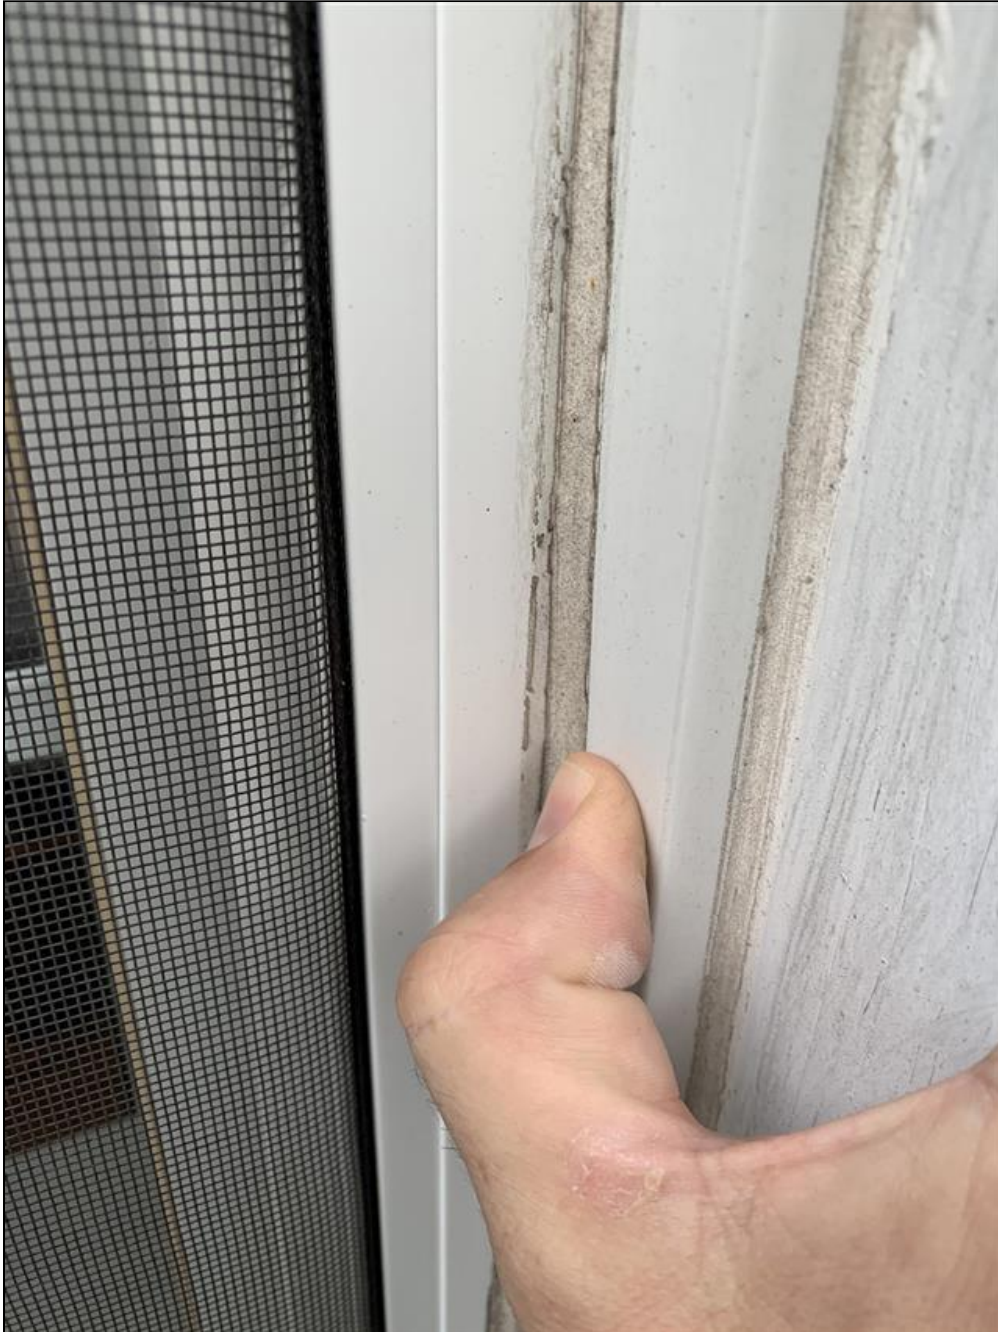
2.2 Item 4(Picture) Exterior window sealant has lost its seal.

**Exterior Window Sealants (Maintain):** Window exteriors were observed to have protective flashings in place which is good. Sealants used around the seams of these flashings are starting to age and loose their seal (this is normal over time). Because sealants will eventually dry, shrink and crack, sealant-dependent areas should be examined on an annual basis and sealant re-applied as necessary. Only four photos are provided for brevity, but this condition was witnessed to varying degrees outside all window exteriors that were examined. It is recommended that all exterior window sealants be maintained to prevent moisture intrusion.

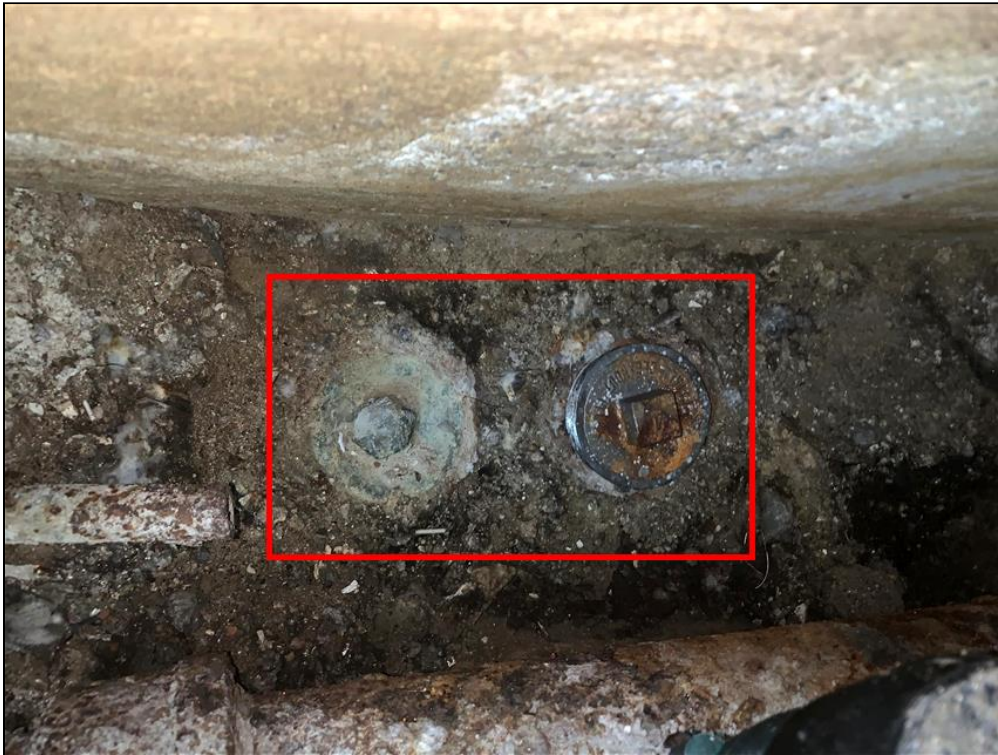
6.0 Item 2(Picture) Sewer trap. One of the caps is newer which may indicate the a repair or the removal of a clog.

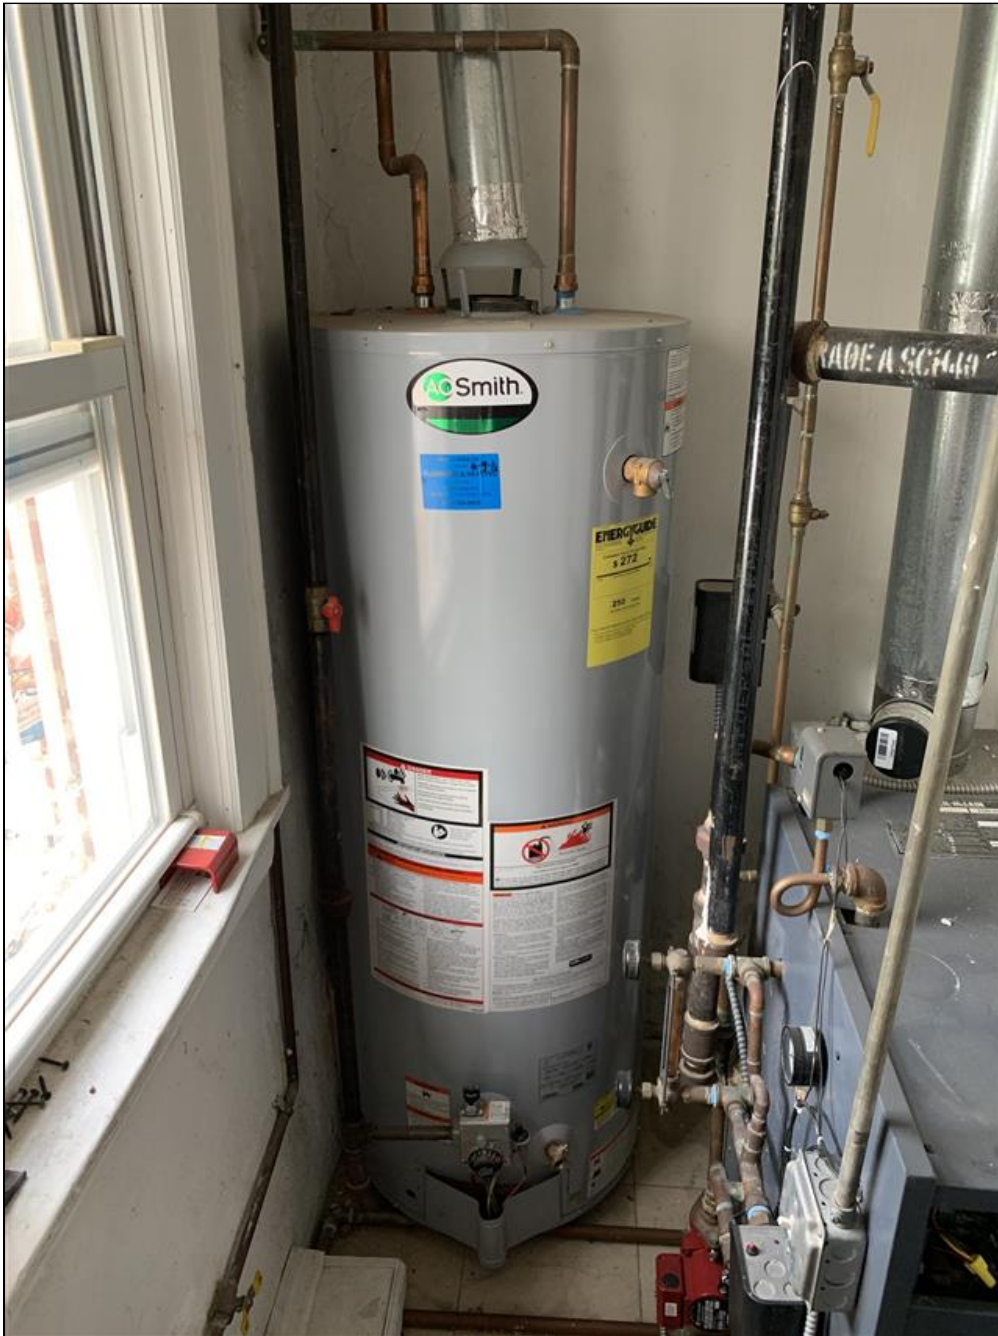
6.2 Item 1(Picture) A.O. Smith brand 50 gallon gas fired water heater.

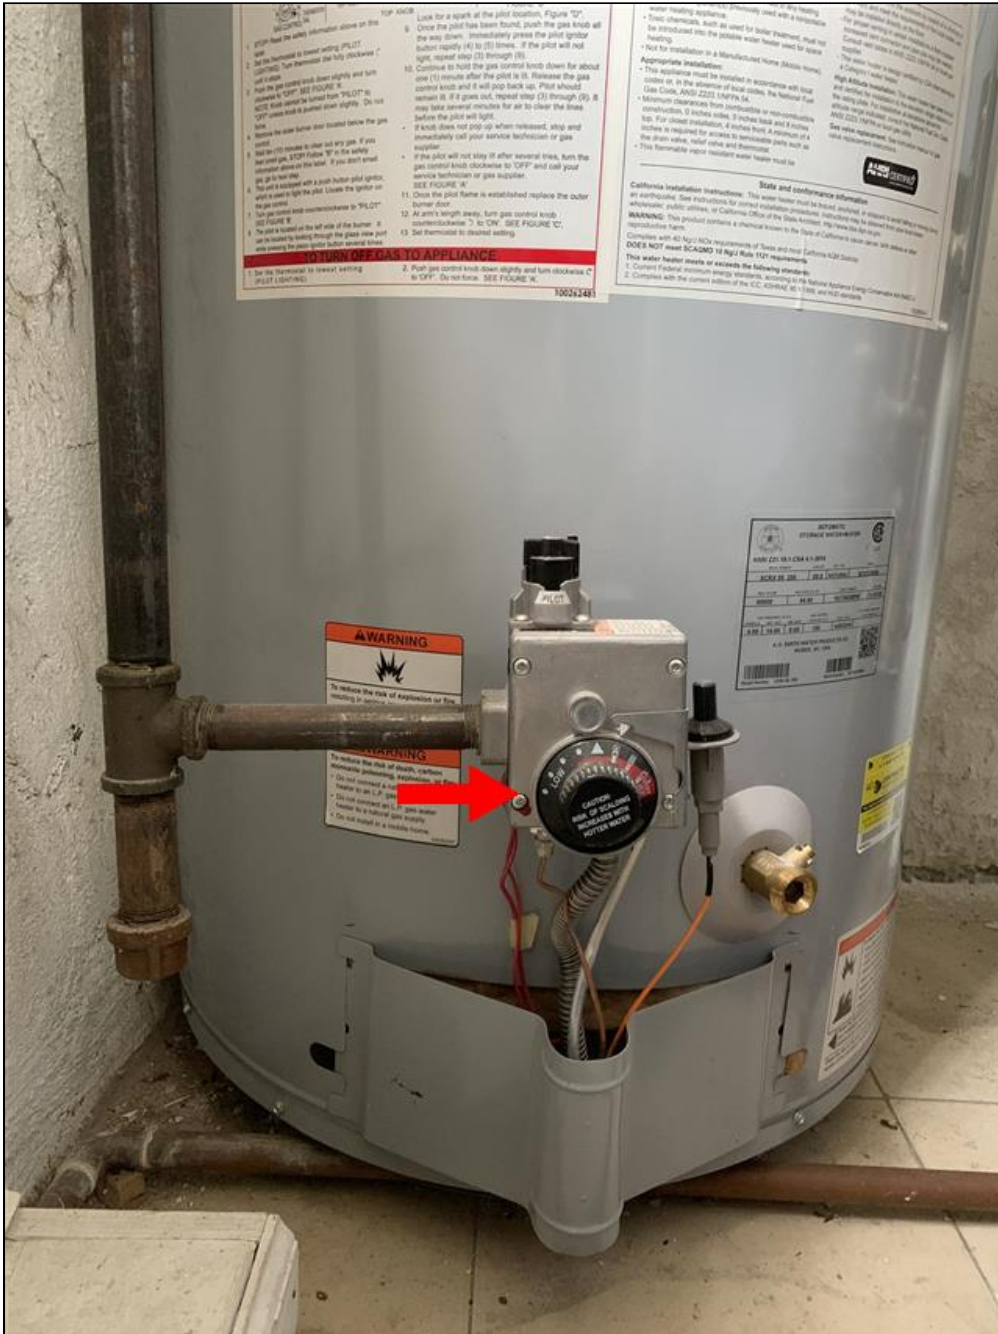
**Hot Water Temperature:** On the day of inspection the hot water of the home was measured to be around 124-126 degrees F which is a bit on the hot side. Safety and energy conservation are key factors to be considered when selecting the water temperature setting of the water heater's thermostat. The lower the temperature, the greater the safety and savings in energy cost. To achieve this, the Inspector recommend a temperature setting of 115 - 120°F. Water temperatures over 125°F can cause scalding. Water temperature can be adjusted via the dial at the lower front of the water heater (see photo).

6.2 Item 4(Picture) Hot water temperatures can be controlled here.

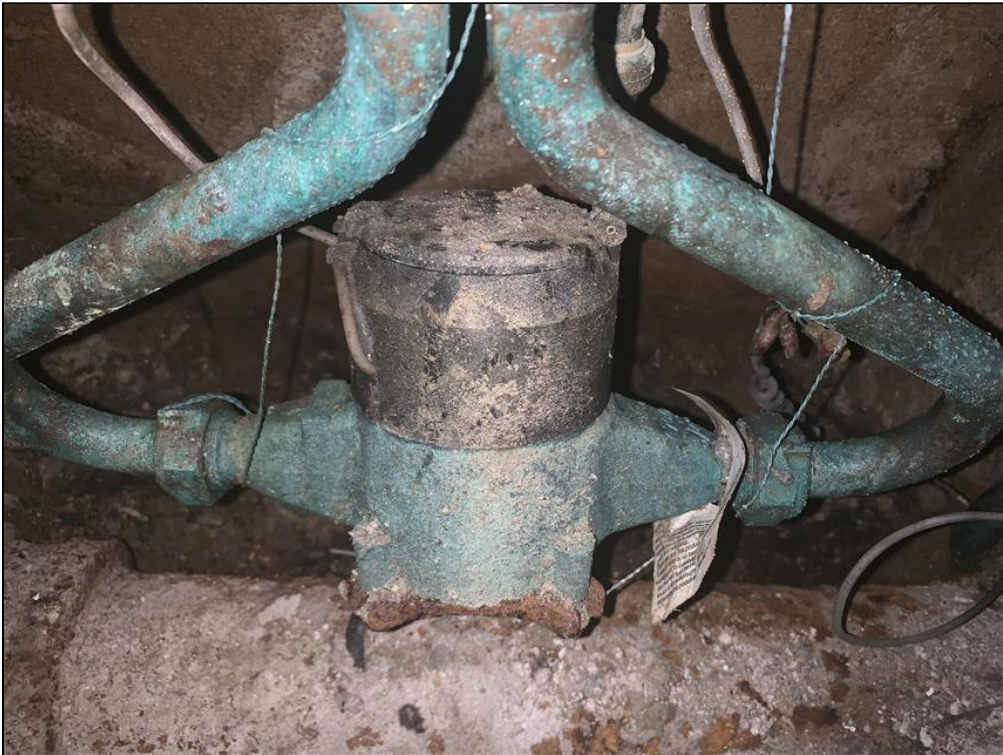
6.3 Item 2(Picture) Water meter.

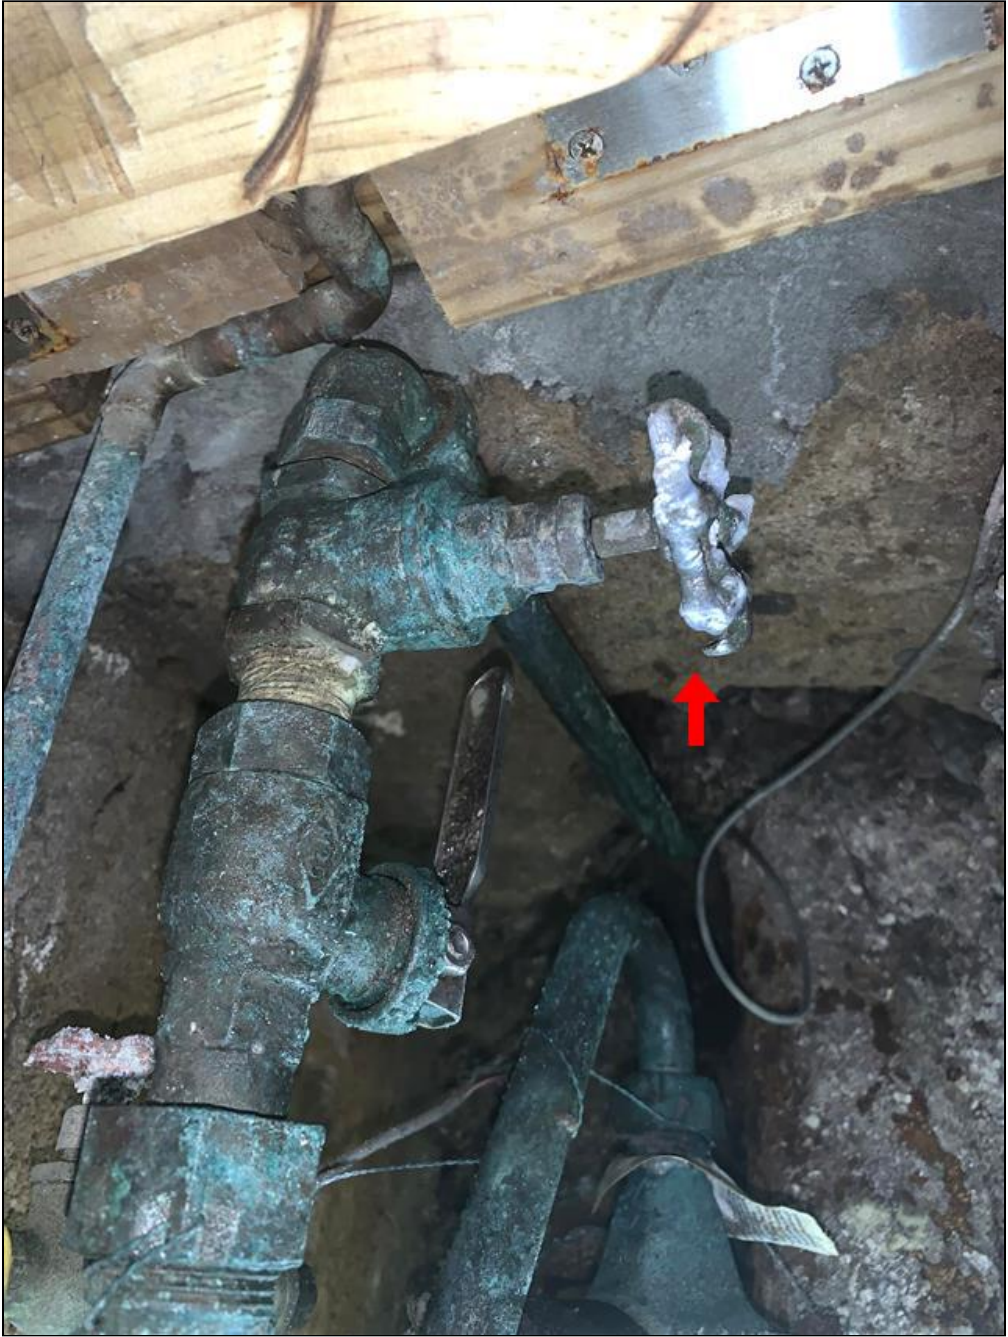
6.3 Item 3(Picture) Shutoff valve.

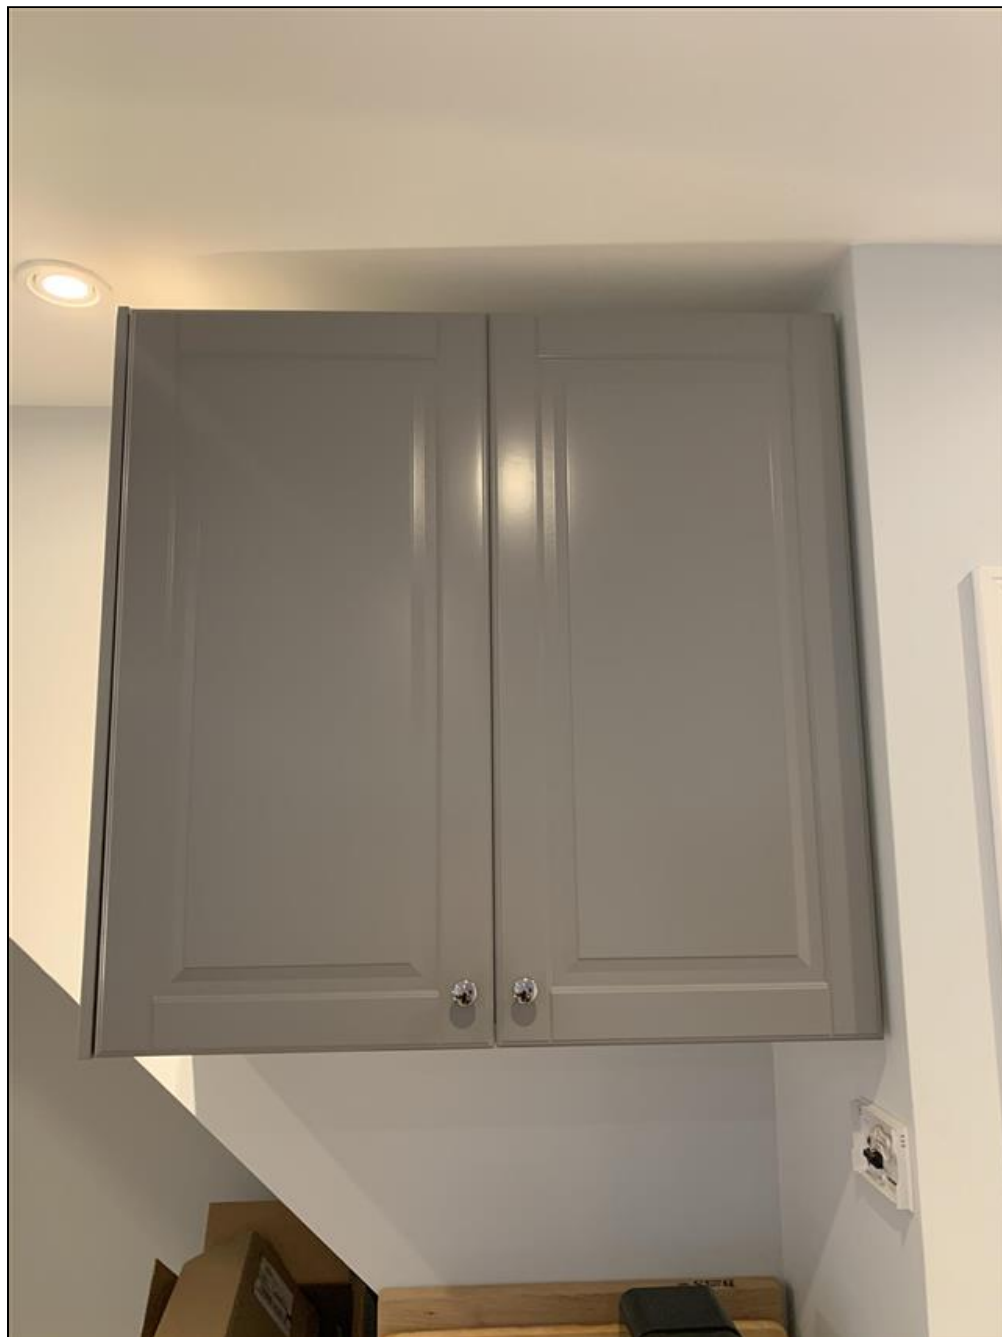
The main fuel (natural gas) shut-off & meter are located in a cabinet near the first floor kitchen. The main gas shut off valve is located just above the gas meter. Operating this valve requires a wrench. Shutting this valve off should shut off gas to the entire home.

6.5 Item 1(Picture) Gas meter is located inside this cabinet near the first floor kitchen area.

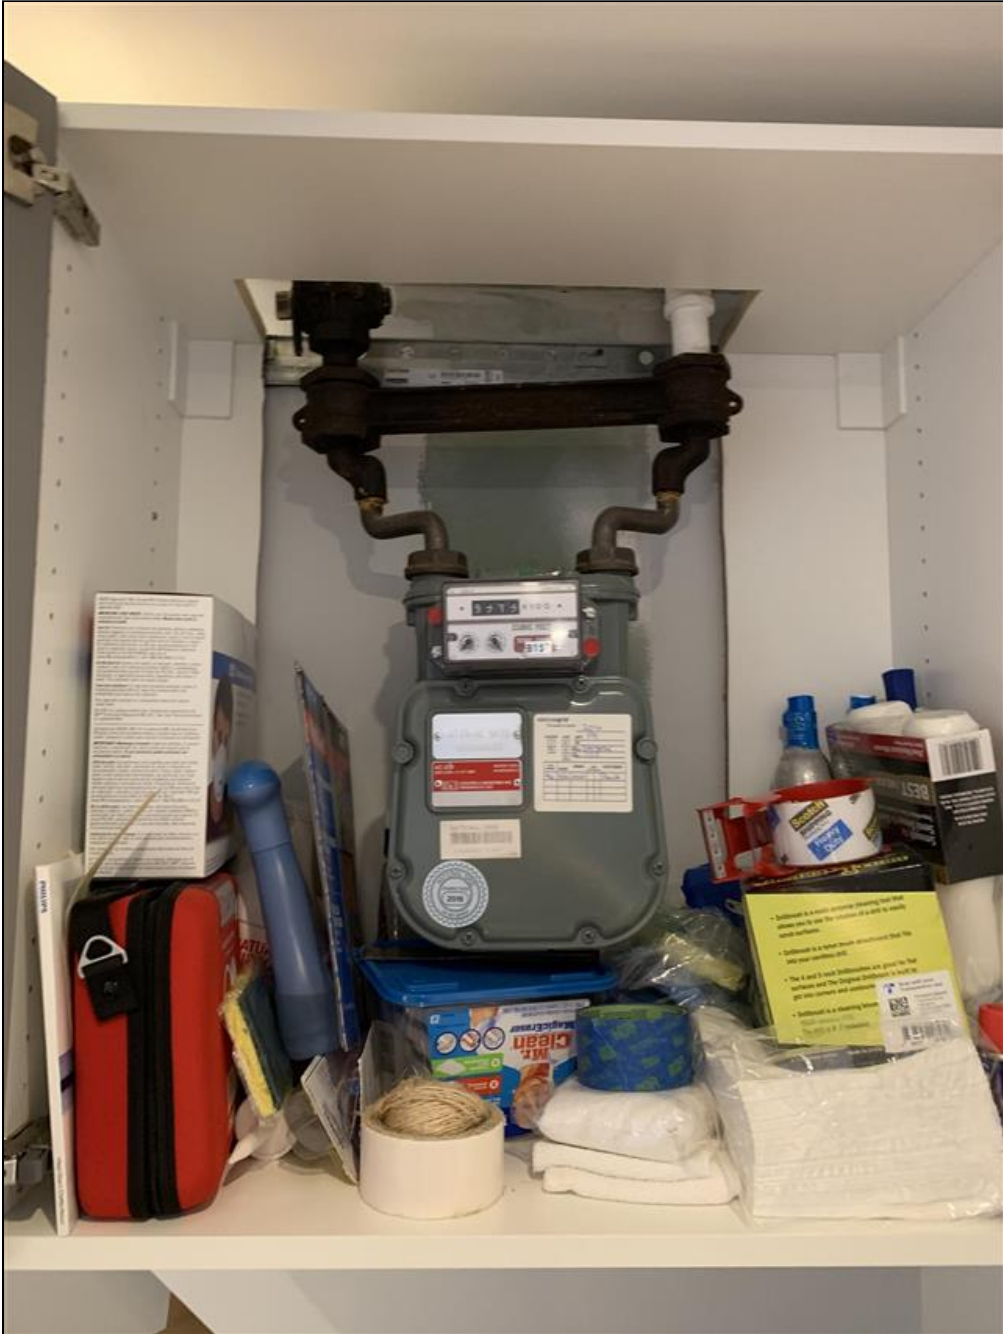
6.5 Item 2(Picture) Gas meter.
