# Inspection Report

## Towne Inspections

<b>Date:</b> 8/16/2019	<b>Time:</b> 09:00 AM	<b>Report ID:</b> 001093
<b>Property:</b>

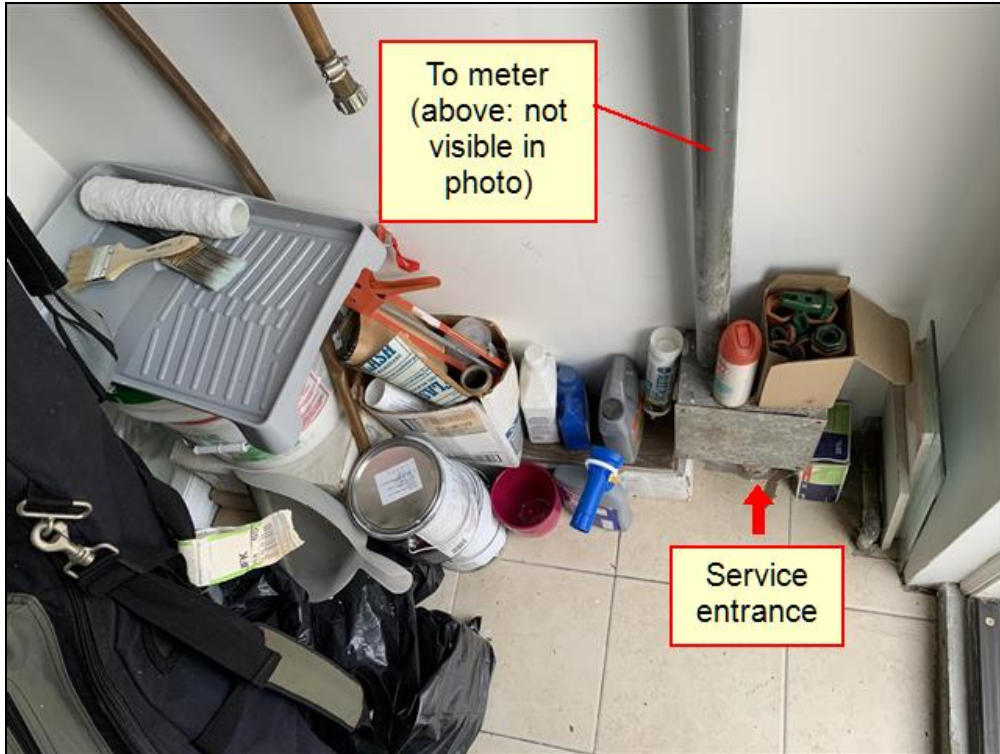
7.0 Item 1(Picture) The main service entrance conductors enter the utility room located at the rear of the home from below ground.

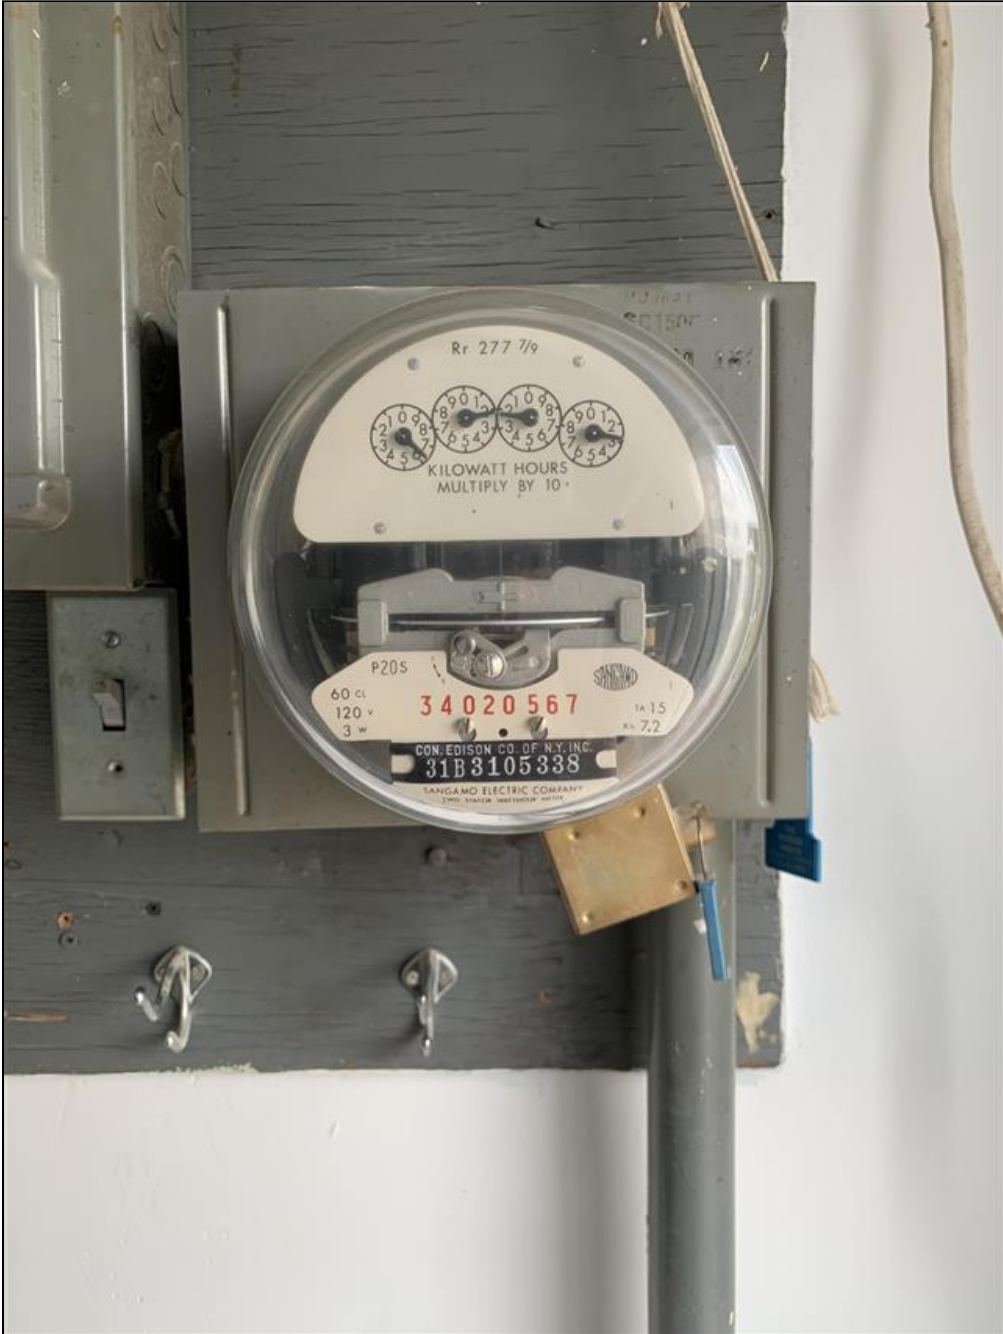
7.0 Item 2(Picture) Electrical meter.

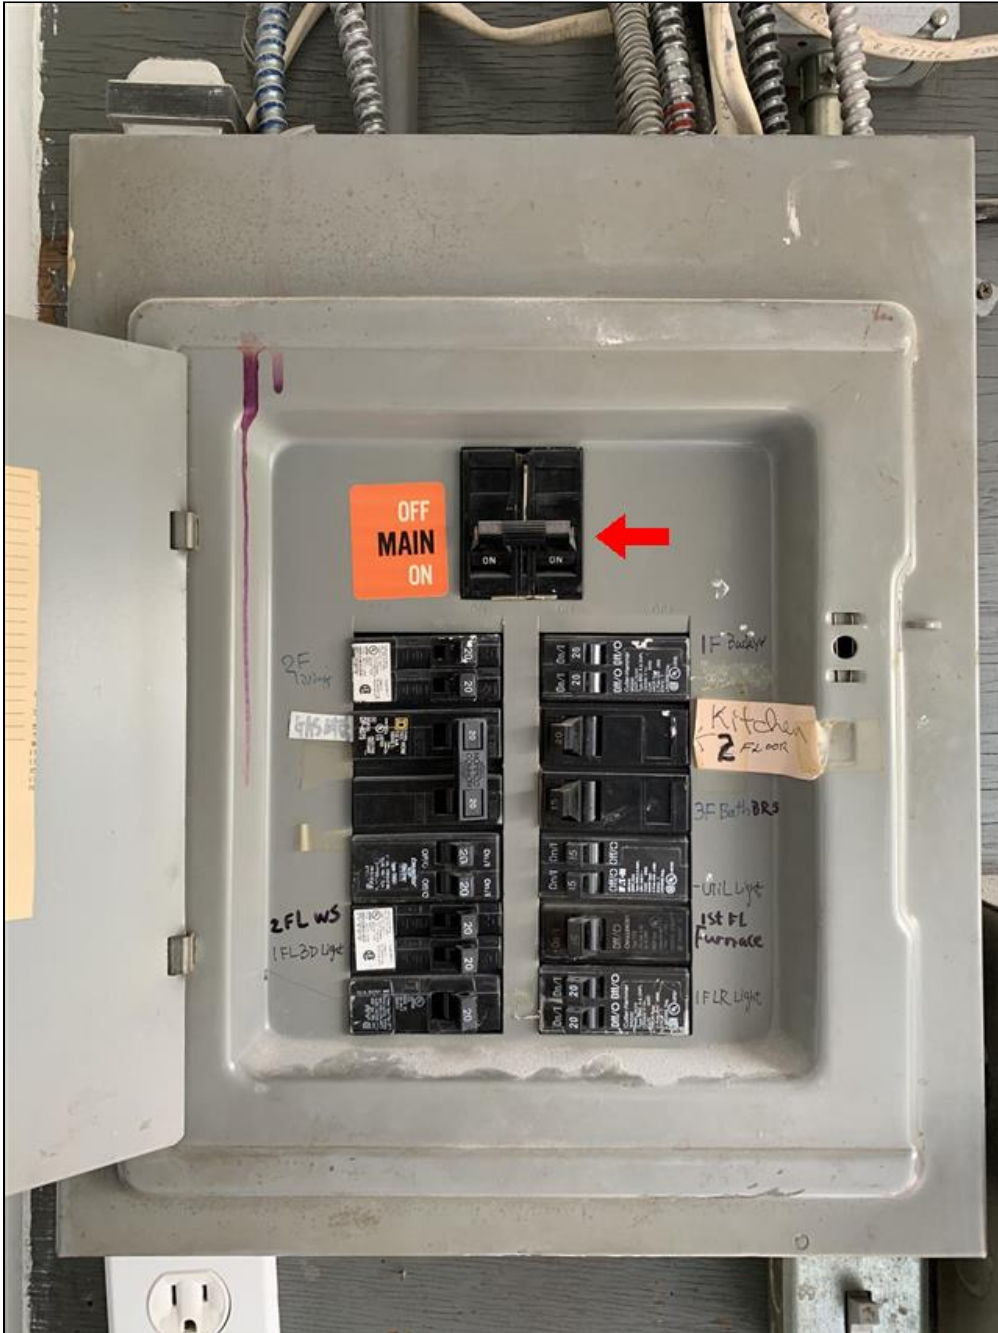
The main overcurrent device serving the home is a 100 Amp circuit breaker located in the electrical panel. This indicates that the panel is provided 100 Amp service.

7.1 Item 1(Picture) Main overcurrent device.

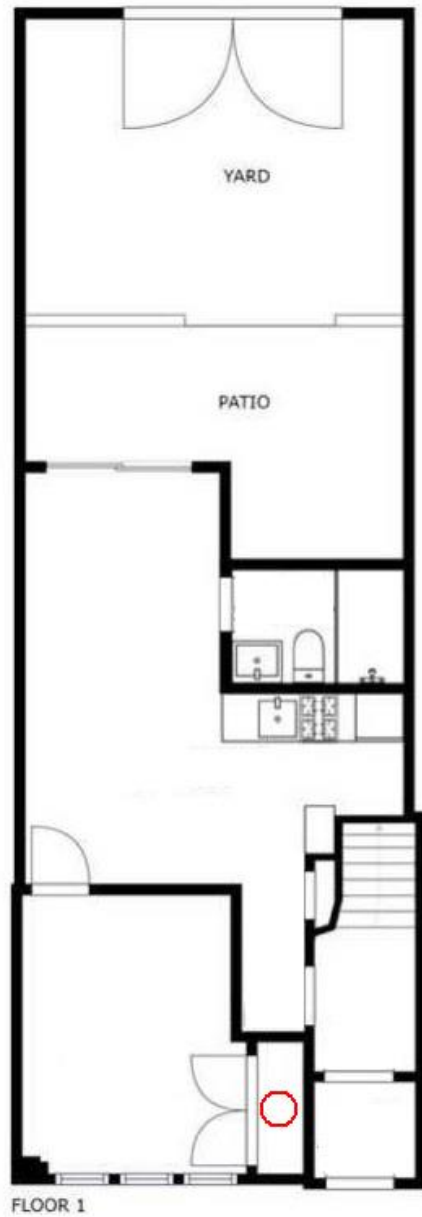
**Missing Cover Plate:** At the time of the inspection, a light fixture located in the first floor bedroom closet was observed to be installed without a proper cover plate. This condition leaves energized electrical components exposed to touch and also could lead to a fire being that this is in a closet with clothing and other flammable items.

7.3 Item 4(Picture) Floor plan showing location of exposed wires.

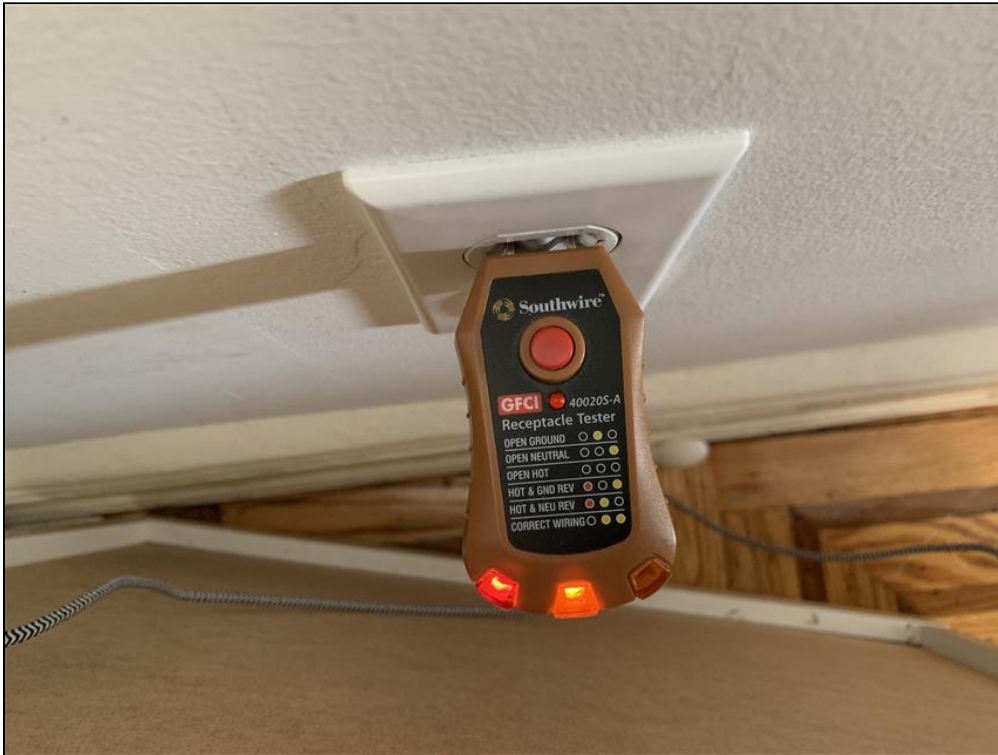
**Hot & Neutral Wires Reversed:** Every electrical receptacle located in the living room of the second floor that were tested read as having their hot and neutral wires reversed. This condition should be corrected by a qualified electrical contractor. These are likely all on the same circuit.

7.3 Item 7(Picture) Hot & neutral wires reversed.

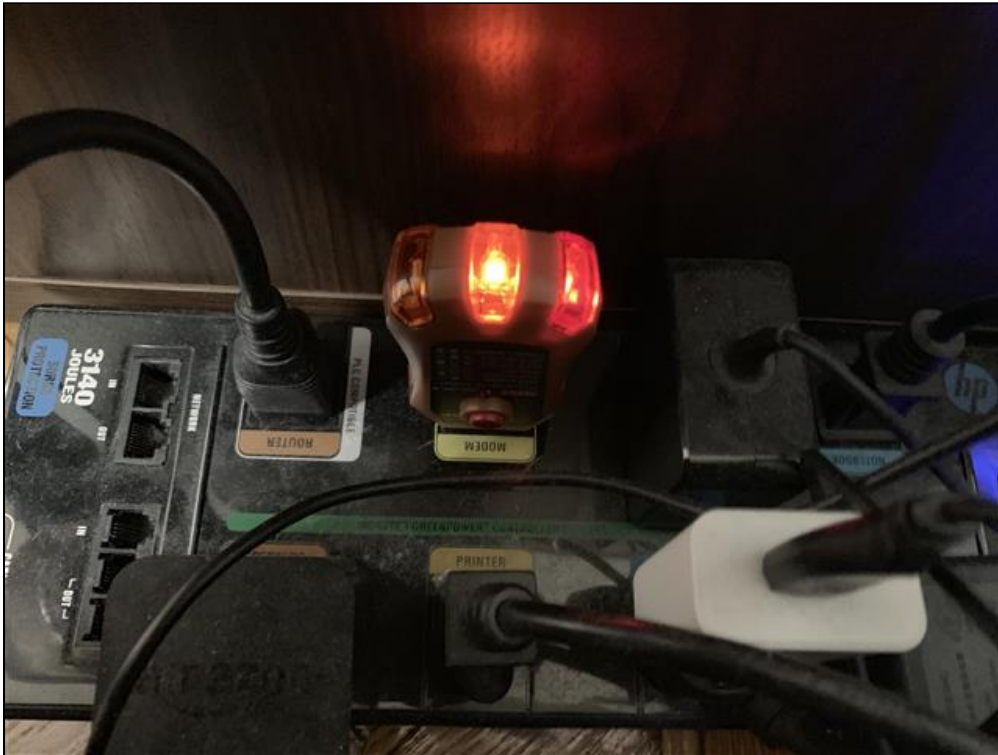
7.3 Item 10(Picture) Hot & neutral wires reversed.

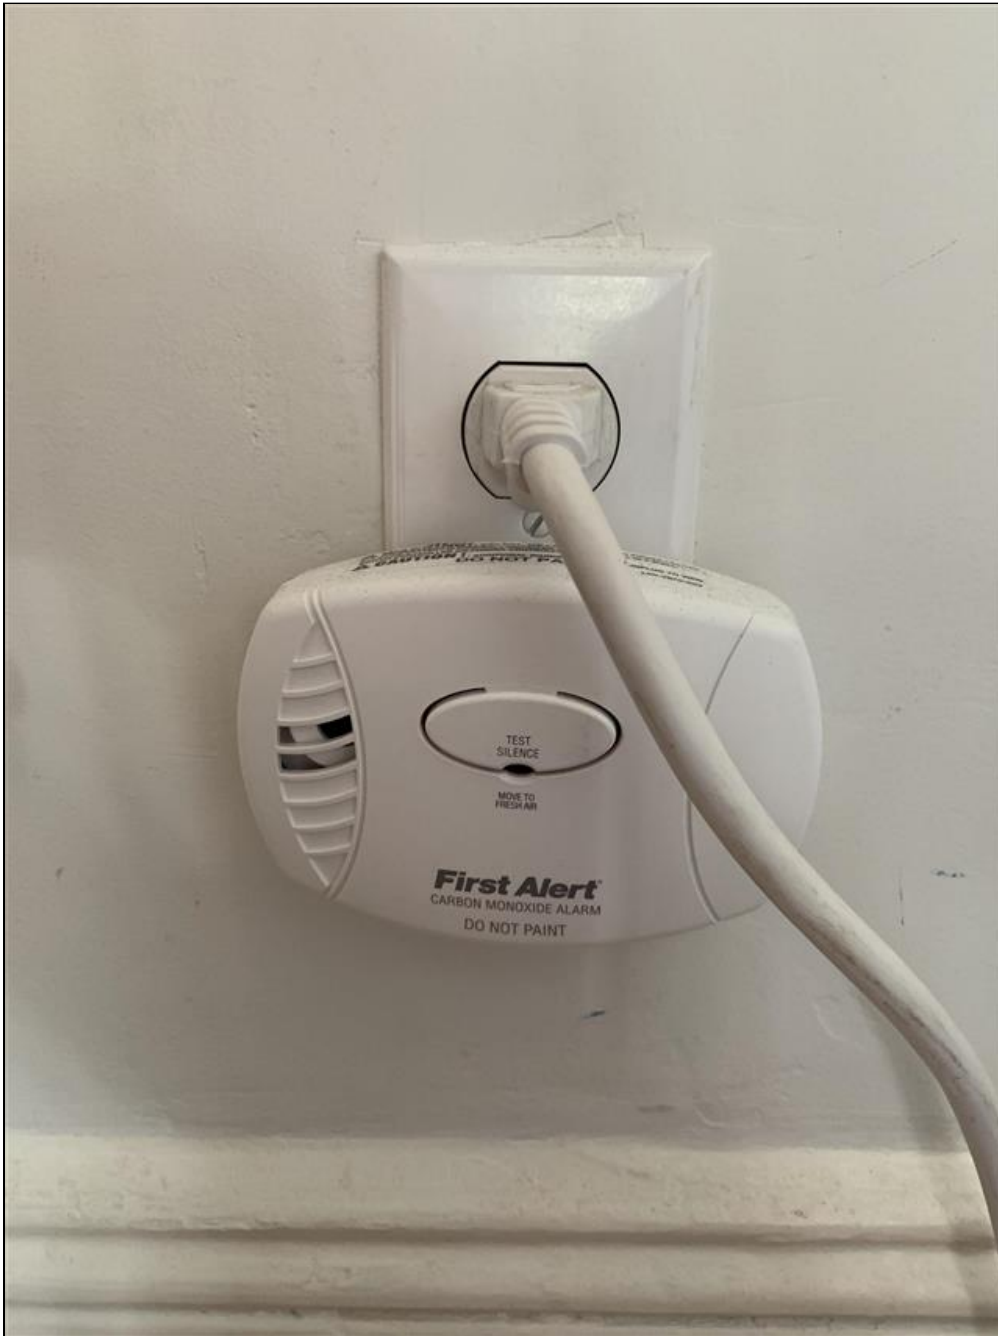
7.8 Item 1(Picture) A few plug-in CO detectors were noted but these may not come with the home.

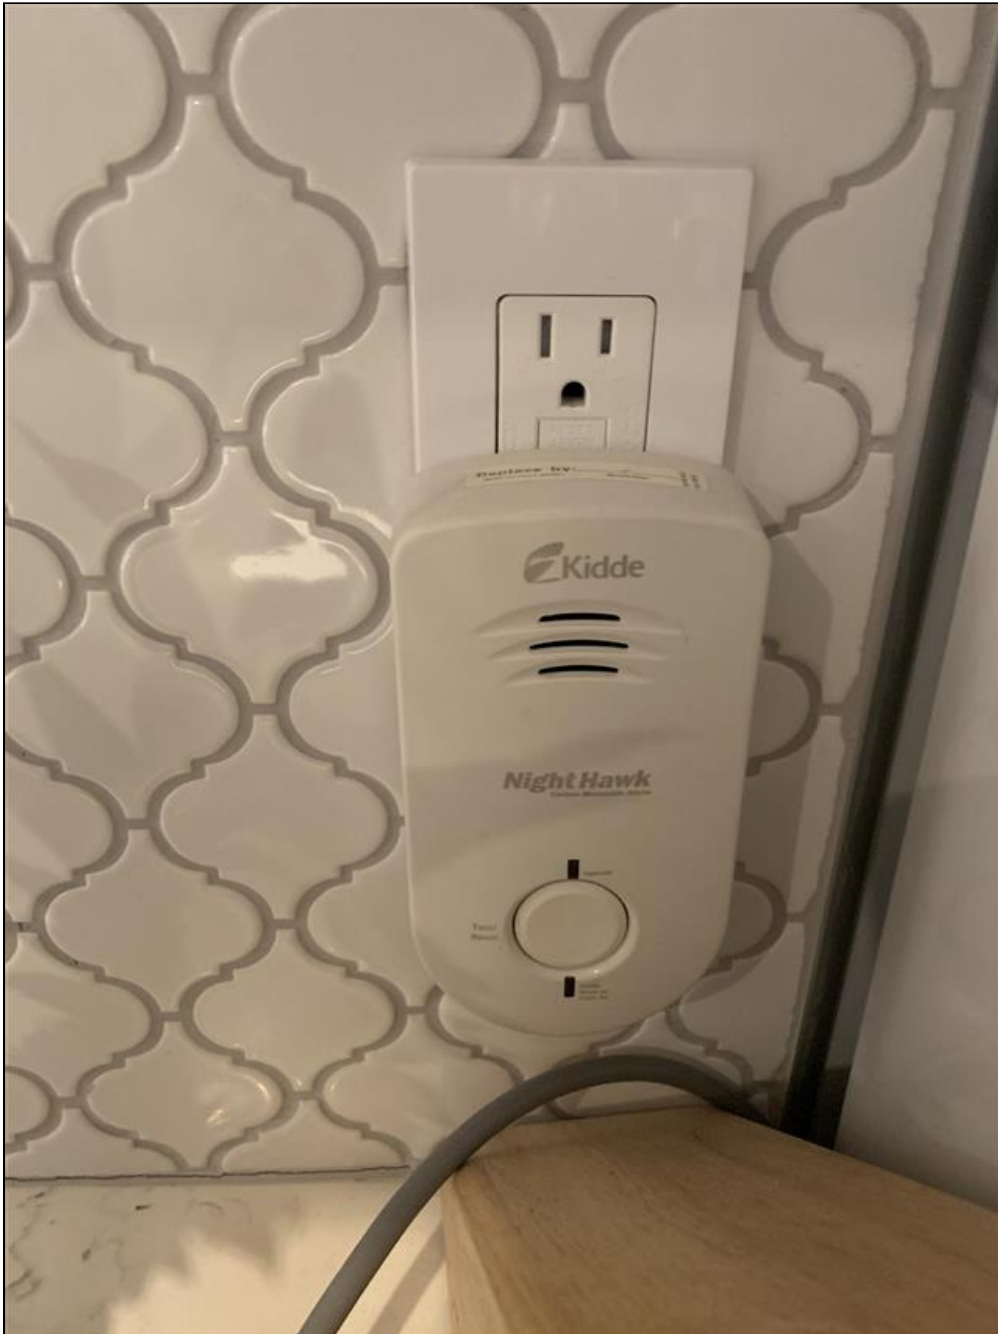
7.8 Item 2(Picture) A few plug-in CO detectors were noted but these may not come with the home.

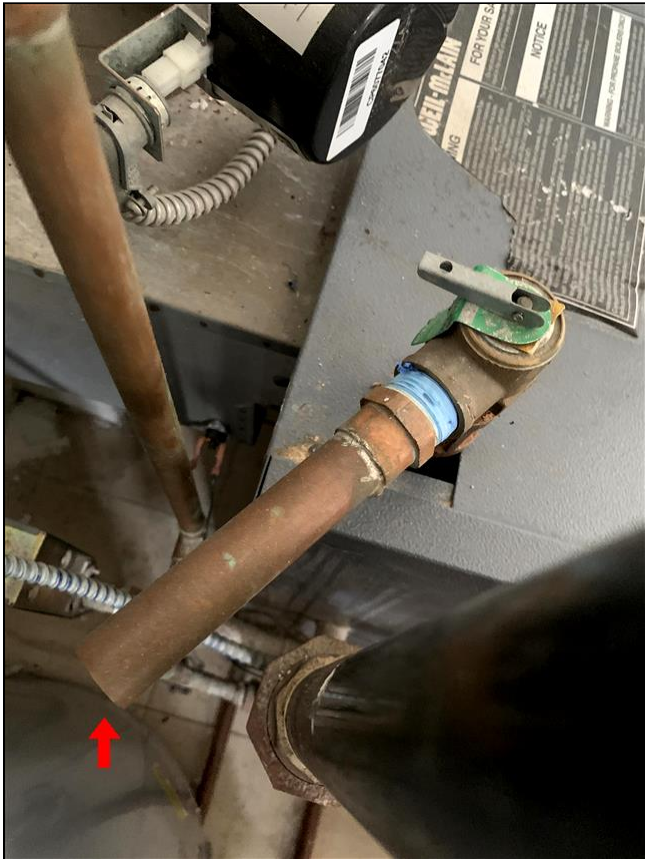
8.0 Item 6(Picture) TPR valve discharge pipe does not extend to 6 inches above the floor.

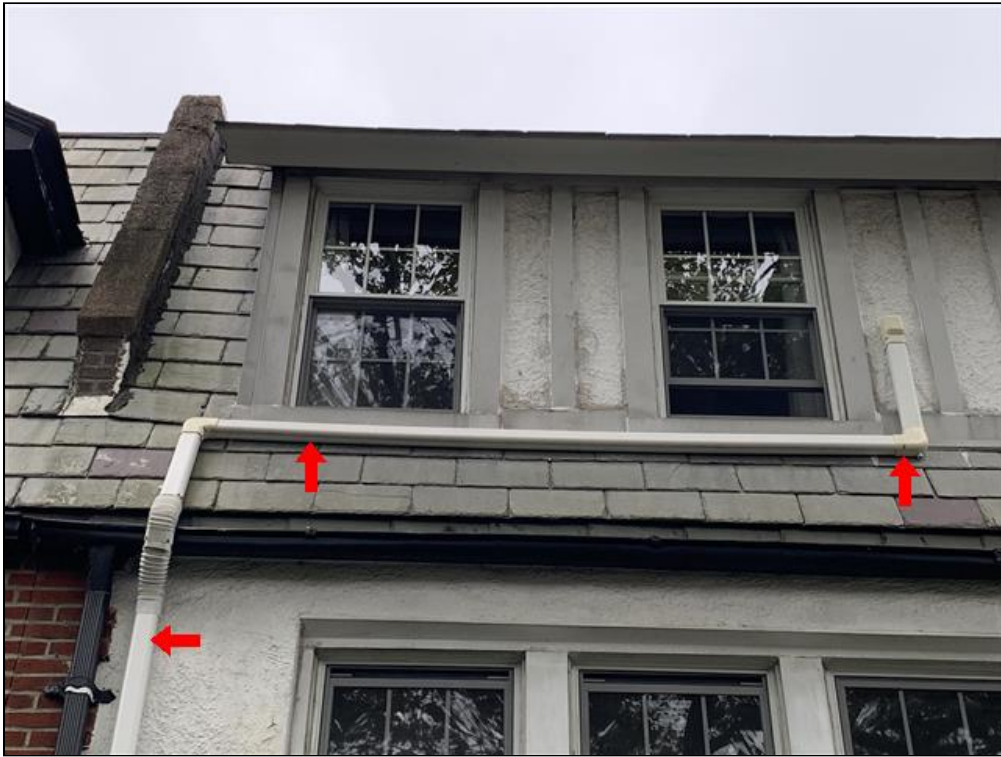
8.8 Item 4(Picture) Conduit for third floor HVAC condensation drainage.

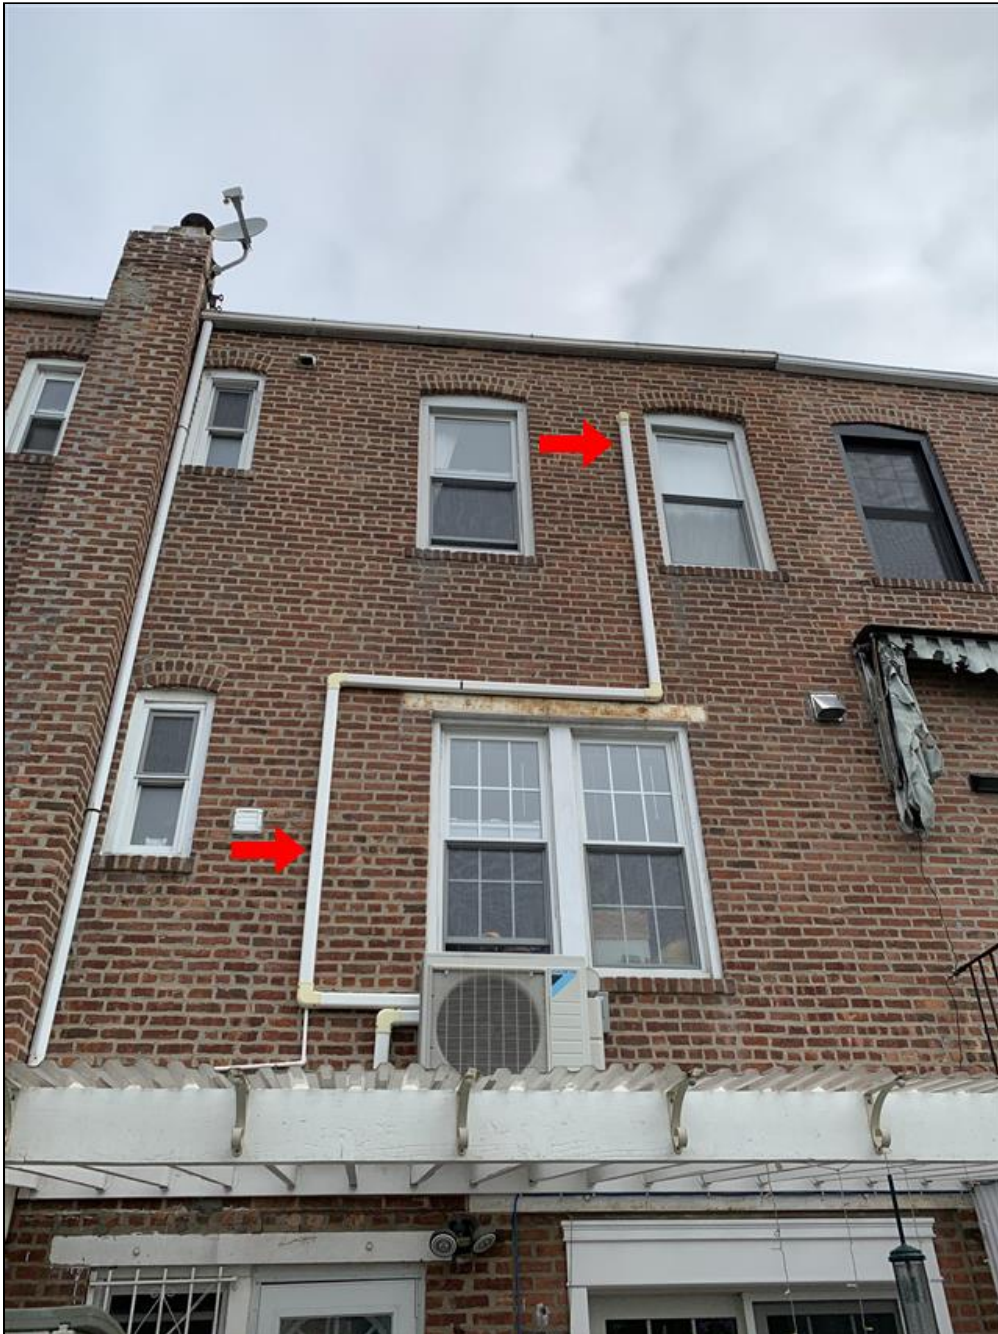
8.8 Item 5(Picture) Conduit for third floor HVAC condensation drainage.
