Inspection Date February 10, 2020

Inspector Brandon Feltner

TREC # 22952, TDA #
0802086

PROPERTY INSPECTION REPORT

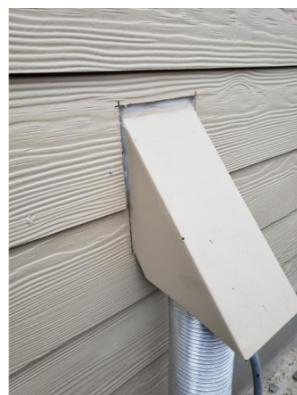
Behind AC-Condenser

Item Siding
Concern Flashing is ineffective (HVAC penetration)
Location Exterior
Impact The flashing is present but not properly installed. The top edge of the flashing should tuck under & behind the siding in a shingle like fashion rather than globbing sealant at the top opening. Over the long term, this sealant will deteriorate & allow water to enter the inner wall at the penetration for the AC-Condenser refrigerant piping. Eventually, water damage to the framework can occur.

Example of proper hood installation

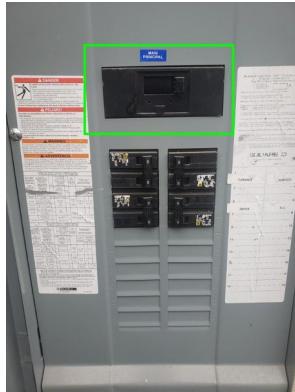
Exterior service panel,
right side of home

Observation FYI- This is the main electrical shutoff for the home. This shutoff is outside so that it is accessible by first responders in the event of an emergency.

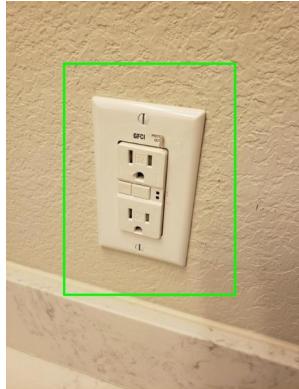
In upstairs bathroom

If ever your bathroom outlets appear to not have power, check here first & push the button marked "Reset" until it clicks back in place.

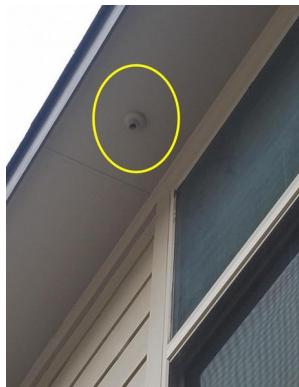
Under eave, left side of home

Item AC-Evaporator Coil
Concern FYI- This is the HVAC secondary drain discharge point
Location Exterior
Impact It is meant as a way to protect the home from water damage if the primary drain stops working. If you ever see water draining/dripping from here, have an HVAC technician service the unit.

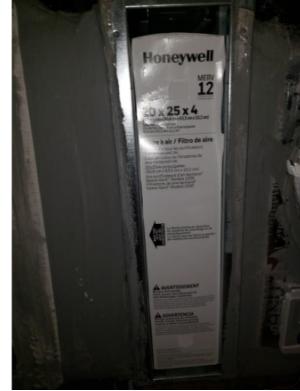
At HVAC unit in attic

Item AC-Evaporator Coil
Concern FYI- This is your HVAC filter size & location
Location Attic

Filter size is 20x25x4

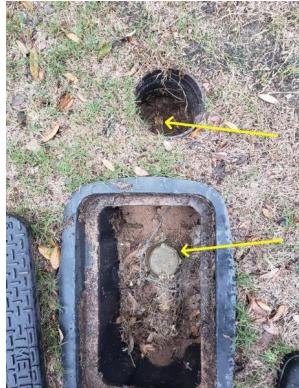
Front yard, left corner of lot

Concern FYI- The black box houses your water meter.
The next pipe up is the main water shut off valve.

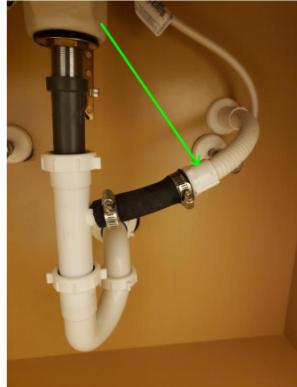
Under right sink in
upstairs bathroom

Concern FYI- This hose is the primary condensate drain line from the A/C. It discharges into the sink drain. This is a very common installation practice.
Always monitor this drain & keep it clean. If this sink ever becomes slow to drain (E.g. hair or buildup) it may effect the ability to properly drain the condensate from the air conditioner.

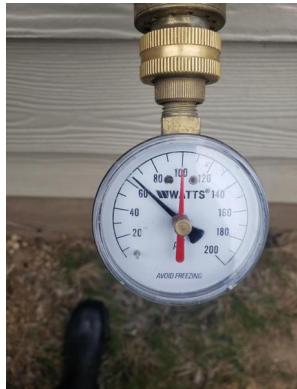
Observation FYI- Water pressure is good at 62 psi. The recommended range is 40-80 psi.

House water pressure is
62 psi

If you ever need the pressure adjusted, you can easily have it increased/decreased at the pressure reduction valve by a licensed plumber or qualified person.
