# Inspection Report

## Towne Inspections

<b>Date:</b> 8/16/2019	<b>Time:</b> 09:00 AM	<b>Report ID:</b> 001093
<b>Property:</b>

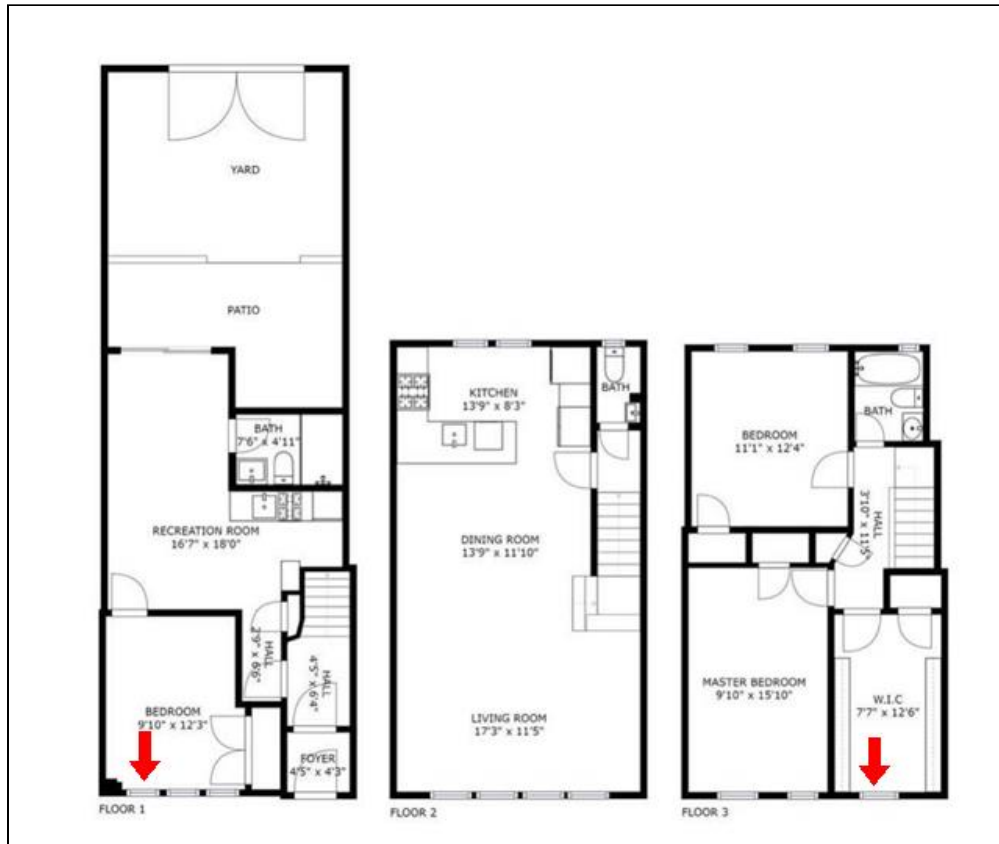
4.7 Item 3(Picture) Floor plan showing locations.

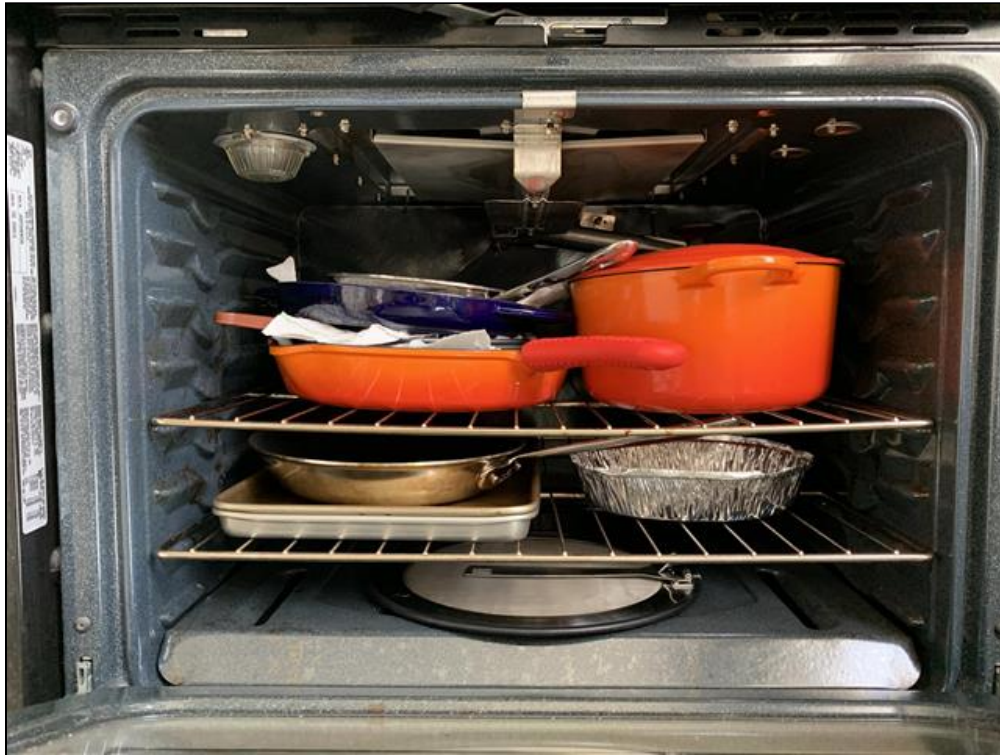
10.0 Item 3(Picture) The oven was not fully run due to items (some flammable) in the oven.

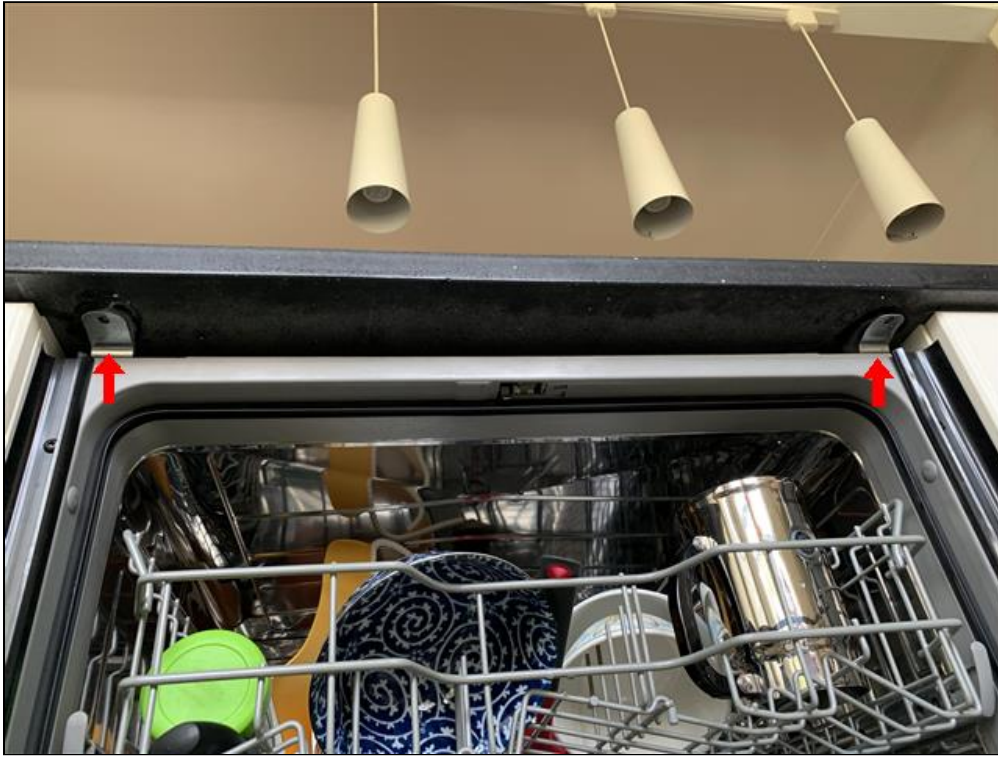
10.3 Item 3(Picture)

**Dishwasher Not Secured:** The dishwasher is loose and needs securing to the underside of the countertop. This can be remedied using a proper length screw on each side.
